10 June 2020

PRODUCT ADVISORY – PLEASE READ

3M™ DBI-SALA® Self-Rescue Training Descent Systems P/N 3320037

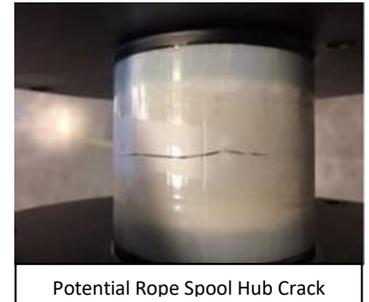
As part of 3M Fall Protection’s on-going commitment to delivering high quality safety equipment, we continually evaluate feedback from our customers on product performance. Through the evaluation of returned training units, we have detected that the inner rope spool may develop a crack after multiple uses. The number of occurrences is very low, and we are not aware of any accidents or injuries related to this condition. This condition could impact the ability of the trainee-user to descend.

Potential Rope Spool Hub Crack

To address this potential condition, we are implementing a design and material change to the inner rope spool. We have therefore placed the RSQ models “On Manufacturing Hold” with an anticipated product availability date of June 2020. In the interim, we have updated our IFU to include an inspection for this condition of the inner rope spool as part of the resetting of the training RSQ device required after each descent. You can access a copy of this notice and the updated IFU through this link <http://go.3M.com/TrainingSelfRSQ>. For those units already in the field, we are requesting that this inspection be completed by the competent person as an additional step when completing the resetting of the training RSQ after each descent. If a crack is detected, please remove the training unit from service and contact the 3M Fall Protection Customer Service Team at informationfallprotection@mmm.com or +33 (0) 4 83 58 08 08. We will repair or replace your units as per our standard warranty policy.
