Product Advisory

Select 3M™ DBI-SALA® ExoFit™ XP Arc Flash Harnesses

1 January 2005 – 1 July 2021

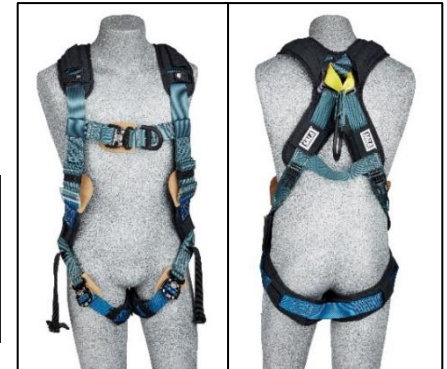
Step 1: Please inspect your 3M™ DBI-SALA® Arc Flash Harness label (see photograph above) to confirm that it is one of the affected part numbers listed above and was manufactured between the dates listed above.

Step 2: If you have identified that you have an affected harness, please follow the instructions accompanying this document to remediate your harness’s attachment clips.
