# Customer Advisory Notice

**STOP USE AND IMMEDIATE INSPECTION REQUIRED**

## ELSA Hood Assemblies used on certain 3M Scott ELSA 2000, ELSA Sprint, and ELSA Muster Emergency Escape Breathing Devices

3M™ Scott™ Fire & Safety

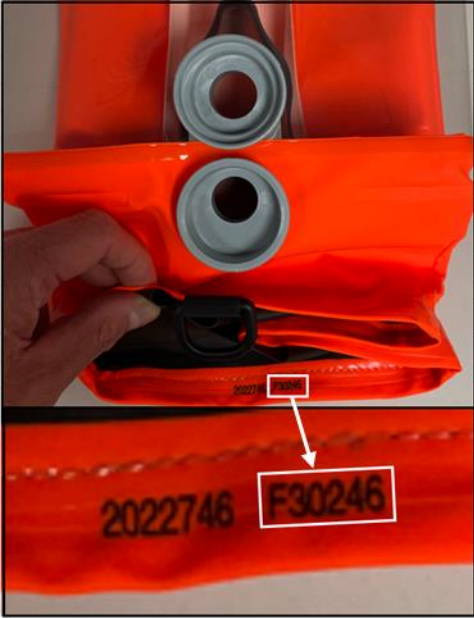
Instructions	Figures										
<p>The ELSA hood has a printed code (e.g. FXXXXX) on its inside edge as illustrated in Figure 1.</p>

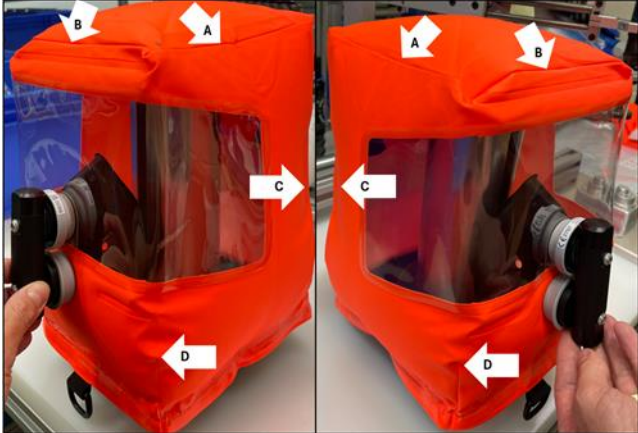
<p><b>Figure 3 – Location points of the hood seams</b></p>

Instructions	Figures								
<p><b>A.</b> The seams of the hood are indicated in figure 3.</p>

<table><tr> <td><b>A</b></td> <td><b>Hood top, left &amp; right</b></td> </tr><tr> <td><b>B</b></td> <td><b>Hood top front</b></td> </tr><tr> <td><b>C</b></td> <td><b>Hood rear, left &amp; right</b></td> </tr><tr> <td><b>D</b></td> <td><b>Hood front, left &amp; right</b></td> </tr></table>

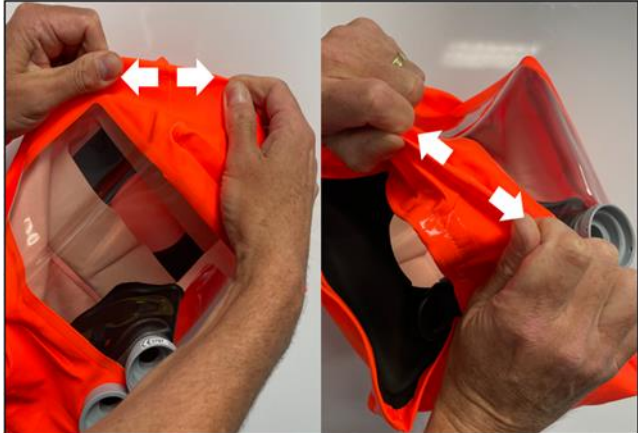
<p><b>Figure 4 – Applying pressure on the seam</b></p>

3M™ Scott™ Fire & Safety has identified a quality issue involving a limited quantity of certain batches of hood assemblies on the 3M™ Scott™ ELSA 2000, Sprint & Muster variants. A limited number of ELSA Hood assemblies have been identified with a seam defect that may cause air to leak from the hood and contaminants from the external environment to flow into the hood.

<b>A</b>	<b>Hood top, left &amp; right</b>	<b>B</b>	<b>Hood top front</b>	<b>C</b>	<b>Hood rear, left &amp; right</b>	<b>D</b>	<b>Hood front, left &amp; right</b>
<b>A</b>	<b>Hood top, left &amp; right</b>								
<b>B</b>	<b>Hood top front</b>								
<b>C</b>	<b>Hood rear, left &amp; right</b>								
<b>D</b>	<b>Hood front, left &amp; right</b>								
<p><b>B.</b> For each seam, pinch the orange material on either side of each of the indicated seams.</p> <p><b>C.</b> Pull apart in opposite directions away from the seams, as indicated by the white arrows in Figure 4. If the seam is faulty, it will separate relatively easily.</p> <p>If any of the seams separate when the pull force is applied, kindly return the hoods to a 3M Scott Authorised Service Centre for hood replacement.</p> <p>If none of the seams separate when the pull force is applied, please repack the hood into the ELSA bag.</p> <p>Alternatively, please return the quarantined items to your nearest 3M Scott Authorised Service Centre.</p>
