# Inspection / Evaluation of 3M VHB Structural Glazing Tape for Structural Integrity after Years of Service

CLIENT:	<b>3M INDUSTRIAL ADHESIVES &amp; TAPES DIVISION</b>
CDC PROJECT #:	F00892
TESTING PERFORMED BY:	KEN BOWNDS & BRYAN HEAKE (CDC)
TESTING ASSISTED BY:	STEVE AUSTIN, KEN GOH, & PEDRO TERZI (3M)
REPORT PREPARED BY:	BRYAN HEAKE
SUBMITTED ON:	JANUARY 11, 2011

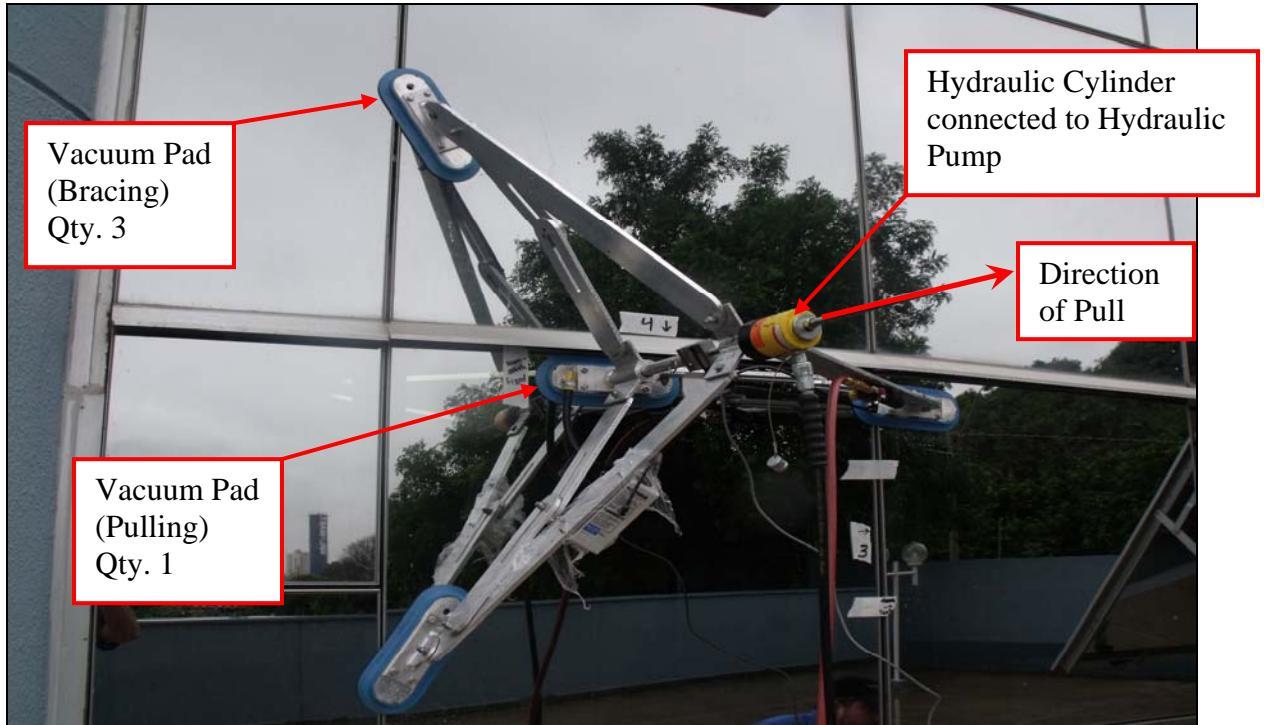
**Photo #001:** Testing apparatus in position on the wall. Pulling vacuum pad is close to the center of the length of tape to be tested. Bracing vacuum pads are positioned at interior aluminum framing members.

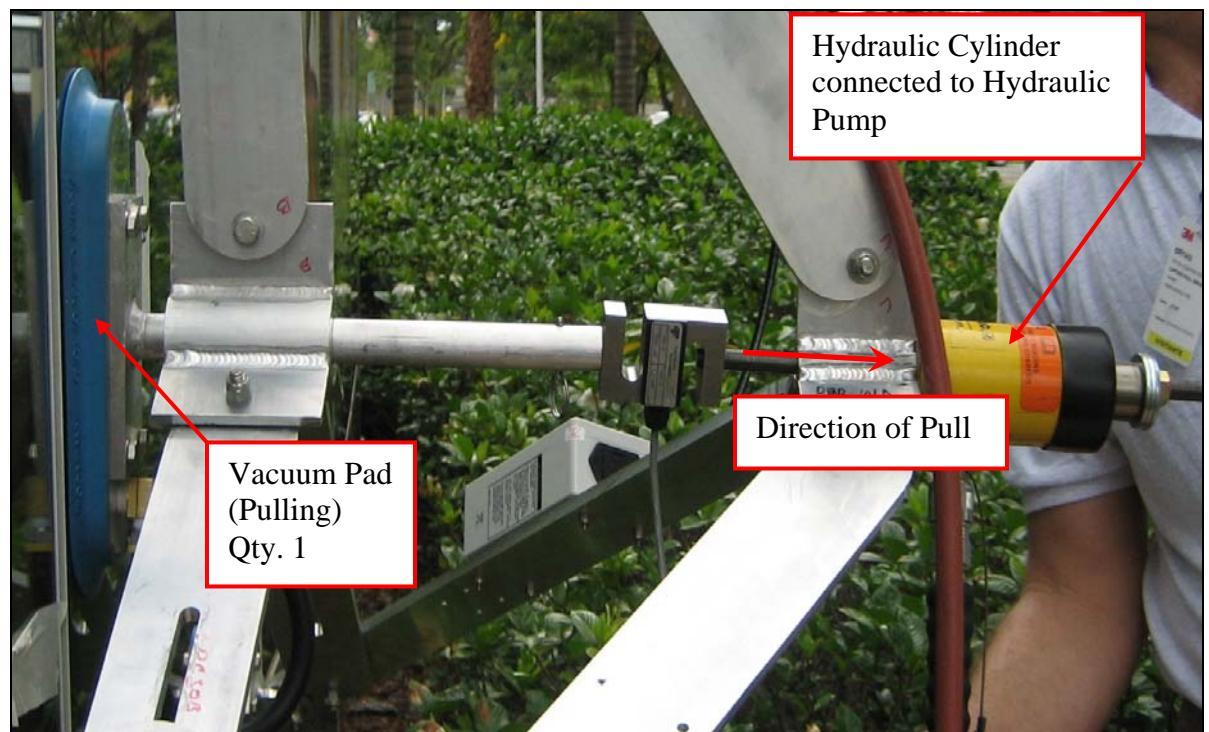
**Photo #002:** Enlarged view of the apparatus where the hydraulic cylinder pulls the vacuum pad; load cell measuring the amount of force is connected to a pressure meter (Photo #004) which recorded the pressure readings.

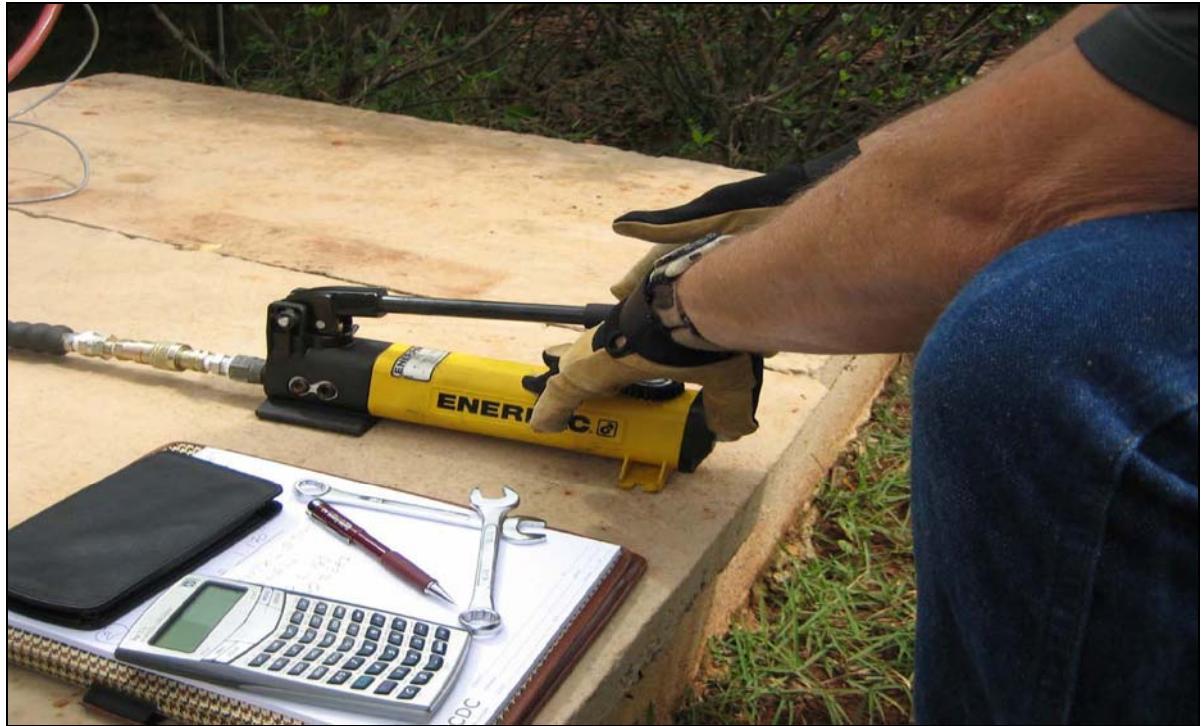
**Photo #003:** Hydraulic pump which is connected to the hydraulic cylinder on the test apparatus. The pump operator monitored the pressure meter, keeping it at the desired load.

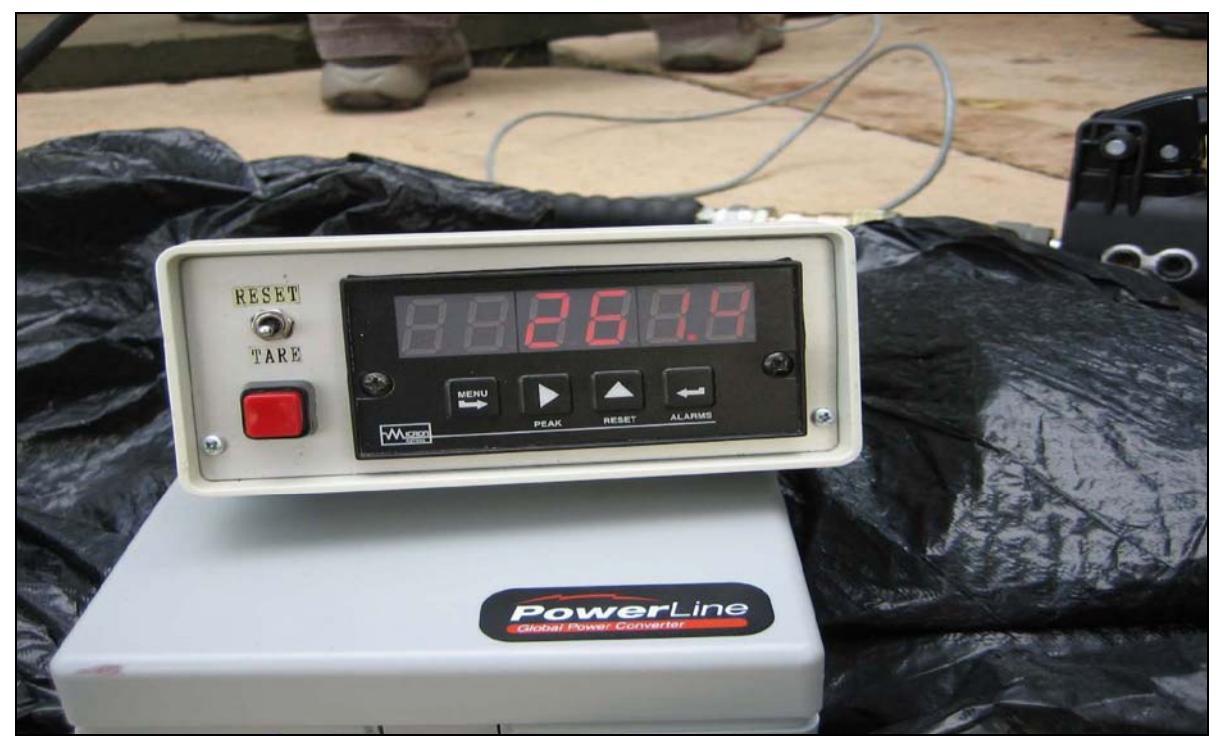
**Photo #004:** The pressure meter connected to the load cell was monitored, keeping the desired force being pulled on the vacuum pad. "S"-Type Load Cell & Pressure Meter were calibrated by RECAL on 11/29/2010 (See Certificate of Calibration attached to this report).

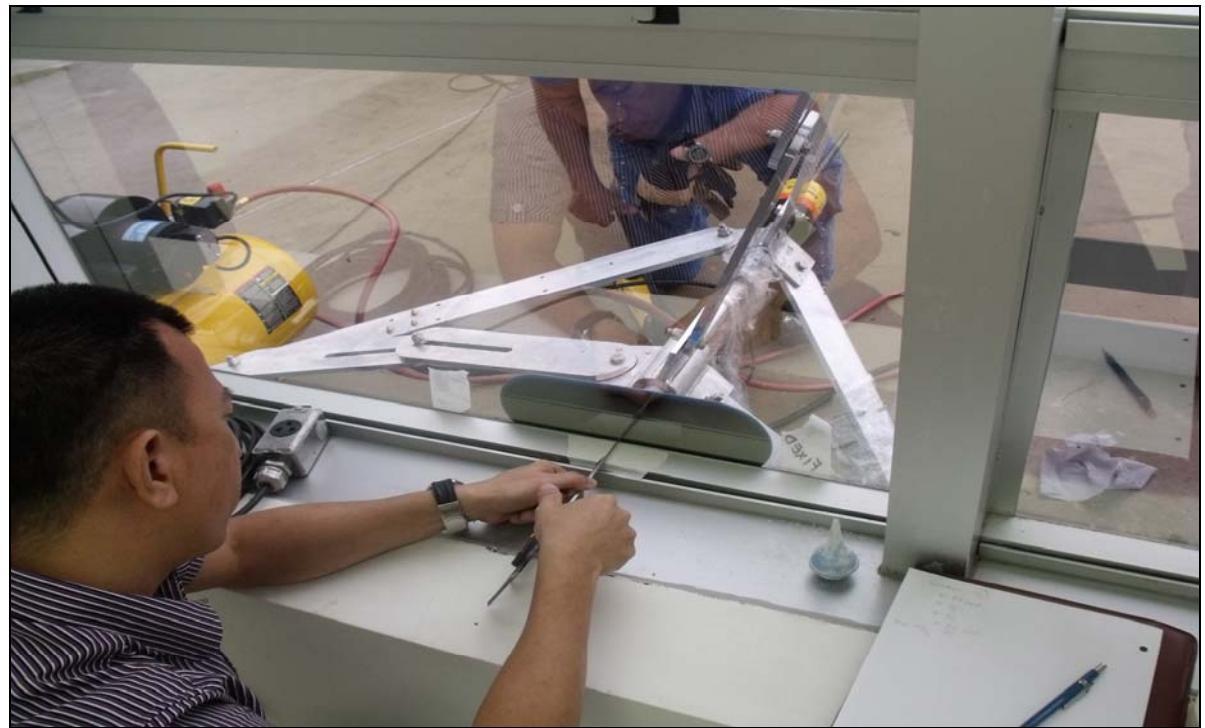
**Photo #005:** Prior to testing, the distance from the inside face of glass to a surface on the aluminum framing is measured (if possible) in its original state of rest using calipers. During each test, the displacement of the glass relative to the aluminum framing is also measured and recorded.

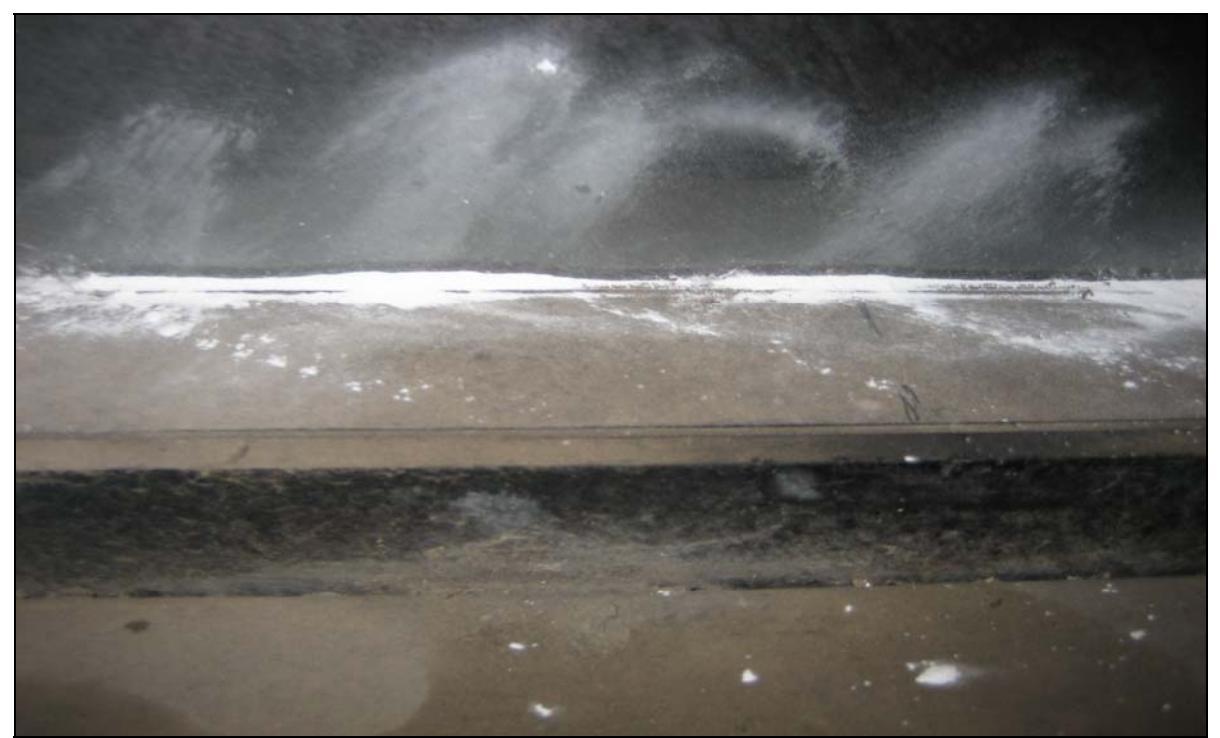
**Photo #006:** Talcum powder was applied at the interior 45 seconds into the overload test to determine if there was evidence of adhesion failure of the VHB SGT to the glass. If adhesion failure occurred, powder would fall into the detached area or void, producing an uneven line of powder when viewed from the exterior (See Photo #007 for exterior view).

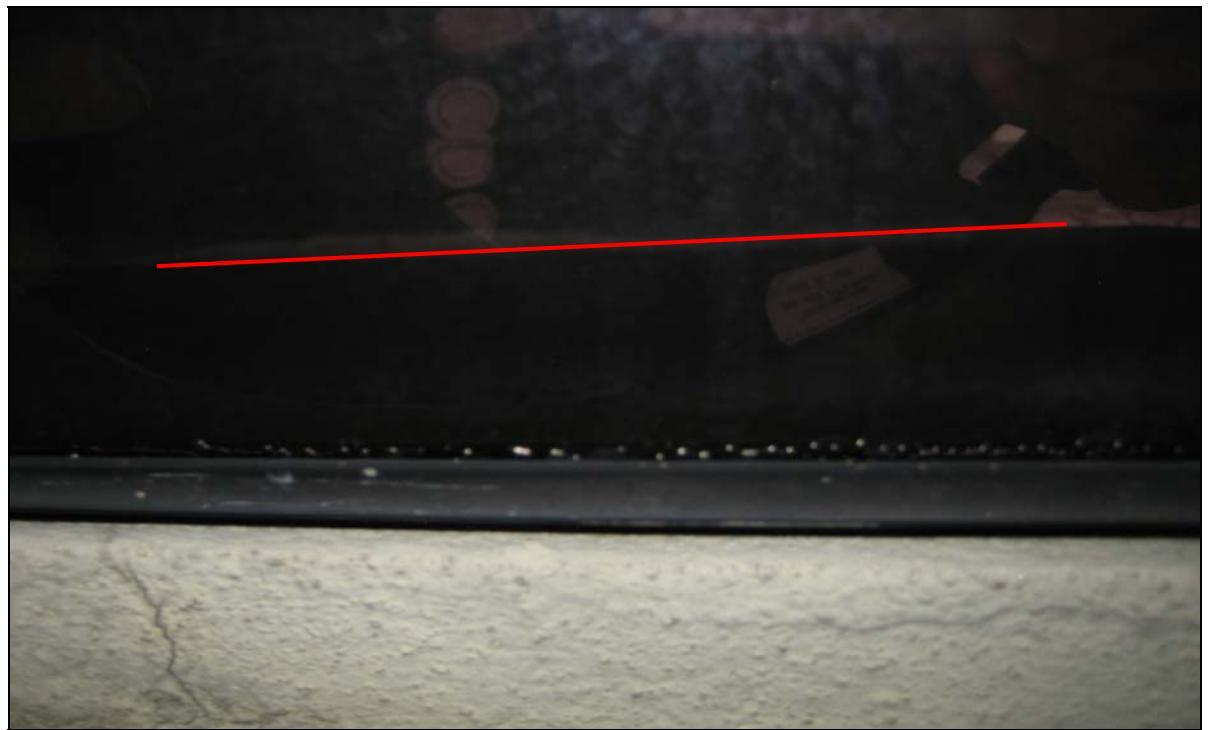
**Photo #007:** Exterior view looking through the glass at the talcum powder. A clean, straight line indicates no visible adhesion failure between the VHB-SGT and glass.

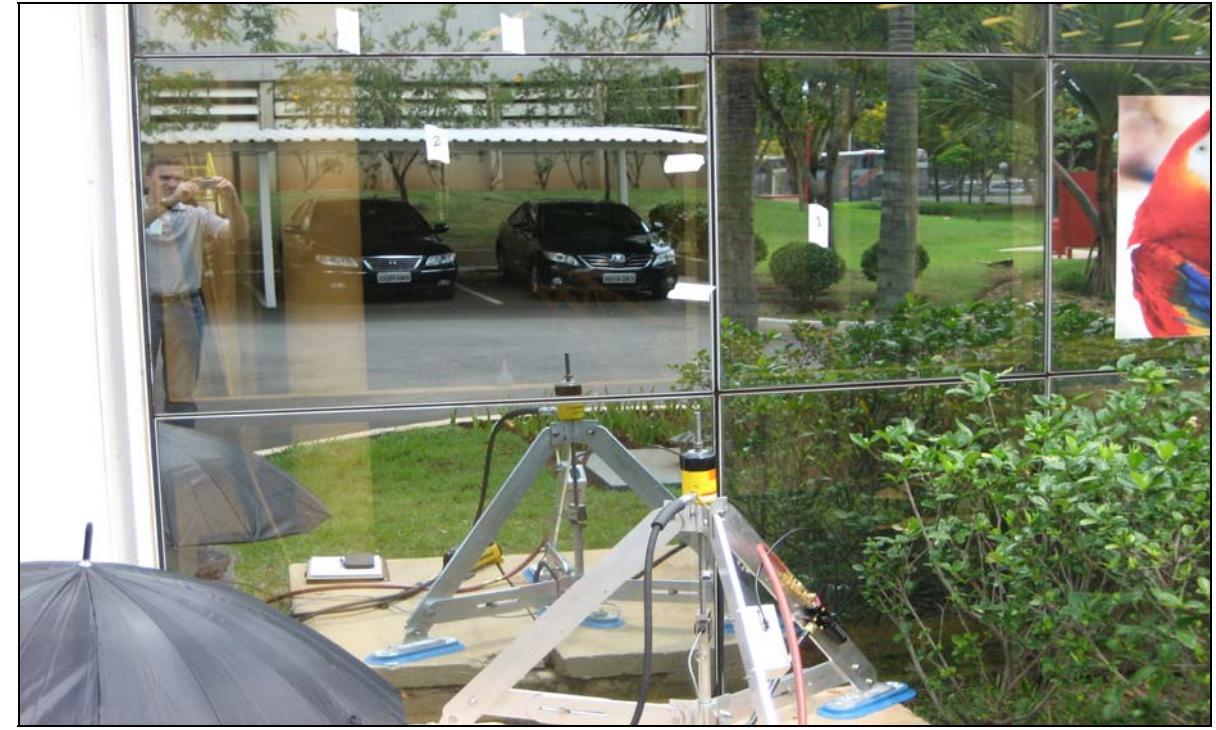
Photo #008: Test Location #1-3M Brazil CTC

Locations 1 and 2 were located at Ground Level, facing West. The glass make-up is: 4mm Tinted/6mm Resin Fill/4mm Clear. The measured tape width was 1.17 inches (29.72 mm). Design Load = 1.17" X 11.75" X 12 psi = 165 lbs. (75 kg) Overload = 1.17" X 11.75" X 18 psi = 247.5 lbs. (112 kg)

#### Both locations passed, with no evident adhesion or cohesion failure.

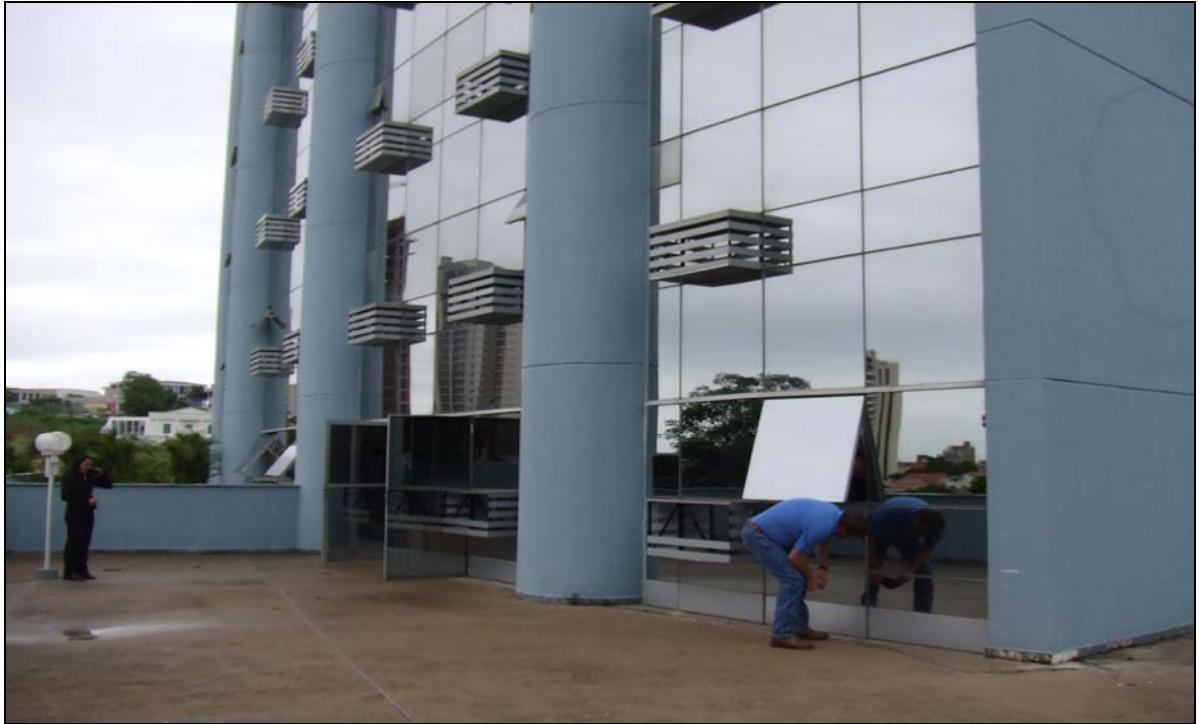
Photo #010: Test Location #2-Dallas Tower

Locations 3 through 7 were located on Level 4, facing North. The glass make-up is: 4mm Reflective/PVB/4mm Clear. The measured tape width was 1.17 inches (29.72 mm). Design Load = 1.17" X 11.75" X 12 psi = 165 lbs. (75 kg) Overload = 1.17" X 11.75" X 18 psi = 247.5 lbs. (112 kg)

Each location passed, with no evident adhesion or cohesion failure.

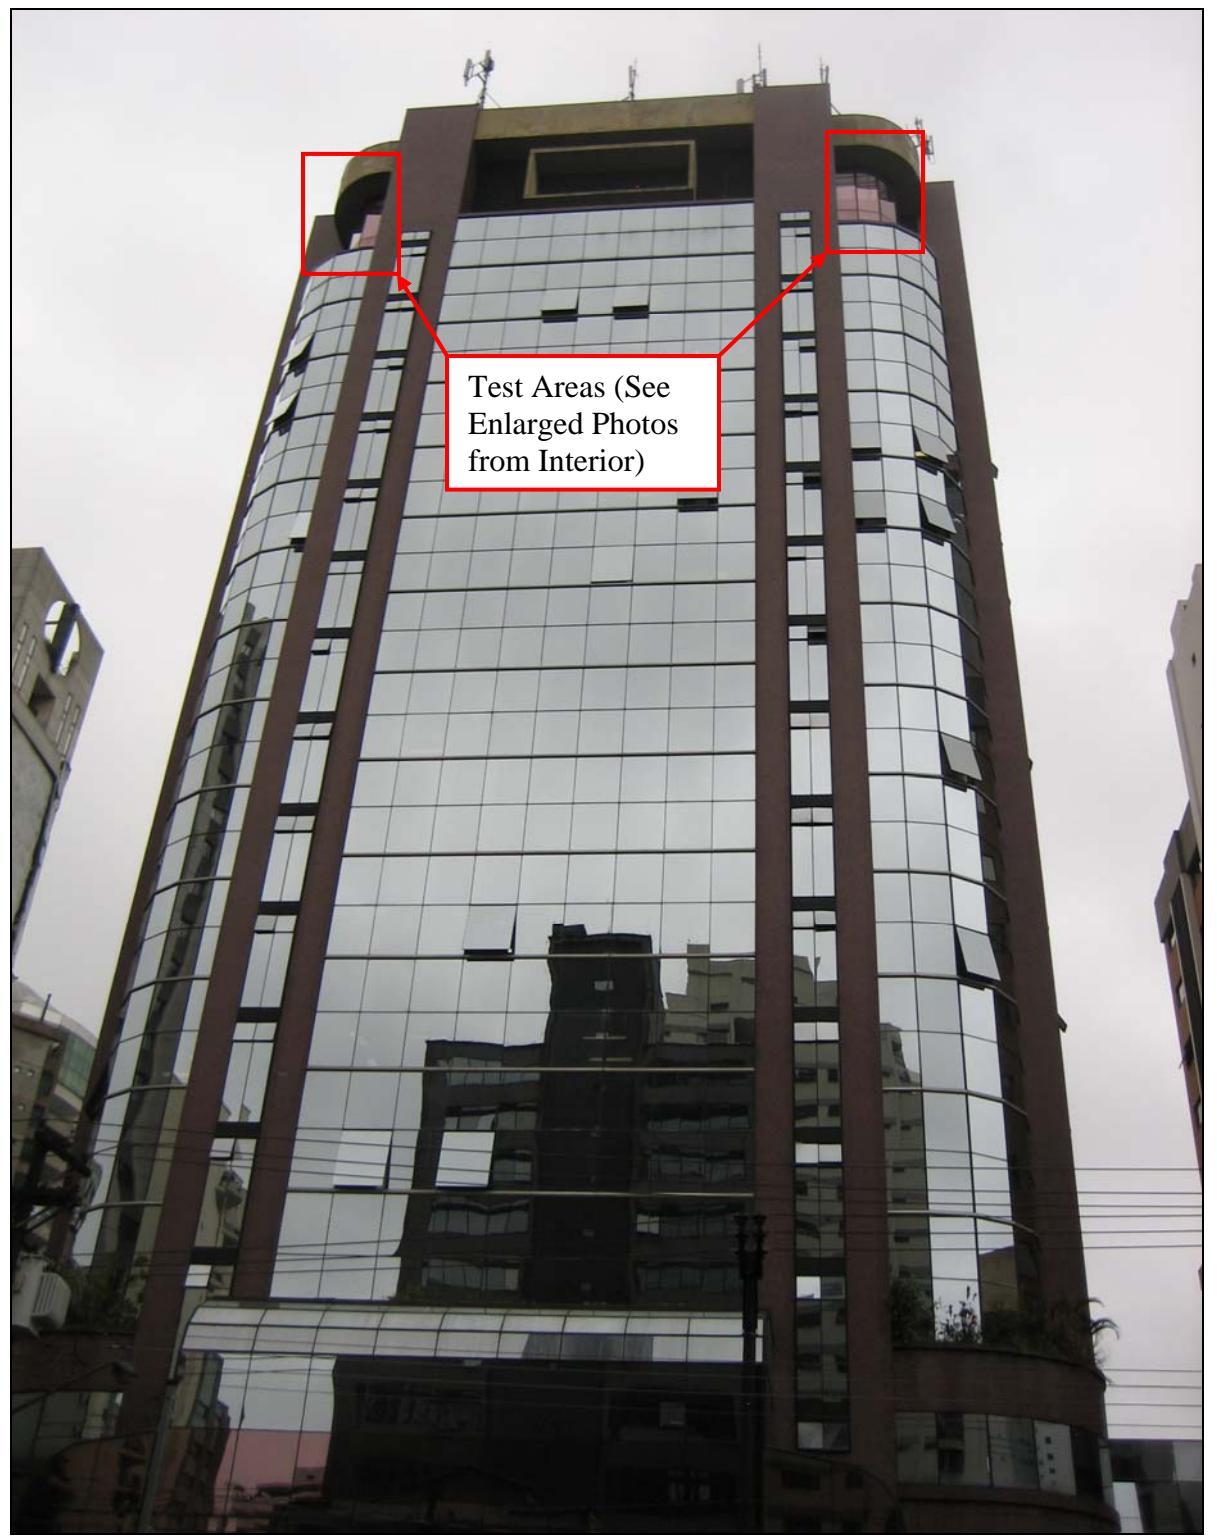
Photo #012: Test Location #3-Glass Tower

Locations 8 through 13 were located on Level 16, facing West. Locations 14 through 19 were located on Level 16, facing South. All glass was fixed (not operable).

Each location passed, with no evident adhesion or cohesion failure.

\*Window sub-frame began to disengage from the main framing members; therefore measurements could not be obtained.

\*\*Testing was stopped due to disengagement of glass/sub-frame to main framing members.

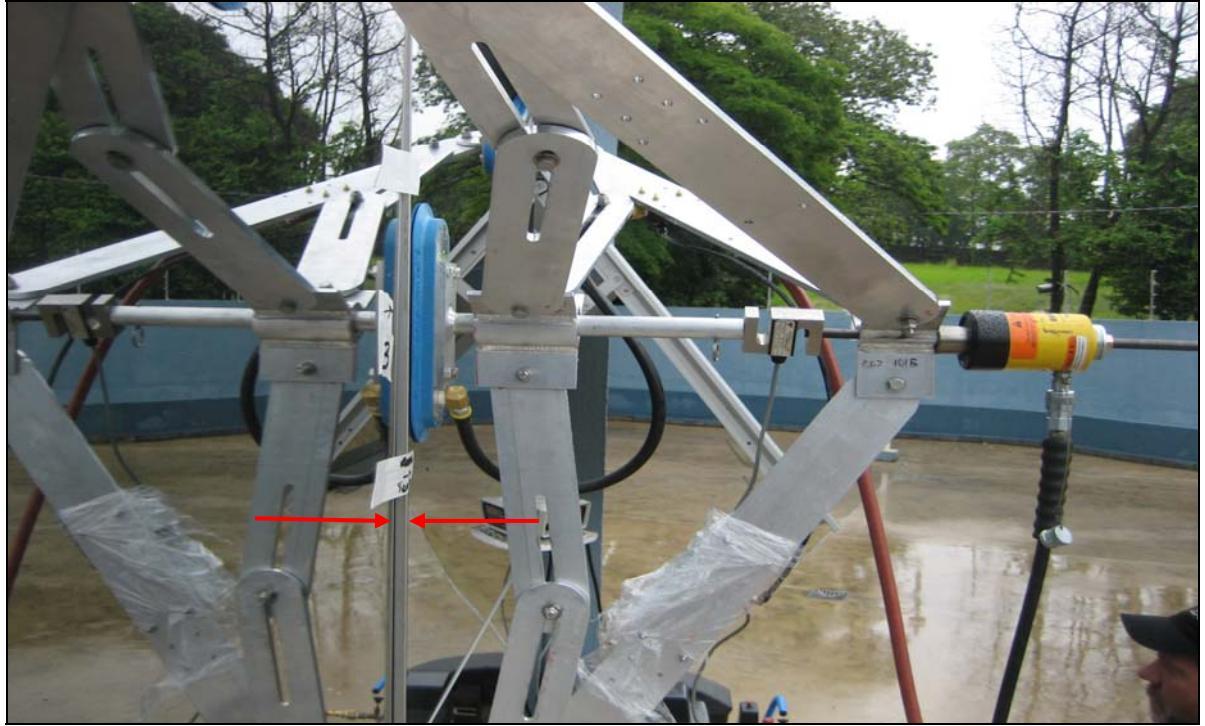
Photo #019: Testing being performed. Note the amount of offset at the adjacent glass / framing.

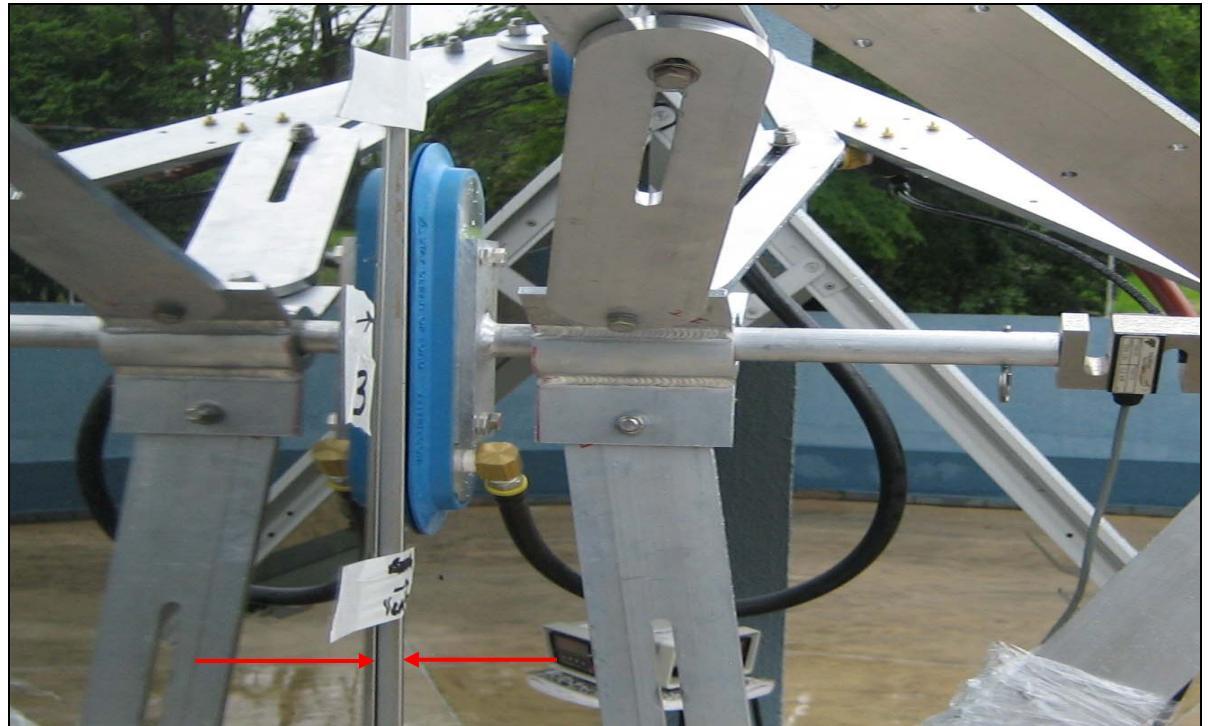
Photo #020: Blow-up photo of glass / framing offset due to testing (pulling action) being performed.

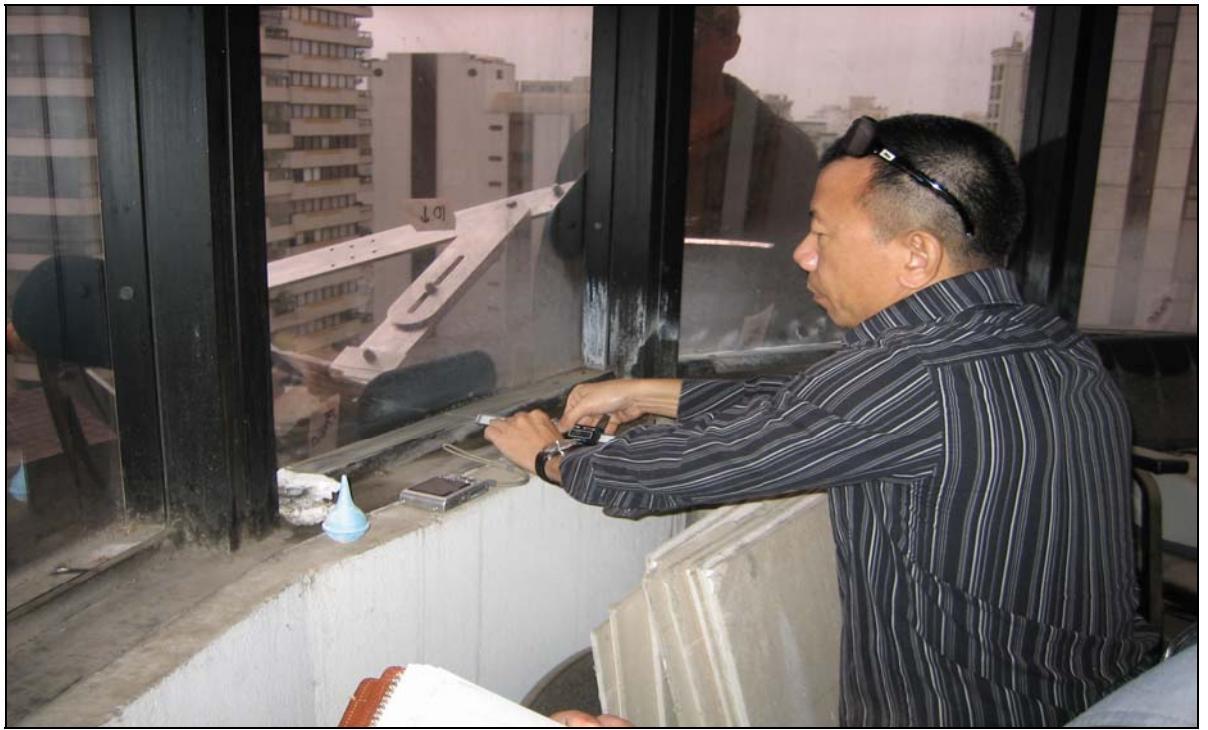
**Photo #021:** During each test, the displacement of the glass relative to the aluminum framing is measured and recorded.
