Measurement and Analysis of Diamond Retention in CMP Diamond Pad Conditioners

Authors: Brian Goers, Senior Product Development Engineer – 3M Company
Gary Palmgren, Product Development Specialist – 3M Company
Vince Laraia, Product Development Specialist – 3M Company

Date: March 14, 2000

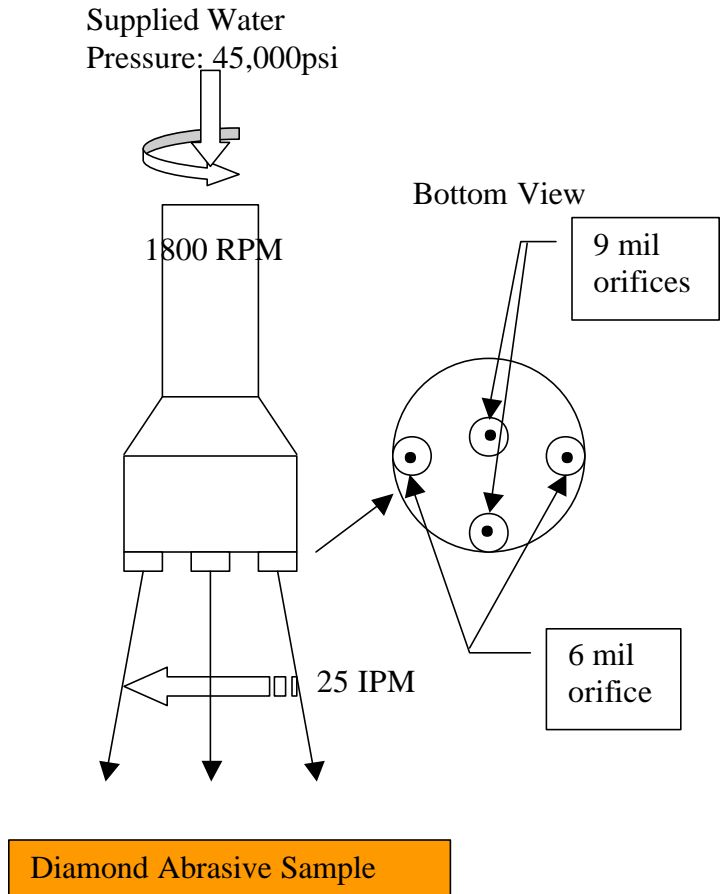
Fig. 1 Washing Apparatus Schematic

1.2 Test Apparatus: The test apparatus consists of a high pressure washing head mounted to a Romeo Engineering Inc., (Fort Worth, TX, model AWJGU2) waterjet cutting and cleaning device. Water is delivered to the washing head via a high-pressure pump. The 45,000-psi supply water is split into four streams and passes through 6mil and 9mil orifices in the configuration shown in figure 1 (bottom view). The washing head (Jet Edge Inc. Mpls, MN P/N A3126) is rotated by a pneumatic motor at 1800 rpm, thereby producing a circular wash pattern that will contact the entire surface of the part as it is passed over it.

1.3 Test Procedure: The diamond abrasive sample is fixed in the waterjet tank. The head is then passed over the diamond abrasive sample at a rate of 25 IPM at a height of 3 inches. SEM micrographs are then taken of the washed and unwashed samples at 20X and 100X at a 60 degree angle.

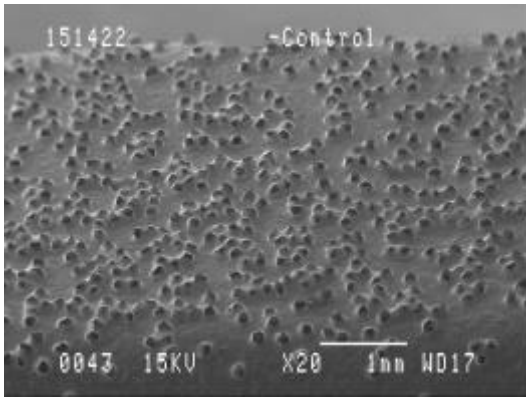
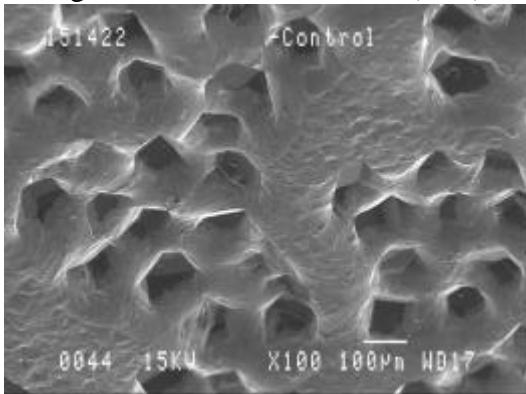
Fig. 2 Vendor A- Unwashed (20X)

Fig. 3 Vendor A-Unwashed (100X)

1.4.1 Vendor A: The product of brazing technology is shown in the pretest state in figures 2 and 3. The diamond particles form a random/clustered pattern. The diamonds fall in this pattern due to the surface tension of the braze alloy used to bond the diamonds to the substrate as well as the random placement of the diamonds prior to brazing.

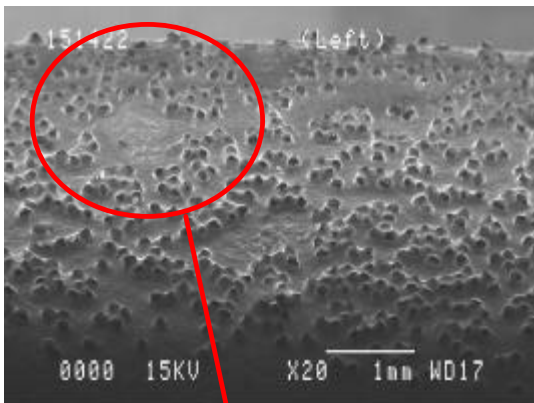
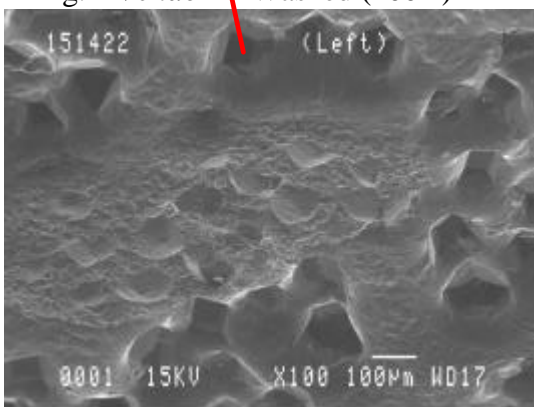
Fig. 4 Vendor A-Washed (100X)

Fig. 5 Vendor A-Washed (20X)

SEM micrographs of the waterjet washed *Vendor A* sample (Figures 4 and 5) shows the effect of the high pressure waterjet washing on the *Vendor A* diamond to metal bond strength as well as the overall diamond strength. Large islands of diamond and metal bond were removed with the wash test. In some cases, partial diamond fragments were still attached to the substrate (figure 5).

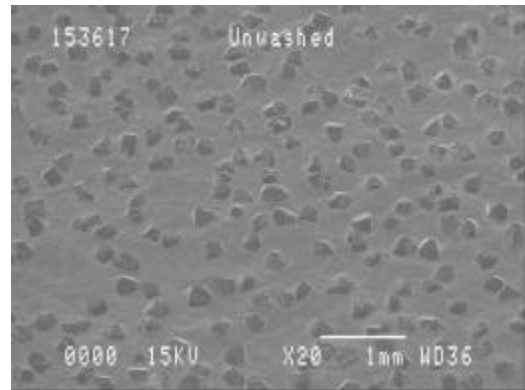
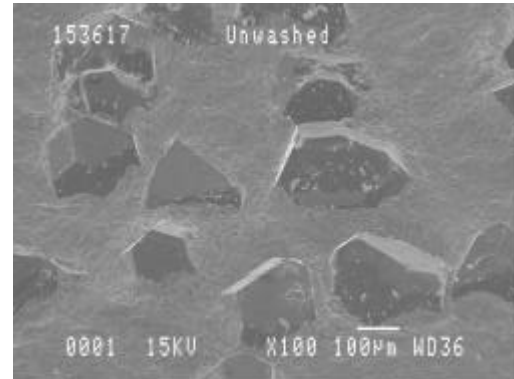
(STD): The 3M sintered diamond material utilizes patented techniques for controlled placement of diamonds in a corrosion resistant sintered metal bond matrix. The unwashed 3M STD sample is shown in figures 6 and 7.

Fig. 6 3M Std. Unwashed (20X)

Fig. 7 3M Std. Unwashed (100X)

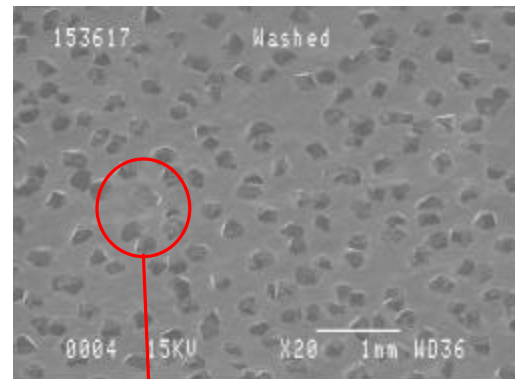
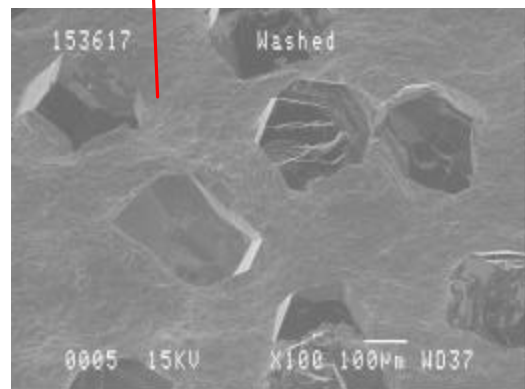
SEM micrographs of the 3M conditioning disk- washed sample (figures 8 and 9) shows minimal loss of diamond. In this test, scattered individual diamonds are removed from the metal bond matrix. In the typical region depicted in Figure 8, only 1 diamond out of 189 was removed over an area of about 26mm².

Fig. 8 3M Std. Washed (20X)

Fig. 9 3M Std. Washed (100X)

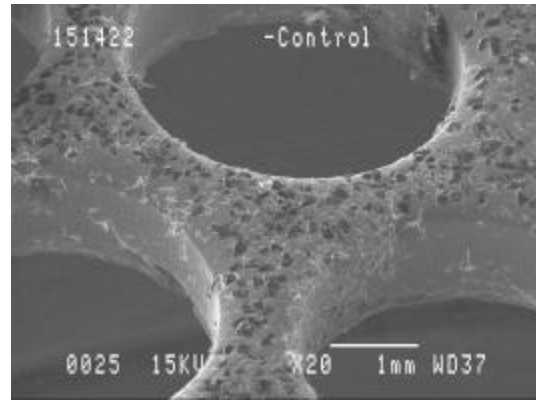
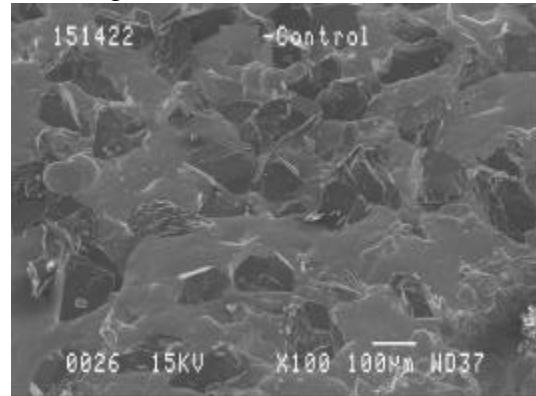
1.4.3 Vendor B: The *Vendor B* diamond pad conditioner is shown in its unwashed or pretest state in figures 10 and 11. These disks utilize standard plating technologies on a perforated metal substrate. This technique randomly drops diamonds onto the substrate and mechanically holds them in place with an electroplated nickel bond.

Fig. 10 *Vendor B* Unwashed (20X)

Fig. 11 *Vendor B* Unwashed (100X)

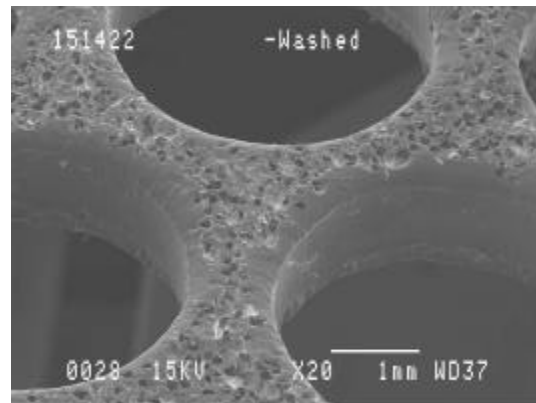
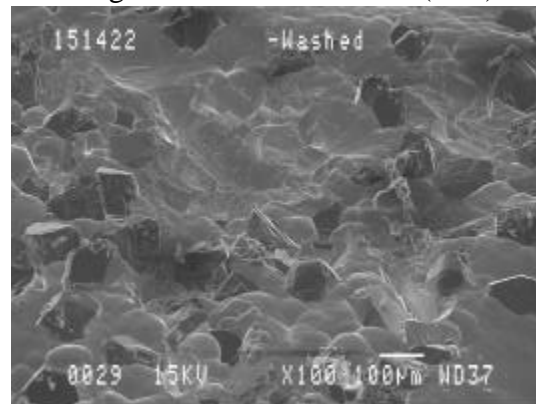
The effect of the high-pressure waterjet wash can be seen in figures 12 and 13. The result of this test shows that a large number of diamonds have been removed from the disk, either by diamond fracture and/or poor diamond adhesion to the substrate. Due to the large amount of diamond loss, it is very difficult to get an exact count from the SEM micrograph (figure 12). However, figure 13 was used to get a more accurate count of diamond loss, then the area was taken into account to get an approximate number (approx. 125). The amount of diamond loss would be even larger if the area of the perforations was included.

Fig. 12 *Vendor B* Washed (20X)

Fig. 13 *Vendor B* Washed (100X)

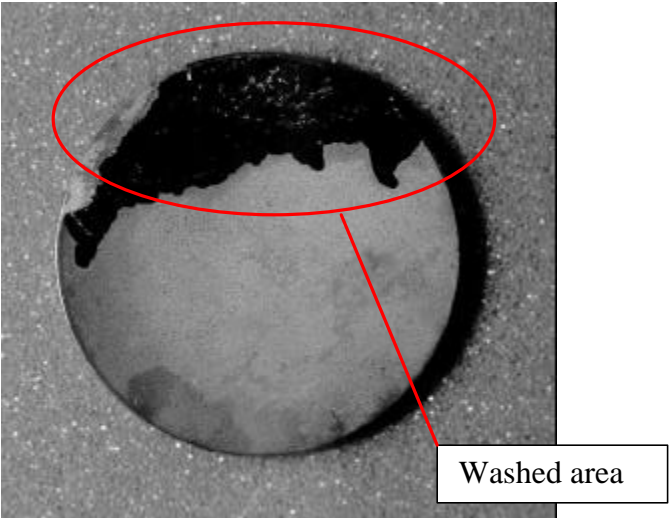
Fig. 14 *Vendor C* Washed

1.4.4 Vendor C: A photo of the Vendor C disk is shown in figure 14. This photo shows the complete failure of the CVD diamond bond to the silicon wafer. This vendor utilizes a CVD diamond coating process to bond diamond particles (50 micron) to a silicon wafer substrate. The high-pressure waterjet stream was strong enough to cause brittle failure of the CVD coating at the CVD-Silicon interface. In the summary of the diamond loss, *Vendor C* will be listed as 200 diamonds removed (full scale on the graph for complete diamond loss).

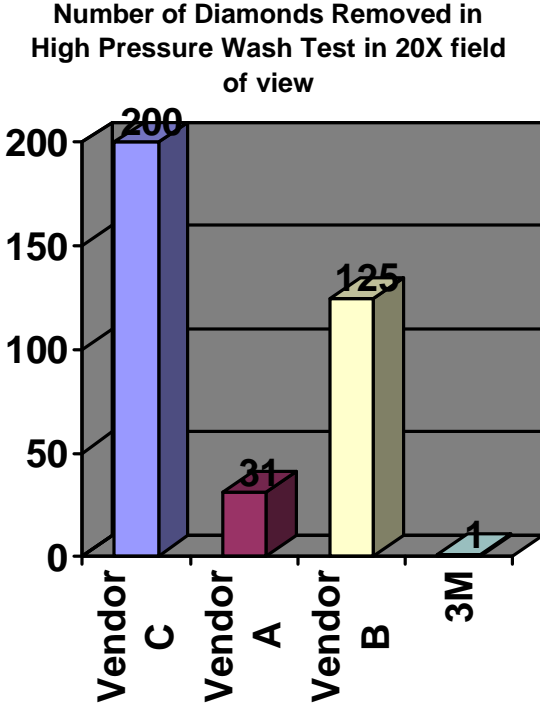
1.5 Conclusion: A quantitative result from the high-pressure Waterjet Wash test is shown in Fig. 15. This graph shows the number of diamonds removed from the field of view in the Washed 20X SEM photos. Note: *Vendor C* is listed as 200, as previously noted

Under these very extreme conditions, the 3M sintered diamond material has an order of magnitude lower susceptibility to diamond loss than the next best product, *Vendor A*.

Figure 15. Diamond loss comparison for various diamond pad conditioners

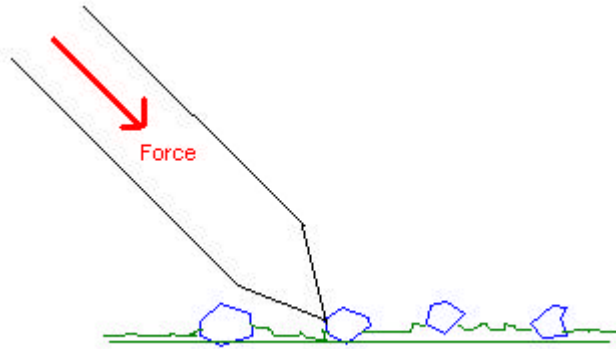
2.2 Test Apparatus: The test apparatus consists of a hardened steel pick that is attached to a digital force gage (Shimpo model FGV-50A). A schematic of the apparatus is pictured in figure 15. In order to place the hardened steel pick on a diamond, it is necessary to do this alignment under the microscope (typically 10-40X magnification).

2.3 Test Procedure: The diamond pad conditioner that is being tested is clamped to the work surface. The hardened steel pick is placed on a single diamond while viewing the placement through the microscope. Force is then applied to the diamond at a 45° nominal angle. The force to dislodge or crush the diamond is then recorded from the force gage.

Figure 15- Schematic of Diamond Pick Experimental Procedure

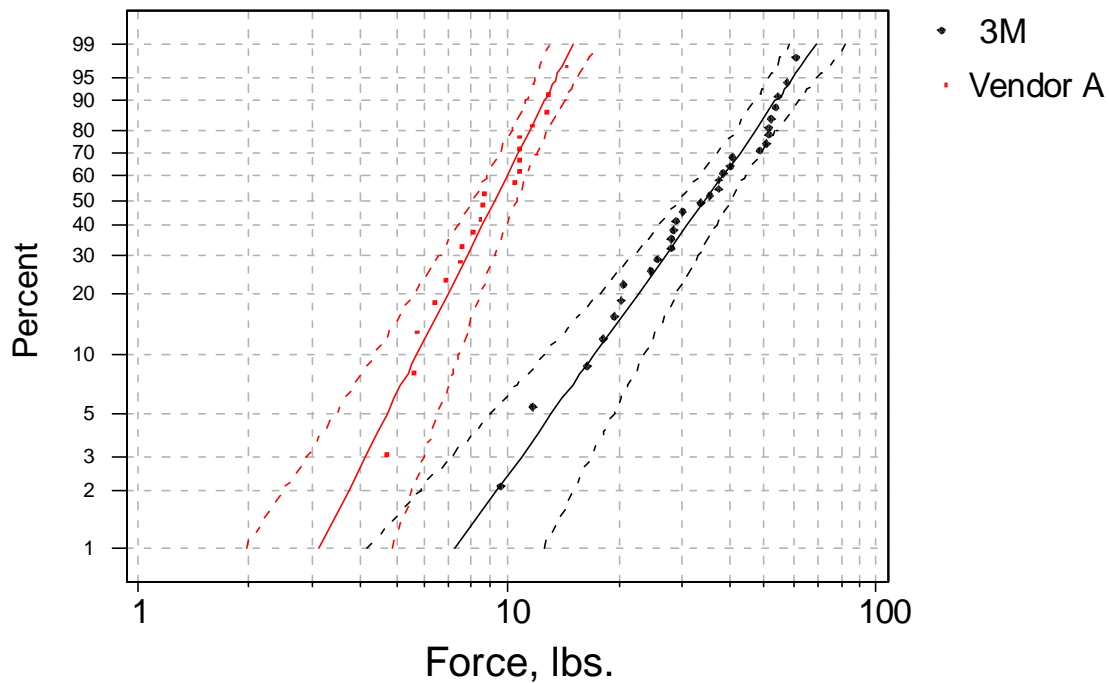
Weibull Probability Plot

The analysis involves plotting the data on a Weibull probability chart, in which the cumulative probability of failure is plotted against the break strengths.¹

2.5 Conclusion: From this graph one can see that at the force needed to break 50% of the *Vendor A* diamond bonds, only about 2% would fail in the 3M product. The 3M disk exhibits an average break force of 35.2 lbs., approximately 3.8 times the corresponding strength of the *Vendor A* product (average break force of 9.2 lbs.). Because of the high strength of the diamond-metal interfaces in the 3M product, only a small fraction of the measured failures (about 13%) actually resulted from diamonds popping out under the applied stress. More often, the test ended with diamond fracture. This change of failure mode should not be surprising given that all but 2 of the individual diamond bonds tested on the 3M product withstood higher forces than *any* of the individual tests of the *Vendor A* product.

2.4 Test Results: The break strengths measured with the pick held by hand at about 45° are given below in Table 2.1. In tests of this kind, it is particularly useful to use Weibull statistics in analyzing the results. This approach is generally most applicable if the failure strengths being represented by this distribution function are essentially determined by a population of flaws, in this case in the diamonds or at the diamond-metal interface. Examples of “flaws” might include inclusions within diamonds, interface defects, or even unusually small areas of contact between diamond and matrix.
