Aesthetic periodontal splint-bridge

DR. ROMAN PIDLISNYI
Lviv State Medical University
69, Pekarska str.
Lviv 290010, Ukraine
e-mail: pidlisnyi@meduniv.lviv.ua

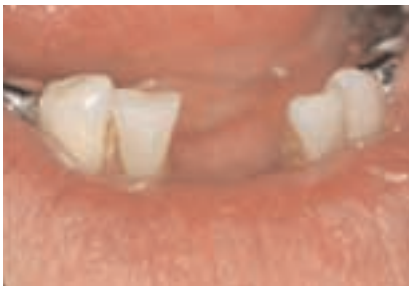
1 The patient had stage II mobility in the remaining front teeth, and wanted treatment to save them. The missing teeth were not available to make a splint-bridge.

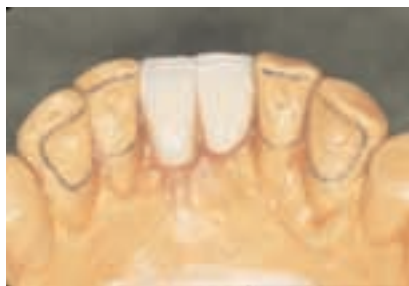
2 Small retention holes were prepared in the teeth. A model was produced from an impression, the future outline of the prosthesis was marked and the denture teeth were adjusted and fixed with wax.

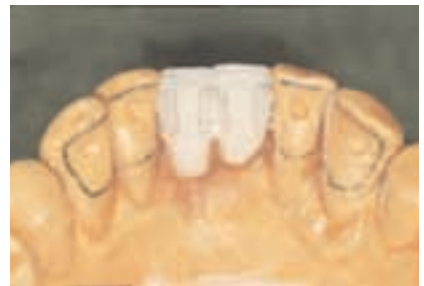
3 Undercuts were prepared on the proximal-lingual surfaces to enhance the connection with the Ribbond framework.

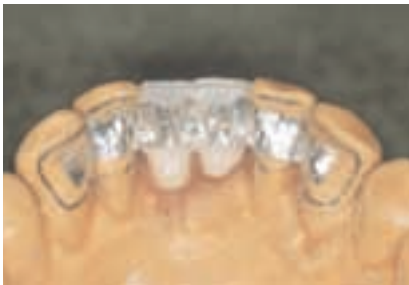
4 The correct length for the Ribbond fibres was established with the help of tin foil. Then the entire lingual surfaces of the denture teeth were wetted with a monomer of heat curable resin and dried. Single Bond adhesive was then applied to these surfaces and light cured.

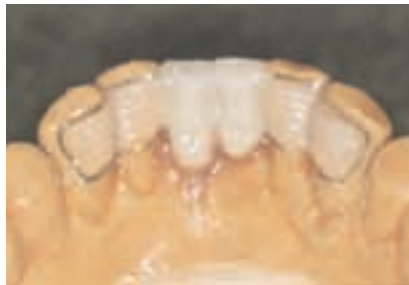
5 Then the proper length of Ribbond fibre is positioned onto a thin first layer of uncured Z100 restorative. The fibre is pressed into the composite for optimum wetting. The composite was then light cured.

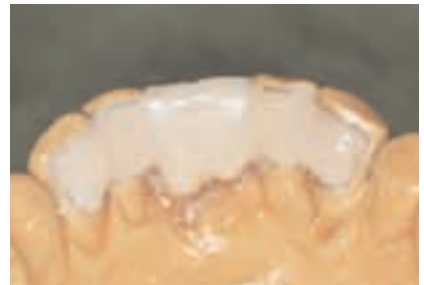
6 A second layer of the composite was applied to smooth the exposed surfaces.

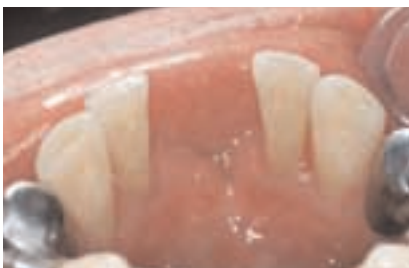
7 The lingual view of the teeth prior to placement of the splint-bridge. The tooth surfaces were prepared by proper application of Single Bond adhesive which was light cured.

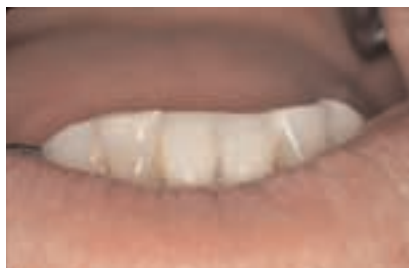
8 The bridge was then placed with a thin layer of Z100 restorative, which was cured through the bridge. This is the labial view 6 months after placement.

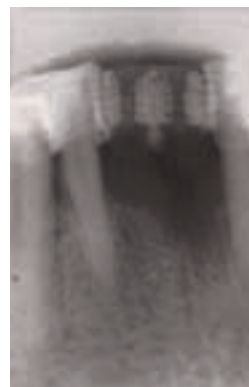
9 A radiograph of the restoration shows the weave of the fibres and the thicker areas of composite in the undercuts.
