**Report 601-00474
August 2016**

Proportion of the UK working population tested who achieved an effective fit with the 3M 8835+ FFR

Report Number 601-00474 – Proportion of the UK working population tested who achieved an effective fit with the 3M 8835+ FFR

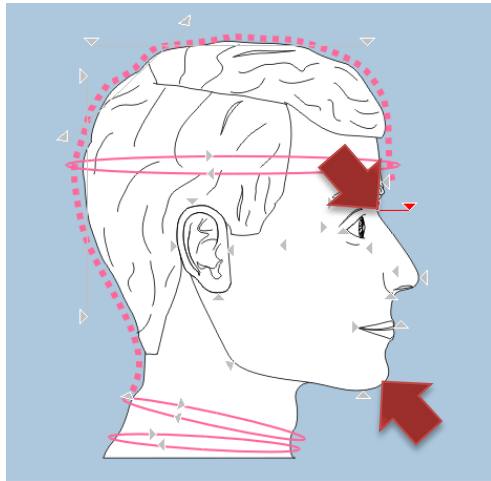
Figure 1: Menton-Sellion² Length (face length)

3.1 The following three measurements were taken from each participant.

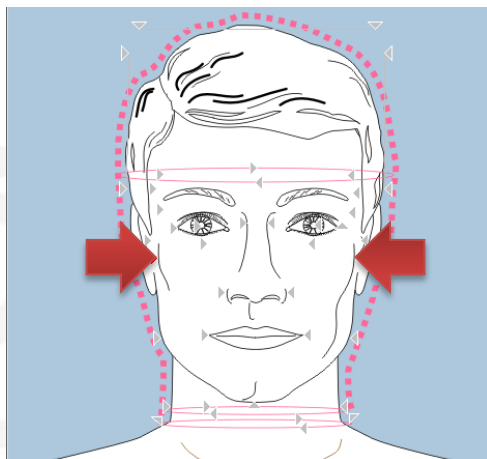
Figure 2: Bizygomatic Breadth (face width)
