IMPACT GUARD RETROFIT & UPGRADE NOTICE

HOIST LINE TENSION LIMITER

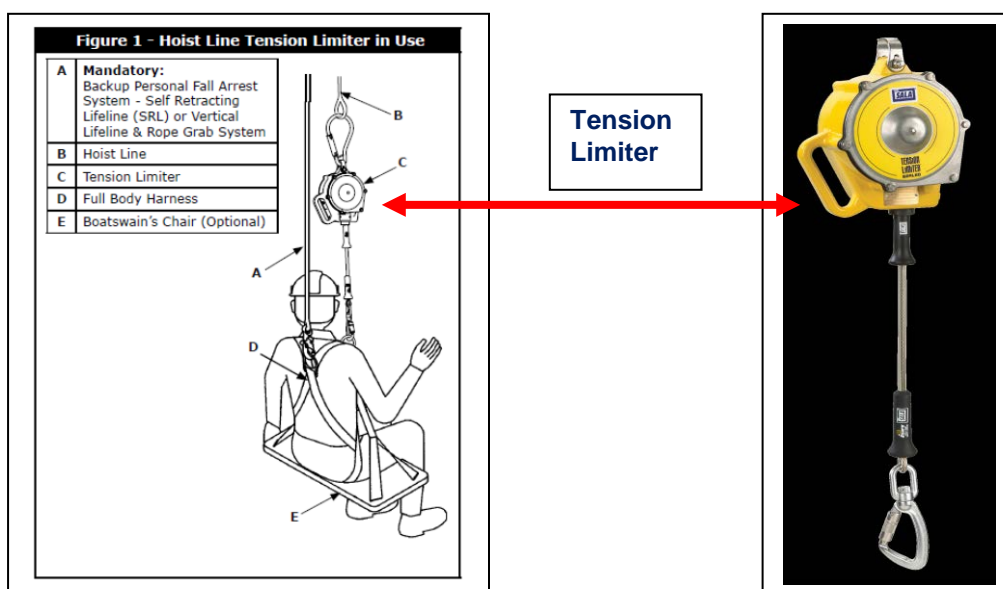
The DBI-SALA Hoist Line Tension Limiter (model #3601490), connects in line between the suspended worker and the winch line. If the worker becomes entangled in a fixed object, the Tension Limiter deploys a bright yellow cable intended to alert the winch operator to stop. When the Tension Limiter deploys, it limits the load on the worker to reduce the possibility of severe injury. A Tension Limiter is not a fall protection system. A backup personal fall arrest system (such as an SRL) must always be used in conjunction with a Tension Limiter (see figure 1).

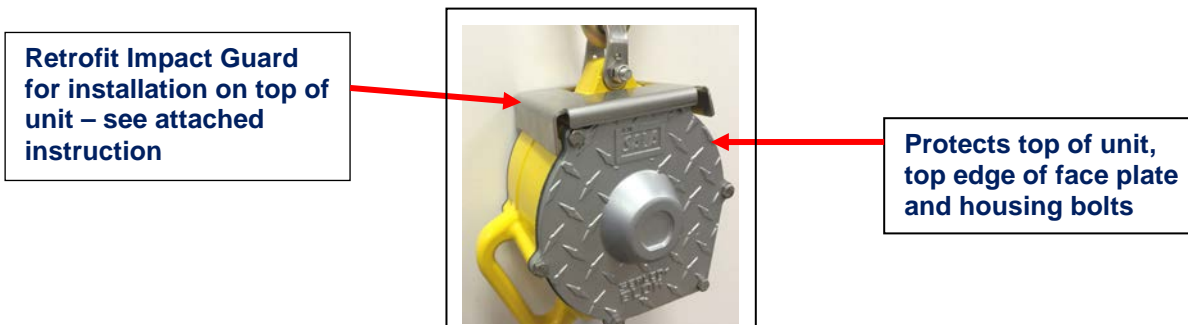
Capital Safety has received a very limited number of reports of inadvertent damage to Tension Limiters during use. Specifically, during ascent, if the Tension Limiter impacts and is trapped by a fixed object while under load from the winch, it is possible that the force applied to the unit by the winch can damage the face plate and housing bolts of the unit. In extreme cases under excessive load, the face plate may be ripped off the unit. In such an event, the resulting damage to the unit can create a risk of injury to the user or workers below. To eliminate the potential for the unit to be damaged as described above, Capital Safety has developed a retrofit kit in the form of an Impact Guard for the Tension Limiter.

The attached single page instruction sets out a very simple procedure for installing the Retrofit Kit. The installation process requires replacement of only two housing bolts and can easily be completed in less than five minutes. Installation of the Impact Guard does not affect the operation of the Tension Limiter.
