# 3M™ Hood BE-10BR Butyl Rubber Inspection Guidance

November 21, 2016

This inspection guidance document is intended as a supplement to the 3M Customer communication dated November 21, 2016 regarding the inspection of BE-10BR hoods.

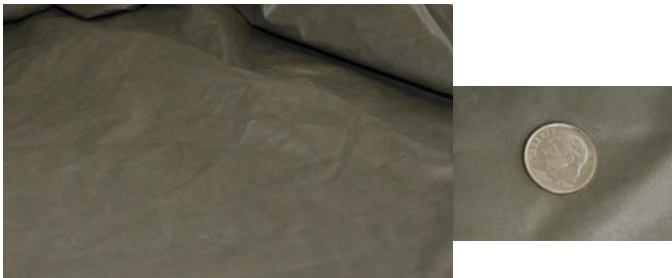
Fabric is intact, without any signs of damage

*Chemical resistance and respiratory protection is intact*

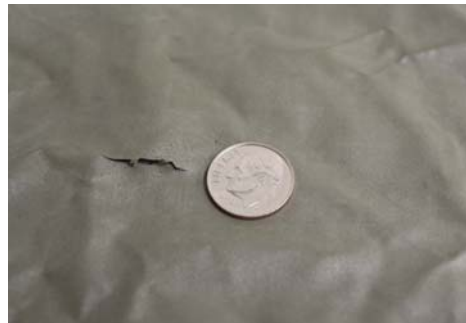
Tear in fabric

Chemical resistance and respiratory protection may be compromised

Remove hoods from service if signs of degradation are found in accordance with the provided inspection guidance. If you have questions on inspection call 3M Technical Service at 1-800-243-4630.

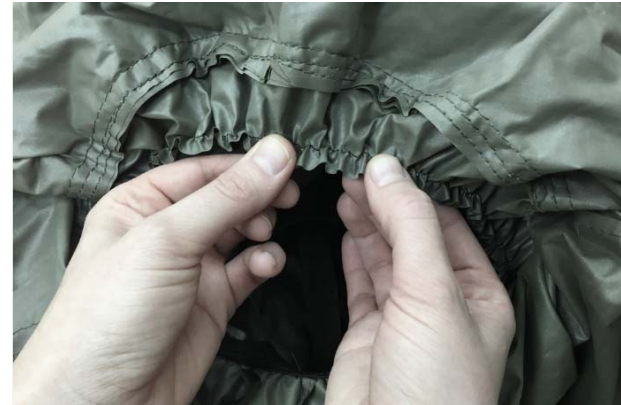
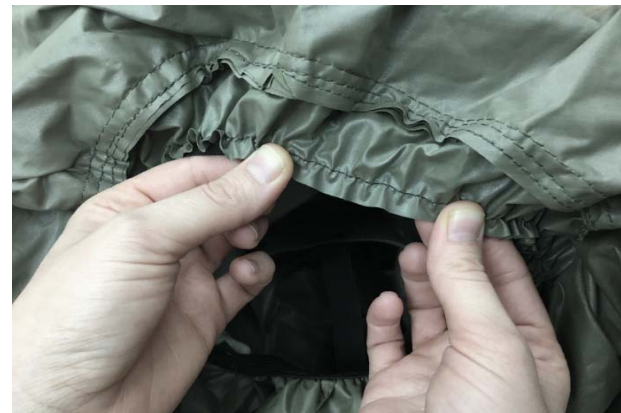
Elastic being stretched, with recovery to original length

***Respiratory protection is intact***

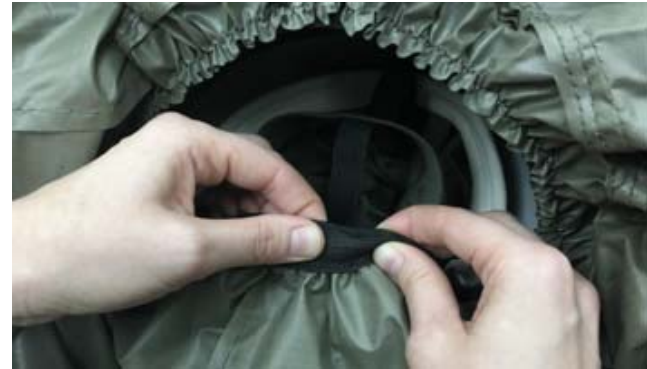
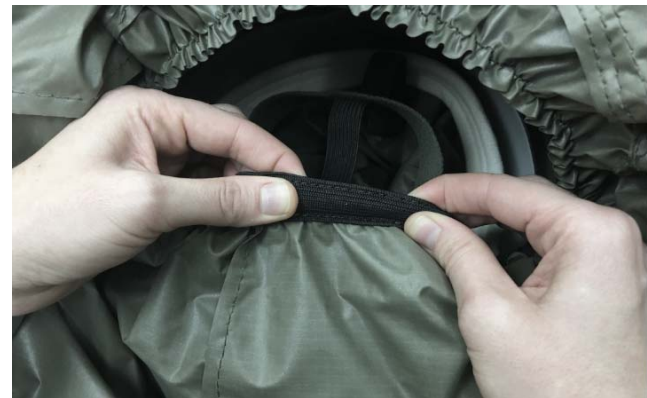
Elastic being stretched, with recovery to original length

*Respiratory protection is intact*

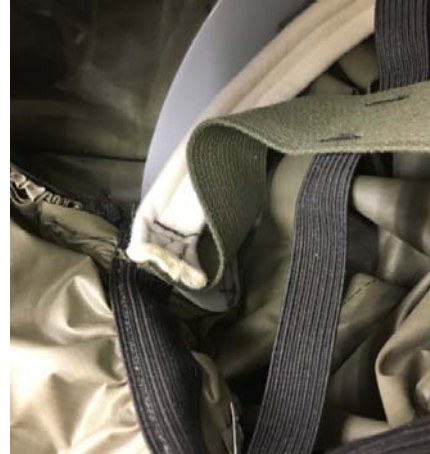
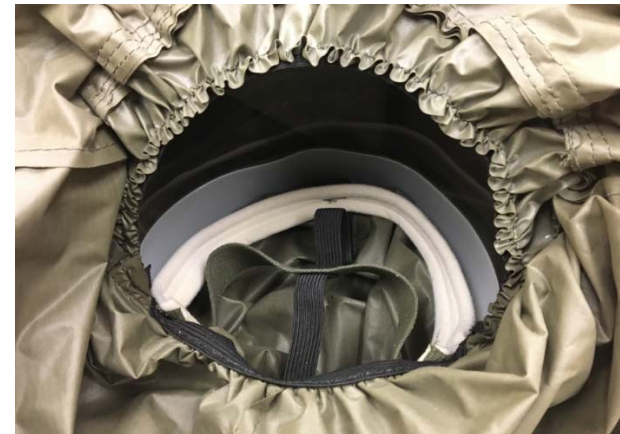
Suspension completely intact, including stitching

- Note: Webbing could be multiple colors

*Respiratory protection is intact*

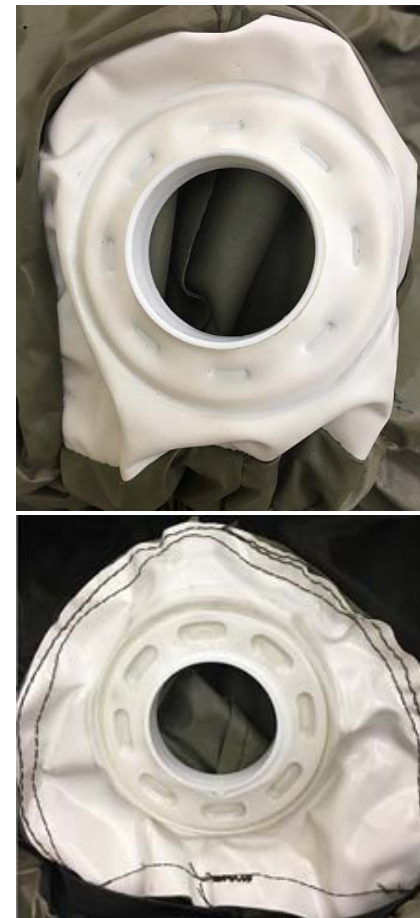
The interior and exterior of the breathing tube connection is intact with no signs of damage

***Respiratory protection is intact***

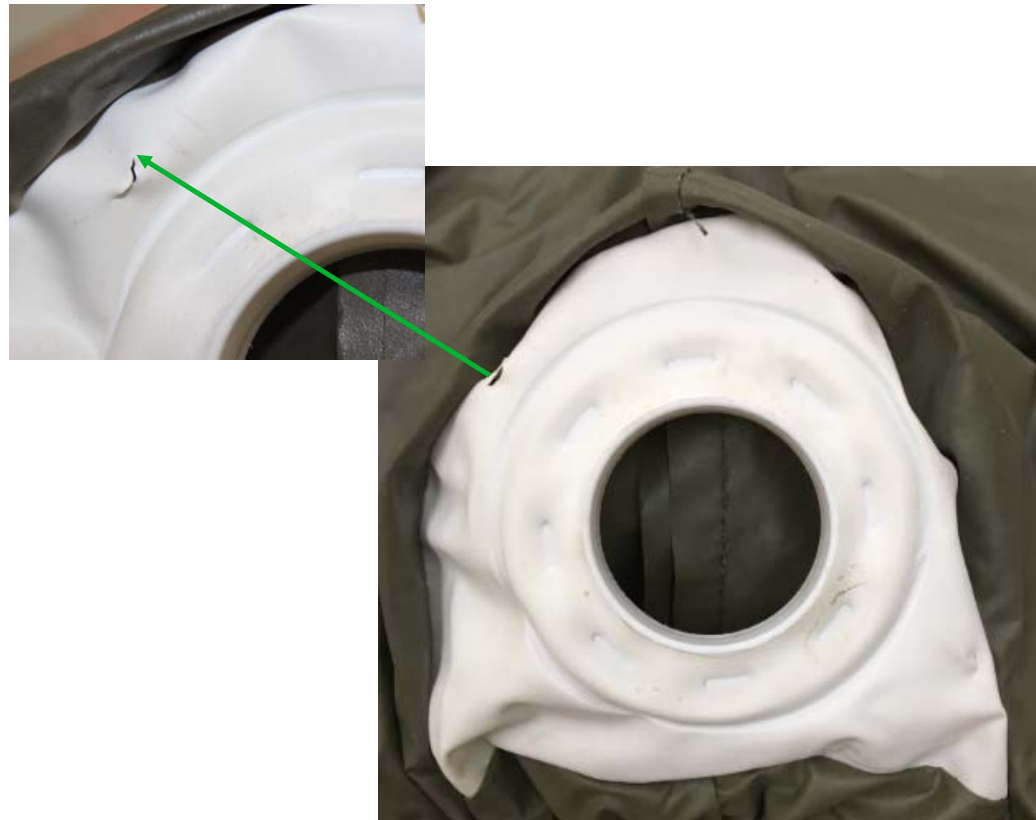
Vinyl on breathing tube connection is cracked

*Respiratory protection may be compromised*

Remove hoods from service if signs of degradation are found in accordance with the provided inspection guidance. If you have questions on inspection call 3M Technical Service at 1-800-243-4630.

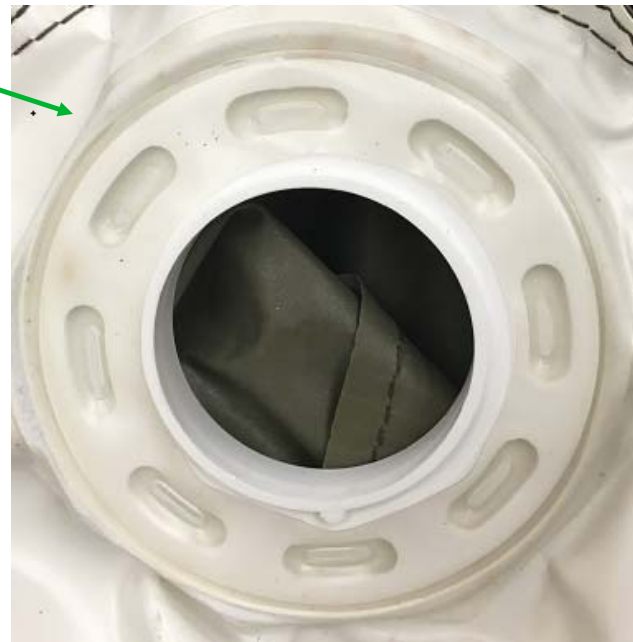
Circular breathing tube connection interface can be rotated freely

*Respiratory protection may be compromised*

Remove hoods from service if signs of degradation are found in accordance with the provided inspection guidance. If you have questions on inspection call 3M Technical Service at 1-800-243-4630.

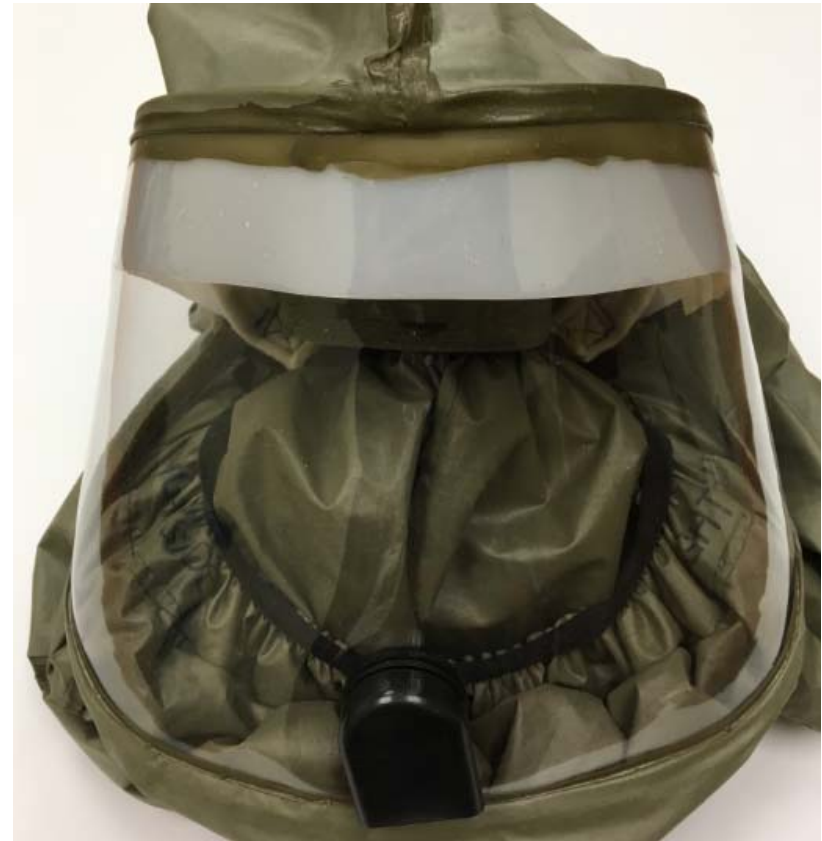
Visor is intact with no signs of damage

*Chemical resistance and respiratory protection are intact*

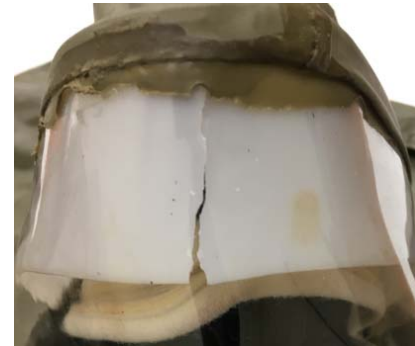
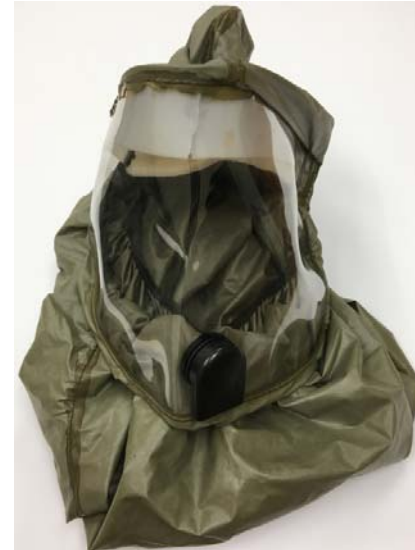
Crack in upper plastic of visor

*Crack in upper plastic may lead to crack in visor or pose a hazard to the wearer*

Remove hoods from service if signs of degradation are found in accordance with the provided inspection guidance. If you have questions on inspection call 3M Technical Service at 1-800-243-4630.

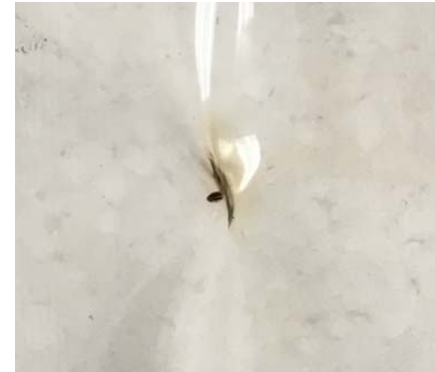
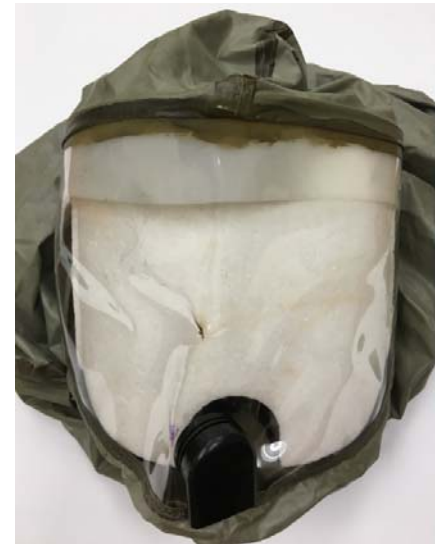
Cut/hole in visor

*Chemical resistance and respiratory protection may be compromised*

Remove hoods from service if signs of degradation are found in accordance with the provided inspection guidance. If you have questions on inspection call 3M Technical Service at 1-800-243-4630.

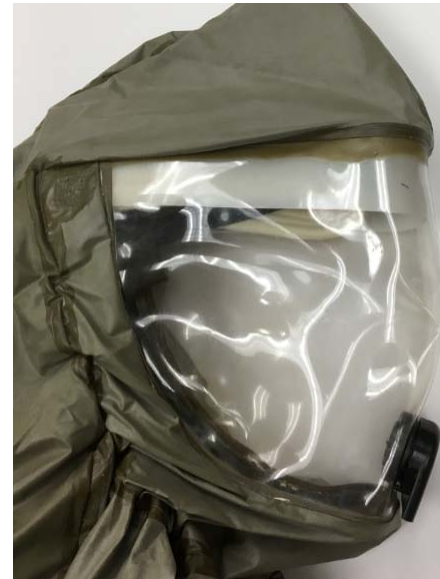
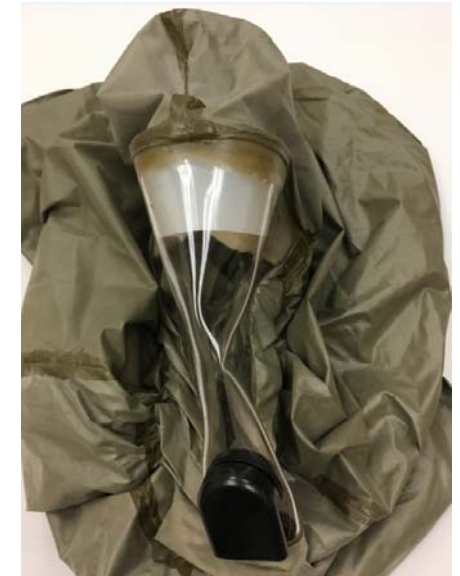
Crease in visor

*If crease left unresolved, could affect fit of hood and lead to crack in visor*

- May be remedied by using RBE-FIH hood insert to help reshape visor

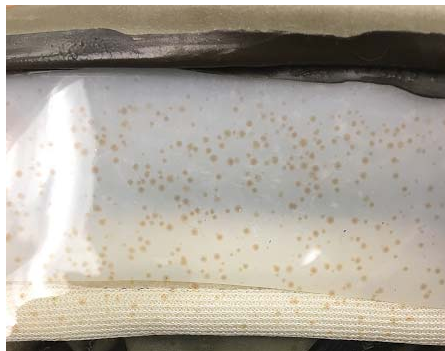
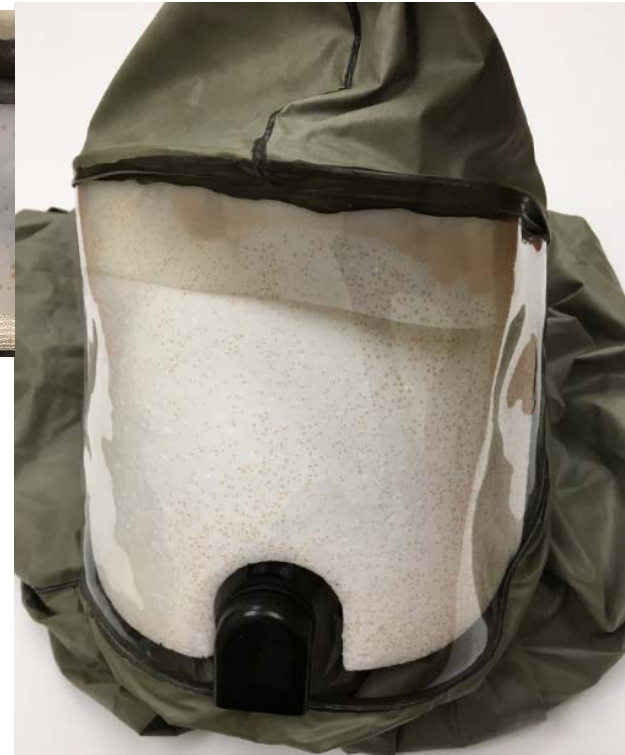
Discoloration of visor

*Discoloration may affect the wearers ability to see through the visor*

Remove hoods from service if signs of degradation are found in accordance with the provided inspection guidance. If you have questions on inspection call 3M Technical Service at 1-800-243-4630.

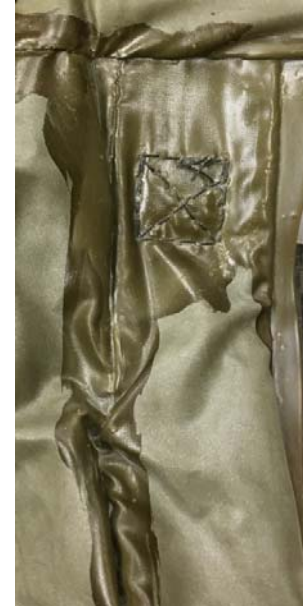
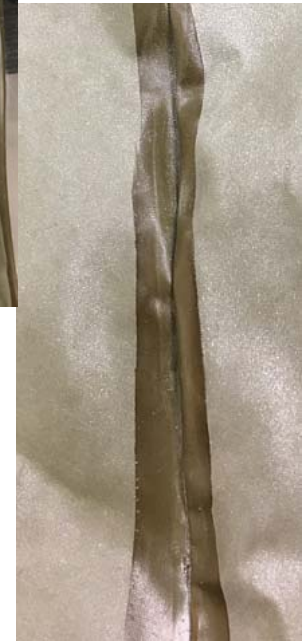
Luting completely covering the seam with no cracks, flaking or other signs of damage

*Chemical resistance is intact*

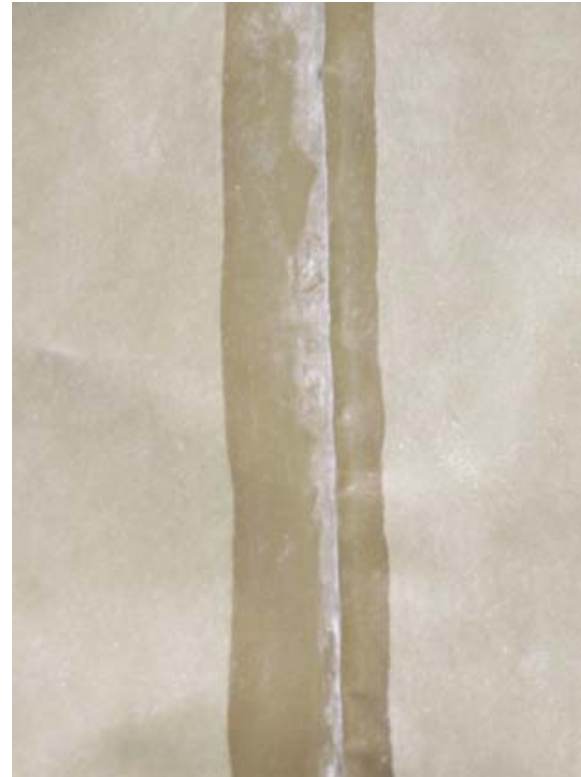
Powder is visible in the seam, but luting is intact

*Respiratory protection is intact*

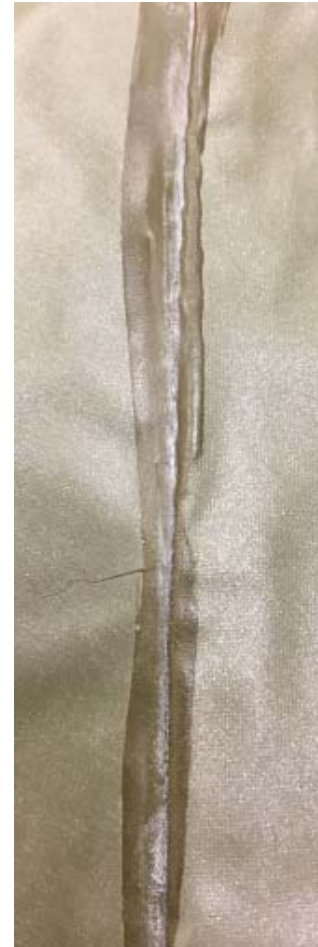
Luting near seam is missing, but seam is still covered

*Chemical resistance is intact*

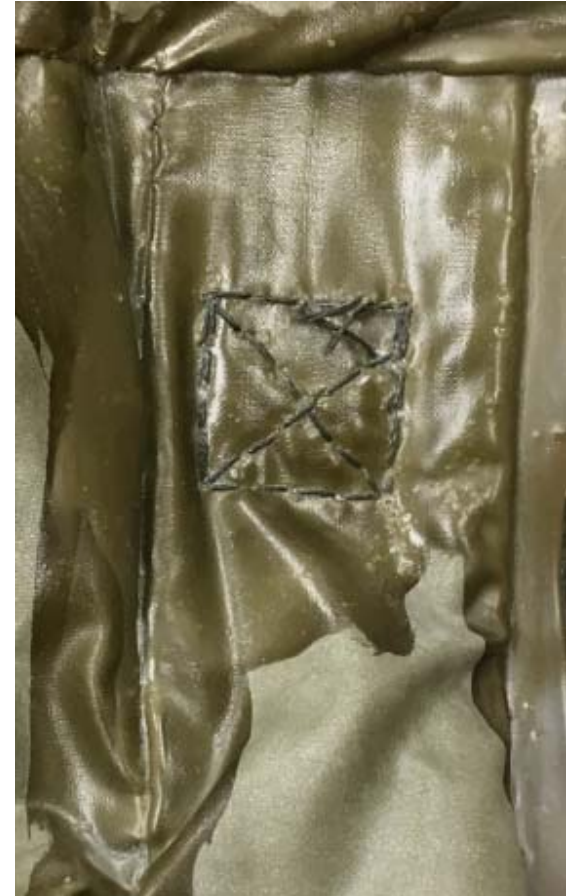
Outline of stitches can be seen, but are covered by luting

*Chemical resistance is intact*

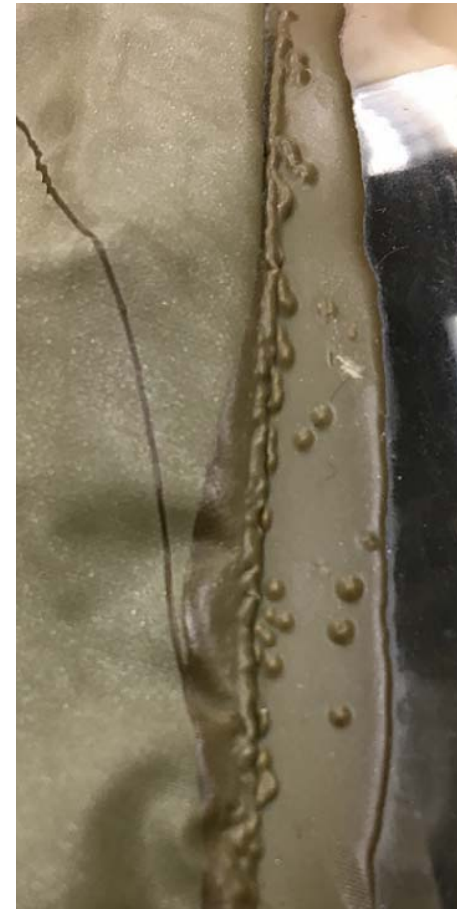
Air bubbles are present in the luting

*Chemical resistance is intact*

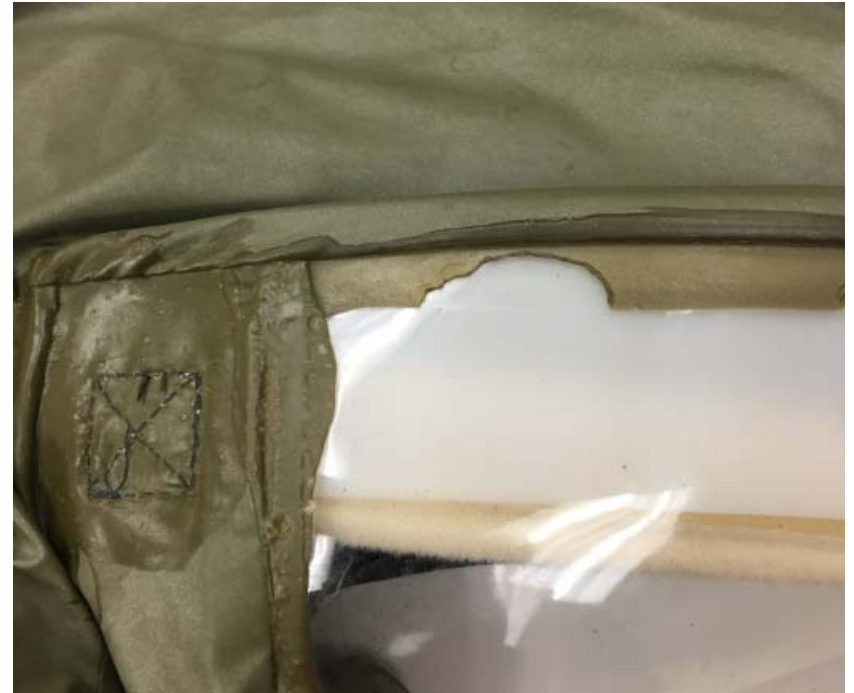
Luting near hood-to-visor seam is missing, but seam is still covered, and stitching is not visible

*Chemical resistance is intact*

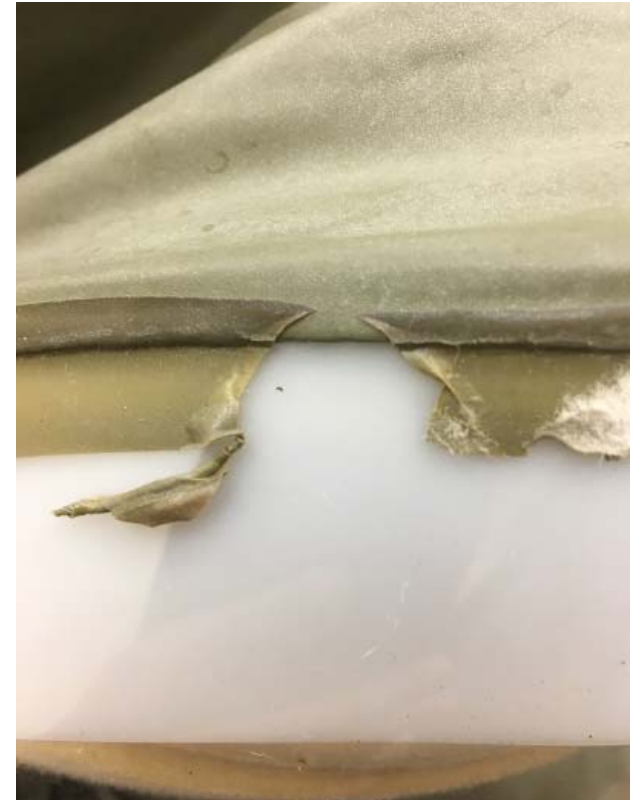
Luting no longer covers the hood-to-visor seam, leaving visible stitching

*Chemical resistance may be compromised*

Remove hoods from service if signs of degradation are found in accordance with the provided inspection guidance. If you have questions on inspection call 3M Technical Service at 1-800-243-4630.

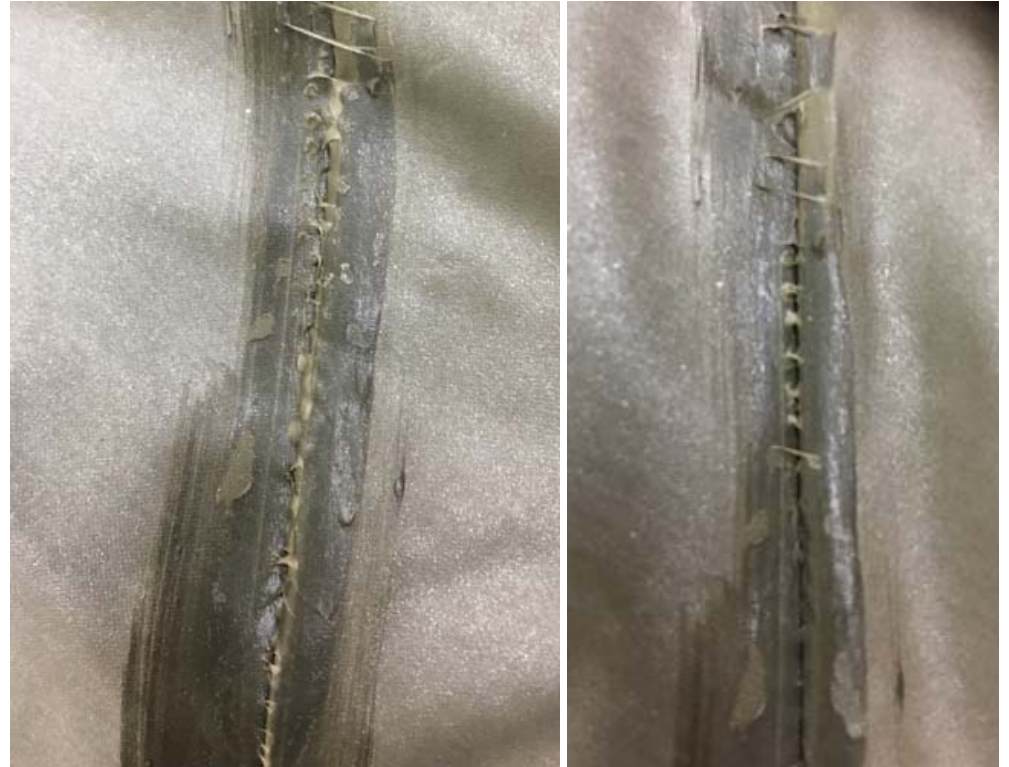
Luting has been pulled apart and is flaking off, leaving stitching visible

*Chemical resistance may be compromised*

Remove hoods from service if signs of degradation are found in accordance with the provided inspection guidance. If you have questions on inspection call 3M Technical Service at 1-800-243-4630.

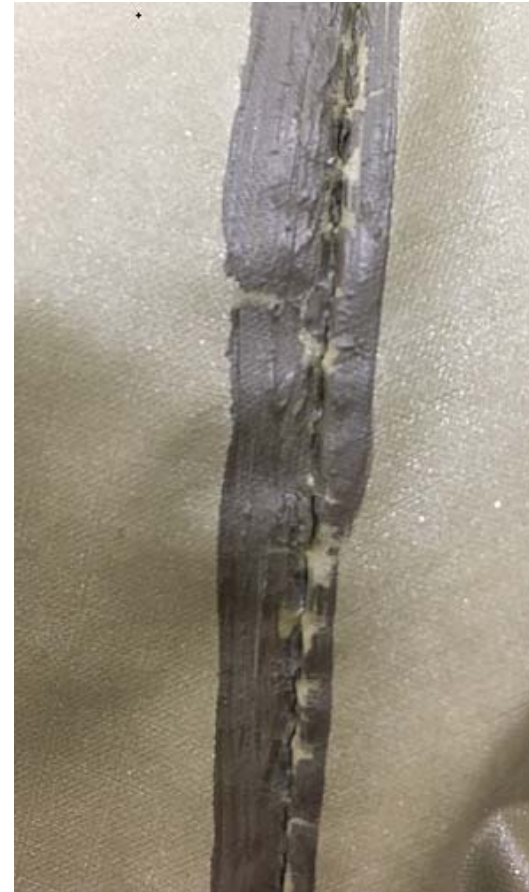
Luting is cracked, leaving stitching visible

*Chemical resistance may be compromised*

Remove hoods from service if signs of degradation are found in accordance with the provided inspection guidance. If you have questions on inspection call 3M Technical Service at 1-800-243-4630.

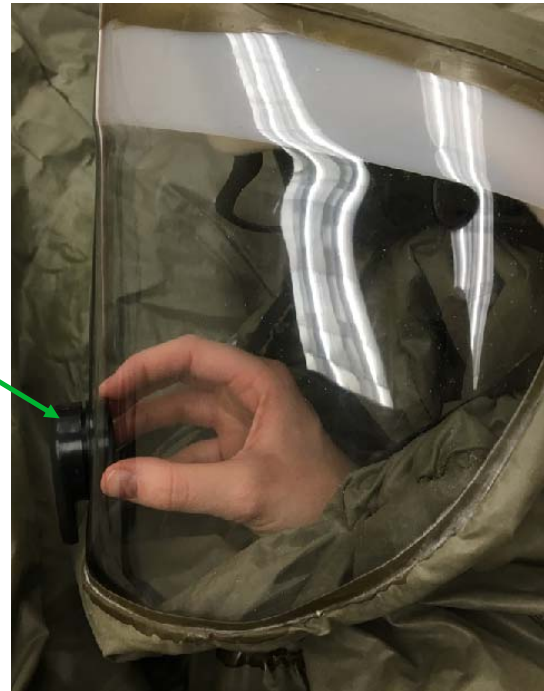
Valve holder is secure to the visor

*Respiratory protection is intact*
