Replacement of inlay and molar crown using 3M™ Lava™ Esthetic Fluorescent Full-Contour Zirconia

Clinical dentistry and photography by: Dr. Gunnar Reich, Munich, Germany
Lab work by: MDT Nicole Freund, Tutzing, Germany

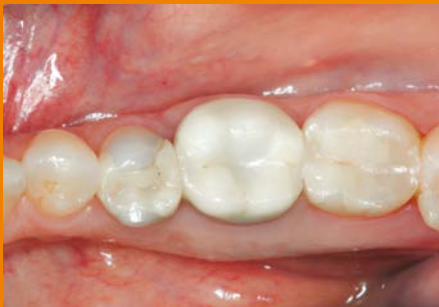
Initial situation: Fractured glass ceramic inlay at tooth #35 and chipped porcelain fused-to-zirconia crown at tooth #36.

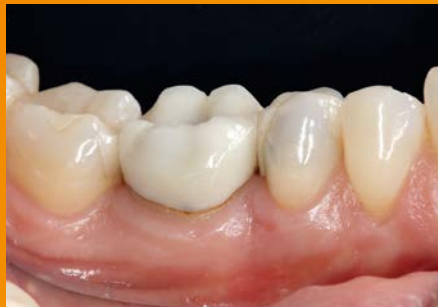
Initial situation – buccal view.

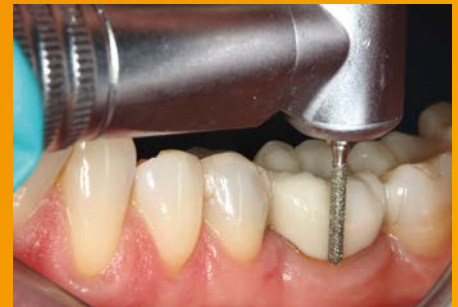
Chipped zirconia crown is removed.

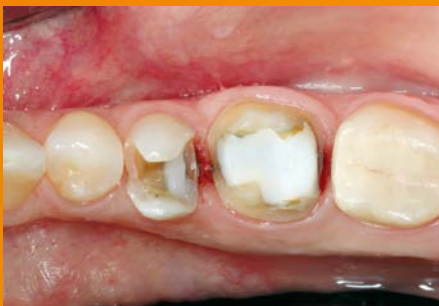
Preparations.

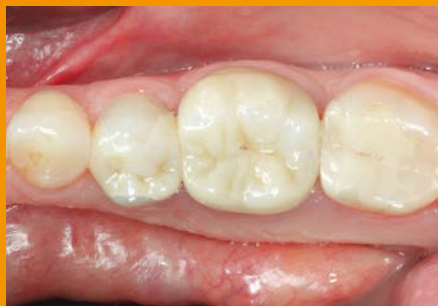
Final situation: 3M™ Lava™ Esthetic Fluorescent Full-Contour Zirconia inlay and crown, shade C1, finished with stain and glaze. Inlay and crown both cemented with 3M™ RelyX™ Ultimate Adhesive Resin Cement.

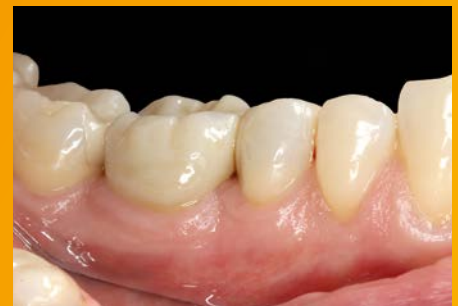
Final situation – buccal view.
