# Test-driving anterior restorations for a highly esthetic outcome.

Giovanni Molina Lugo, DDS, Mexico City, Mexico

**Diagnosis and treatment planning:** A patient with failing restorations on teeth 9 and 10 desired to have an improved smile and esthetics. A treatment plan called for extraction of tooth 10 and immediate implant placement. 3M™ Protemp™ 4 Temporization Material was utilized to provide immediate function during the tissue healing phase, a diagnostic anterior mock up for smile design, and assistance with tissue conditioning after placement of the final implant abutment.

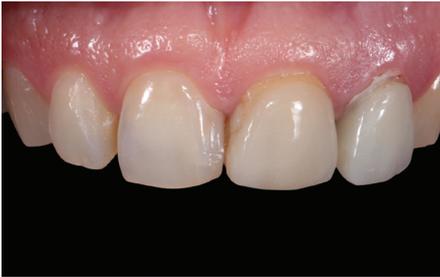
Fig. 1: Initial Clinical situation. Failed restorations on teeth 9 and 10 and unpleasant patient smile.

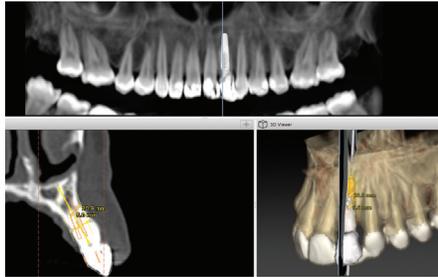
Fig. 2: The CT Scan shows the need for immediate tooth replacement on tooth 10 by placing an implant followed tooth extraction and subsequent implant provisionalization.

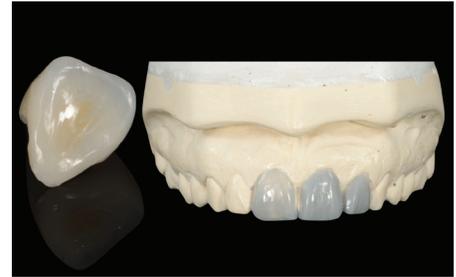
Fig. 3: Preliminary diagnostic wax-up and lab-generated temporary crown made with 3M™ Protemp™ 4 Temporization Material prior to implant placement.

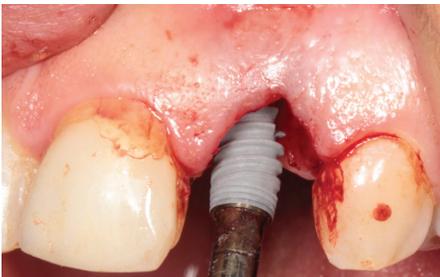
Fig. 4: Immediate implant placement after tooth extraction.

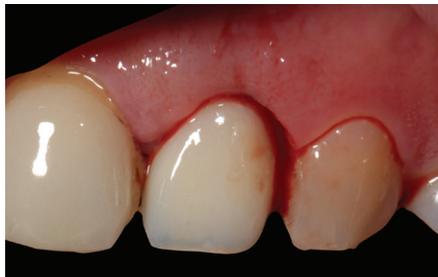
Fig. 5: 3M™ Protemp™ 4 temporary restoration for immediate function.

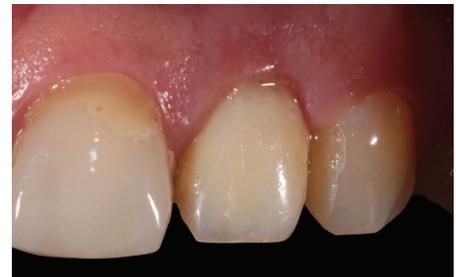
Fig. 6: Facial aspect of healed tissues after three months of implant placement.

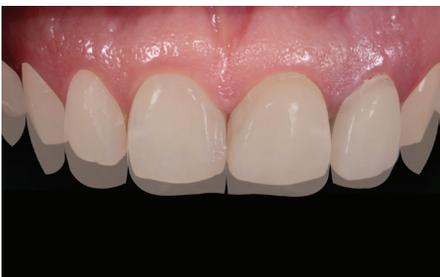
Fig. 7: Digital smile design proposed to the patient showing the need for restoring all the anterior teeth with a conservative approach to obtain a new aesthetic smile.

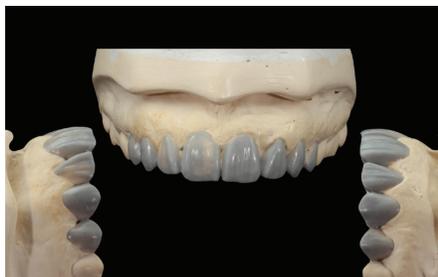
Fig. 8: Complete diagnostic wax-up of anterior teeth according to digital plan.

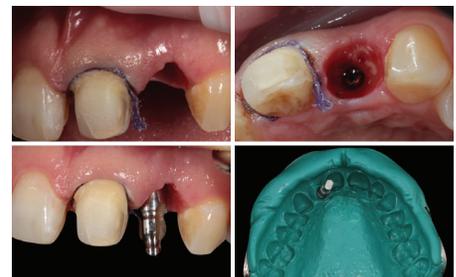
Fig. 9: One step implant and teeth impression with 3M™ Soft Monophase Polyether Impression Material.

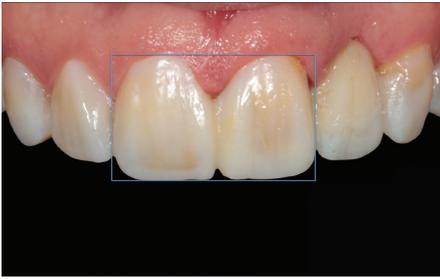
Fig. 10: 3M™ Protemp™ 4 temporary anterior restoration mock-up.

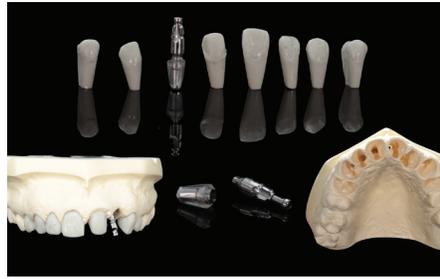
Fig. 11: Alveolar model with interchangeable dies for precision dental esthetics restorations.

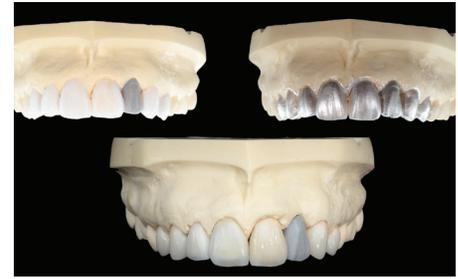
Fig. 12: Ultra-thin glass ceramic restorations obtained from the lab.

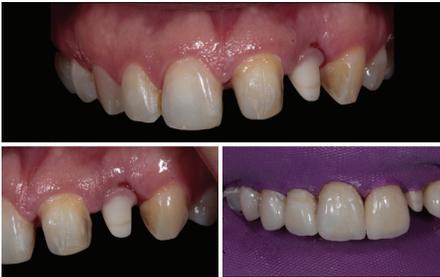
Fig. 13: Final placement of glass ceramic restorations on teeth cemented with 3M™ Single Bond Universal Adhesive and 3M™ RelyX™ Veneer Cement, and placement of zirconia implant abutment.

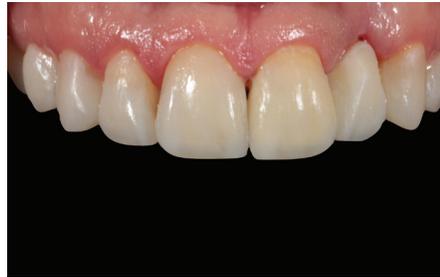
Fig. 14: 3M™ Protemp™ 4 temporary restoration on implant after final cementation of porcelain veneers, and final placement of implant abutment for tissue conditioning.

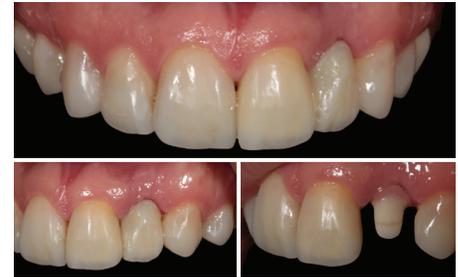
Fig. 15: Soft tissue appearance around implant one week later.

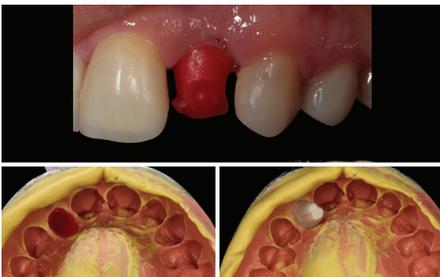
Fig. 16: Pick-up one-step impression with customized impression coping on the implant abutment.

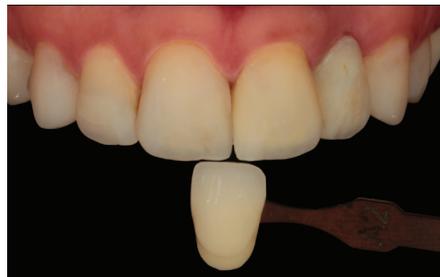
Fig. 17: Picture obtained with polarized light for color details.

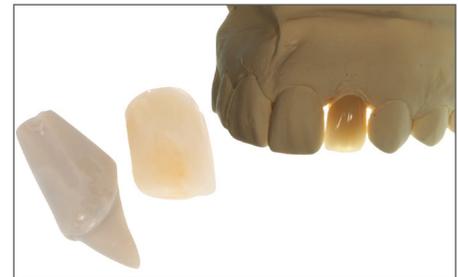
Fig. 18: Final crown for implant abutment delivered from the lab.

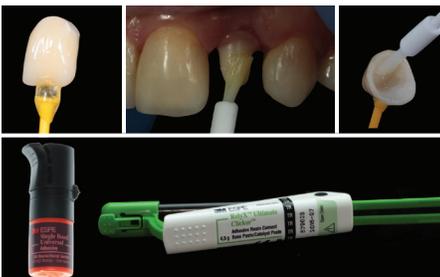
Fig. 19: Adhesive final cementation of the abutment implant crown using 3M™ Single Bond Universal Adhesive and 3M™ RelyX™ Ultimate Adhesive Resin Cement.

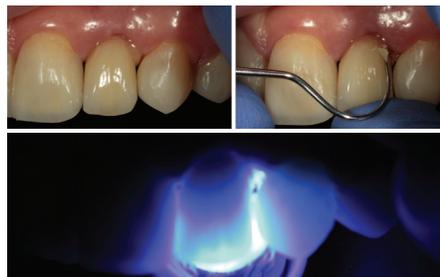
Fig. 20: Excess cement removal and light curing.

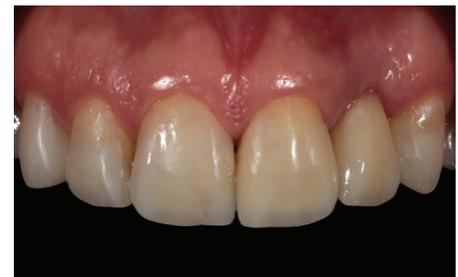
Fig. 21: Final restoration in place.
