案内標識における一部不具合と今後の対応について

Lifting issue on certain road signs made with 3M sheeting

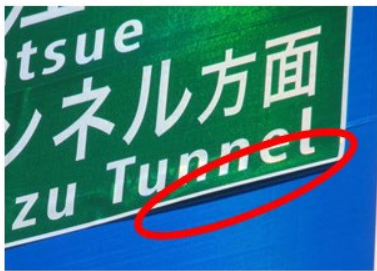
以下の2つの部位において反射シートの浮きが一部確認されております。

事象	多層重ね貼り部分（下地シートの上 に貼られる路線名等を示す箇所）	素地シート重ね貼り部分（下地シート同士 のつなぎ部の 10mm 程度の重なり箇所）
例

現在、道路管理者様が確認なされた剥離事象が発現した案内標識につきましては、弊社において実際に現地にて剥離事象を確認し、補修を進めております。補修作業にあたりましては、変性シリコン系化学反応型接着剤の塗布とエッジシールテープの貼付や案内標識の交換を行い、補修作業完了後は引き続き経緯観察を行ってまいります。補修作業の完了は、本年7月下旬を目途に鋭意進めております。

また、標識メーカー様にて作成中および今後新しく製作する案内標識につきましては、接着強度を増強するために、多層重ね貼り部分の下地および素地シート重ね貼り部分に対するサンディングとエッジシールテープの貼付を実施いただけるよう要請致しております。加えて、標識メーカー様等のご協力のもと作業手順の監査を実施するとともに、補修工事完了後は経過観察を行ってまいります。
