### 台風15号通過後の案内標識の一部不具合の事象確認について

- ・ 事象： 道路案内標識の多層重ね貼りシートの剥離
- ・ 事象確認日： 9月9日
- ・ 事象発生箇所： 国道357号 東京都江東区有明2丁目交差点付近

### Delamination issue on a road sign made with 3M sheeting after Typhoon Faxai

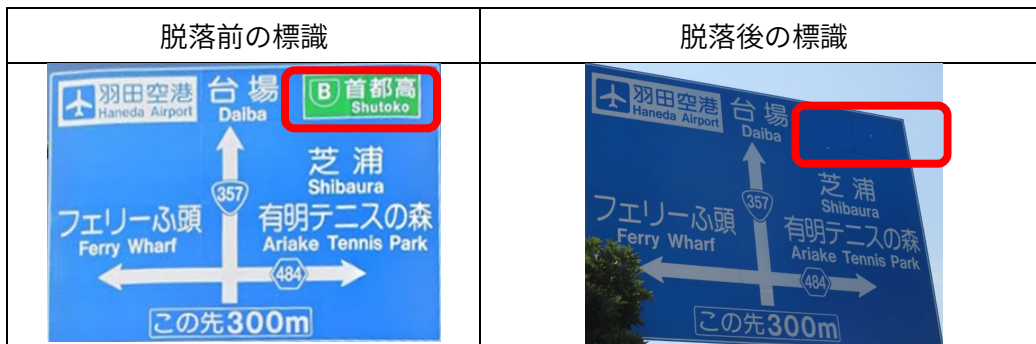
剥離したシートおよび剥離後の標識板の表面状態を観察した結果、多層重ね貼り部端部に剥離があったと想定され、今回の台風での強風にあおられたことが主要因と考えられます。

2019年9月8日から9日にかけて関東地方を通過した台風15号の強風の影響により、当該シートは脱落したものと推定されます。なお、当該標識の設置場所は海岸に面した埋め立て人工島であること、また隣接する道路沿いには高層ビルが建っていることから、局所的に猛烈な強風が発生した可能性もあります。

多層重ね貼りに端部剥離が見られる標識は、端部剥離の状況から必要と判断される場合は、粘着テープ等を用いて緊急的に端部剥離部を元の板上に貼り戻す応急処置を行い、脱落を抑止します。

端部剥離事象が確認された場合は、状況に応じて応急補修を行い、かつ速やかに交換等の補修対応を行います。

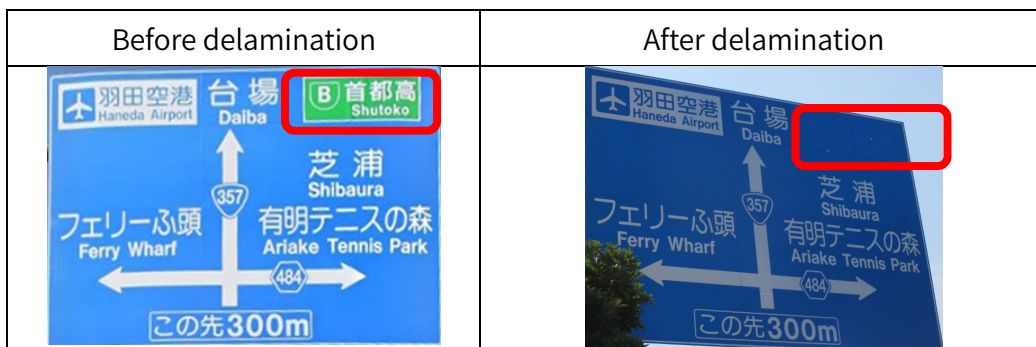
- Issue: Delamination of sheet on sheet part of guide sign
- Confirmed: September 9, 2019
- Location: Route 357, intersection of Ariake 2-chome, Koto-ku, Tokyo

The observation results for both the delaminated sheet on sheet piece and the surface of guide sign suggested that there had been edge liftings of that sheet on sheet piece. It is considered that the main factor of delamination is certain area of edge liftings flapped by very strong wind due to the typhoon Faxsai hit the Kanto region from Sep 8 to 9, 2019. Additionally, the location of the guide sign aside by buildings at bay area has a possibility of local violent wind.

For the sign which shows a certain area of edge lifting, to seal sheet on sheet piece with adhesive tape is effective as a first aid.

3M will keep continue monitoring scoped guide signs with regular reporting, and conduct repairs with necessary measures for the entire warranty period when 3M finds a sheet lifting.
