Prevena[™]
Incision Therapy

Case studies: Series 1

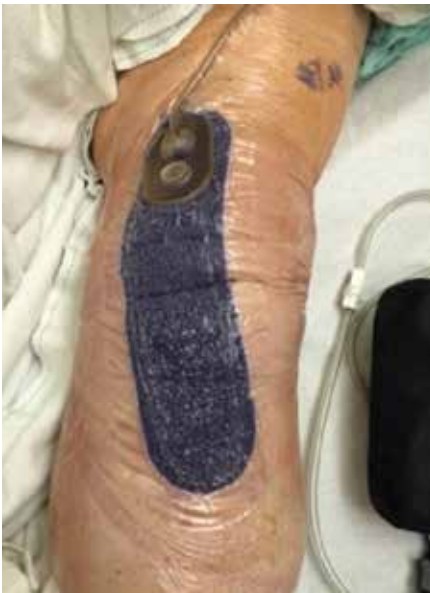
Figure A. Application of 3M™ Prevena™ Therapy over the closed incision.

At the conclusion of the knee arthroplasty procedure, the 3M™ Prevena™ Incision Management System with Peel and Place Dressing - 20cm was applied over the closed incision at -125 mmHg to optimize wound healing (**Figure A**). The sterile dressing remained in place until removal on day 7 (**Figure B**).

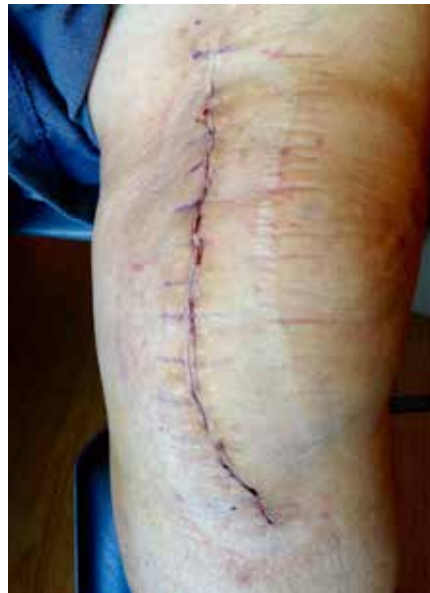
Figure B. Incision after dressing removal on postoperative day 7.

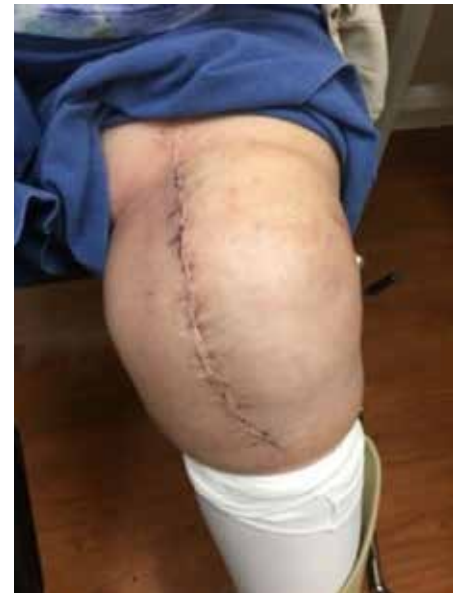
Figure C. Healed incision at 6 weeks post surgery.

By 6 weeks post surgery, the incision healed without postoperative complications (**Figure C**).

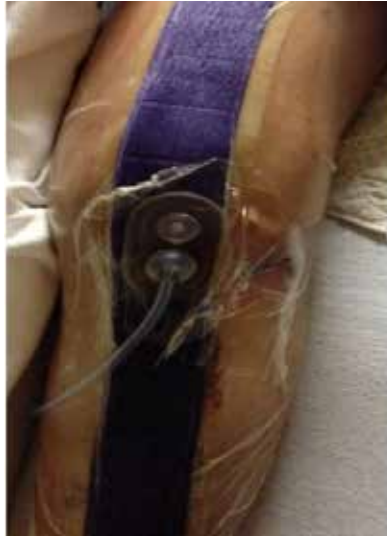
Figure E. 3M™ Prevena™ Therapy with 3M™ Prevena™ Customizable Dressing placed over the closed incision.

Following the total knee arthroplasty, the 3M™ Prevena™ Incision Management System with the 3M™ Prevena™ Customizable Dressing was applied over the closed incision at -125mmHg (**Figure E**).

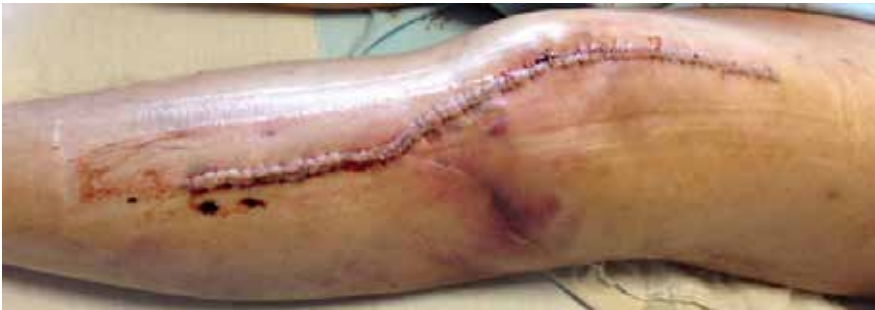
Figure F. Incision after the 3M™ Prevena™ Customizable Dressing was removed on postoperative day 3.

Prevena Therapy was discontinued after 3 days (**Figure F**). Patient was discharged from the hospital on postoperative Day 3. At 2 weeks post surgery, the incision was progressing toward healing (**Figure G**). By 3 months post surgery, the patient had a range of motion of 0 to 110 degrees, and the incision had healed well with no drainage or incision problems (**Figure H**).

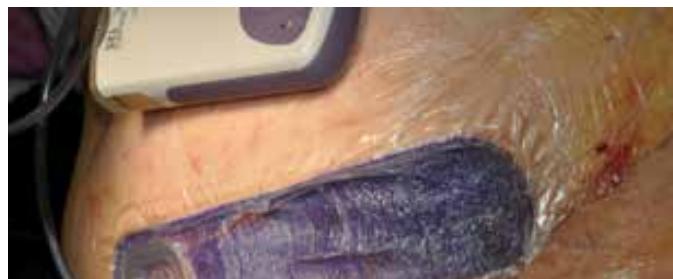
Figure B. Day 0: Application of 3M™ Prevena™ Therapy.

3M™ Prevena™ Incision Management System with Peel and Place Dressing was applied to the incision Prevena Incision Management System post C-section (**Figure B**).

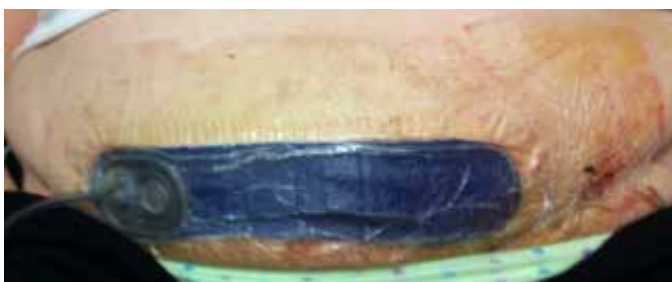
Figure C. Day 7: Dressing prior to removal.

Prevena Therapy was discontinued after 7 days (**Figure C** and **D**).

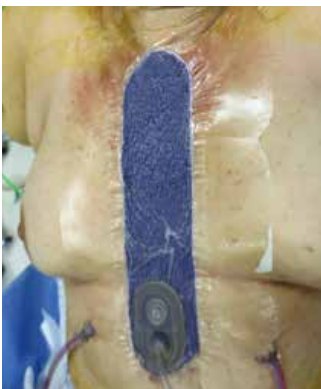
Figure F. 3M™ Prevena™ Peel and Place Dressing was applied over the sternal incision.

The patient was taken to the operating room for soft tissue and sternal debridement. A nonunion of the sternal bone was found, and hardware was removed (**Figure B**). Well-vascularised muscle flaps were needed to obliterate the dead space in the presternal area. A submuscular dissection was performed below the pectoralis major muscle (**Figure C**). The elevated pectoralis muscle flaps were then advanced into the midline to fill the presternal area (**Figure D**). The soft tissue was approximated and the skin closed with horizontal mattress sutures over closed suction drains (**Figure E**). 3M™ Prevena™ Incision Management System with Peel and Place Dressing - 20cm was applied over the closed incision at -125mmHg (**Figure F**).

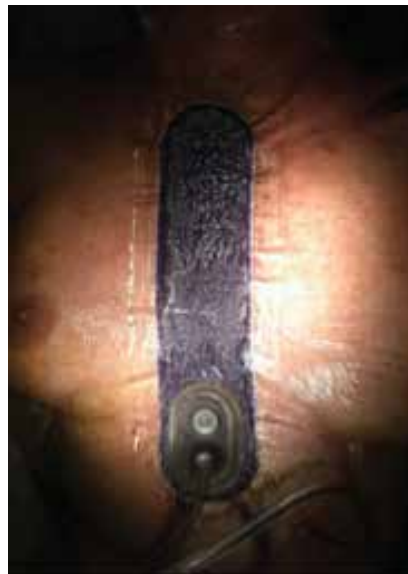
Figure B. 3M™ Prevena™ Dressing in place with negative pressure applied.

The patient was taken to the operating room for an aortic valve replacement and coronary artery bypass graft. Following closure of the incision (**Figure A**), 3M™ Prevena™ Incision Dressing with the 3M™ Prevena™ Peel and Place Dressing was placed over the incision at -125mmHg (**Figure B**).

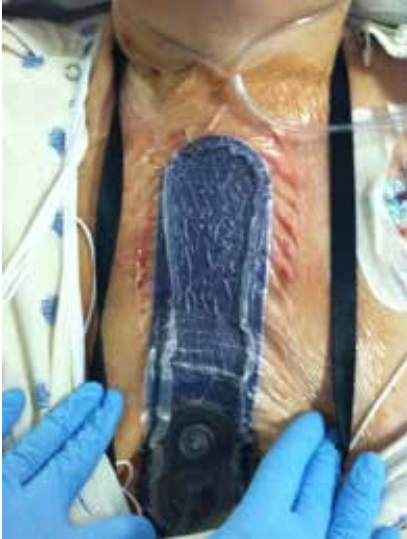
Figure A. Placement of 3M™ Prevena™ Dressing over the closed 17cm incision.

The patient was taken to the operating room for an aortic valve replacement. 3M™ Prevena™ Incision Management System with the 3M™ Prevena™ Peel and Place Dressing was placed over the closed incision at -125mmHg (**Figure A**).

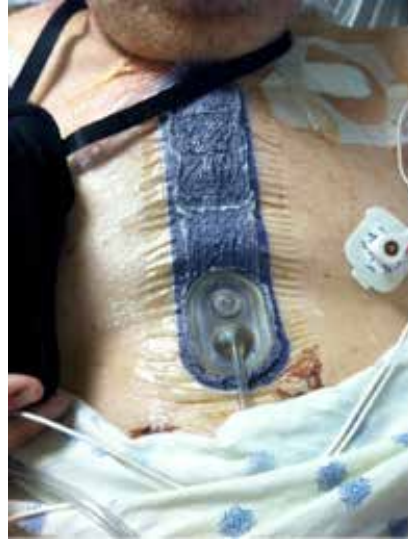
Figure B. 3M™ Prevena™ Therapy applied for 5 days.

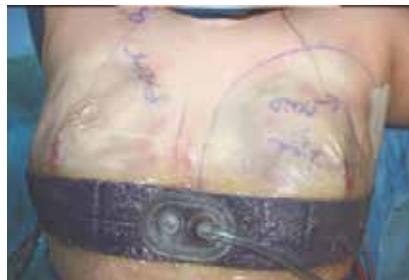
Figure B. Application of 3M™ Prevena™ Therapy following reduction pattern mastectomy.

Following surgery, the 3M™ Prevena™ Incision Management System with the 3M™ Prevena™ Customizable Dressing was placed over the closed incision at -125mmHg (**Figure B**).

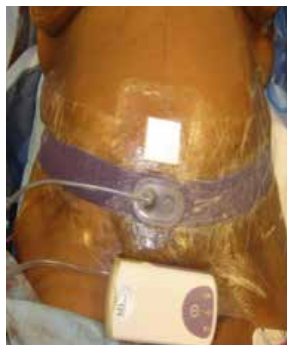
Figure E. Application of 3M™ Prevena™ Therapy for 7 days.

Post panniculectomy (**Figures B and C**), 3M™ Prevena™ Plus Incision Management System with the 3M™ Prevena™ Customizable Dressing was placed over the complete closed incision at -125mmHg (**Figures D and E**). The patient was discharged home on postoperative day 1 with the dressing in place.

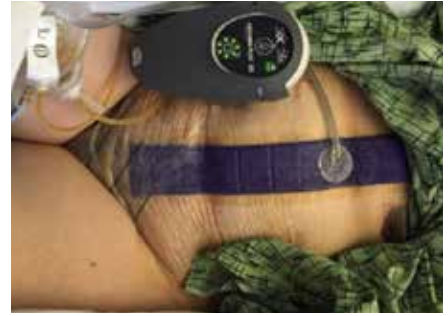
Figure F. 3M™ Prevena™ Therapy with the 3M™ Prevena™ Plus Customizable Dressing placed over the closed incision.

The patient was brought into the operating room (OR) where surgical confirmation of a duodenal D1-D2 junction perforation was made (**Figure C**). Primary intestinal repair was accomplished by double layer duodenorrhaphy with G-tube and distal J-tube placement (**Figures D and E**). Following surgery, the 3M™ Prevena™ Plus Incision Management System with 3M™ Prevena™ Plus Customizable Dressing was applied over the closed incision at -125mmHg (**Figure F**).
