**Dermatac™**  
Drape

**3M™ V.A.C. Dermatac™  
Drape with 3M™ V.A.C.®  
Therapy case studies.**

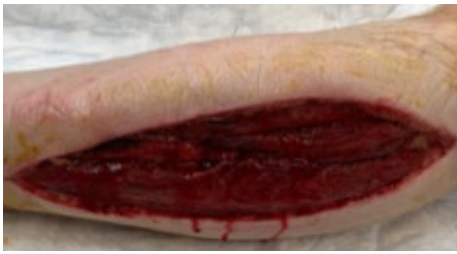
**Figure 1.** Left lateral calf at presentation (20 cm x 12 cm x 0.1 cm).

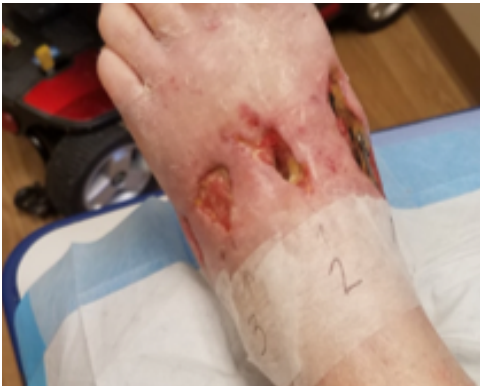
**Figure 1.** Dehiscent wounds after debridement, 1 week of 3M™ Veraflo™ Therapy with standard drape, and 1 week of 3M™ V.A.C.® Therapy with 3M™ V.A.C. Dermatac™ Drape.
