## Indonesia - 3M™ Stamark™ 380AW Pavement Markings shown to enhance visibility and reduce accident rates.

**Project:** Cikopo-Palimanan (Cipali) Toll Road Skip Line Extensions

**Location:** Indonesia

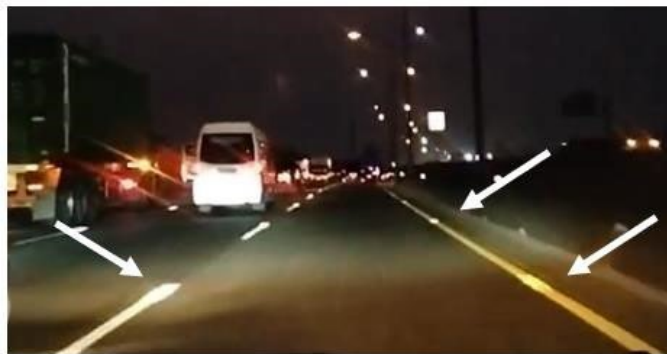
Image above: White arrows indicate 3M™ Stamark™ application.

Skip line extension refers to extending a dashed or "skip" line pavement marking beyond its usual length, while maintaining the same spacing between dashes. This is done to provide drivers with an extended visual cue, especially in areas where lane positioning is critical. It is typically used in situations where additional visual guidance is needed, such as when approaching a curve, lane change area, or intersection. This helps alert drivers to a potential lane change or hazard ahead.

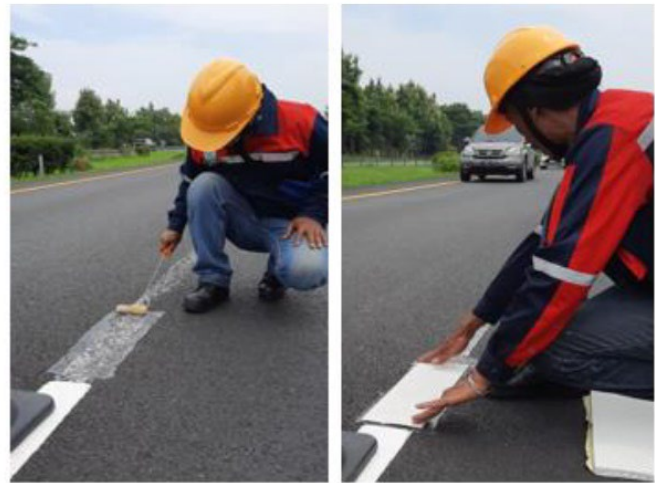
The application process for 3M™ Stamark™ 380AW is straightforward and efficient, involving just a few simple steps: clean road surface, apply adhesive and wait for it to dry, apply the pre-cut tape, then tamp down. This method eliminates the need for complex tools and long pre-application steps required for thermoplastic markings, reducing installation time and minimizing traffic disruptions.

Easy application of 3M™ Stamark™ 380AW Pavement Markings

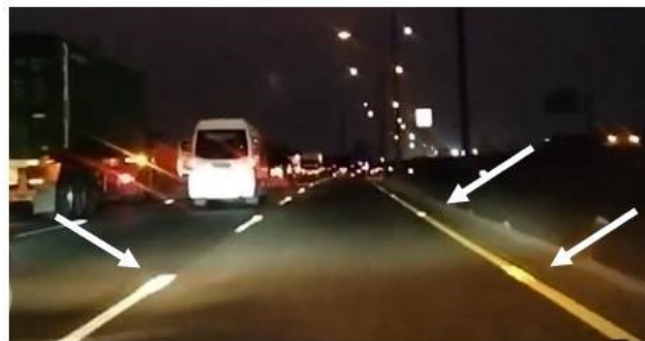
The road was divided into four sections, each with distinct characteristics and accident trends:

**Site 1** - 25.8 km (16.03 miles):  
Accident count reduced by 16.4% at 3M™ Stamark™ 380AW locations, while non-installed locations saw a 40.7% increase.

**Site 2** - 131.4 km (81.64 miles):  
Accident count reduced by 14.3% at 3M™ Stamark™ 380AW locations, while non-installed locations saw a 31.3% increase.

**Site 3** - 54.7 km (33.99 miles):  
Accident count reduced by 31.8% at 3M™ Stamark™ 380AW locations, while non-installed locations saw a 4.5% decrease.

**Site 4** - 17.5 km (10.87 miles):  
Accident count increased by 50% at 3M™ Stamark™ 380AW locations, while non-installed locations saw a 75% increase.
