**RACKING TEST EVALUATION OF EN-WALL 7250 UNITIZED CURTAIN WALL  
SYSTEM WITH 3M™ VHB™ STRUCTURAL GLAZING TAPE**

Final Report

Submitted to:

3M Industrial Adhesives & Tapes Division  
3M Center, Bldg. 220-5E-06  
St. Paul, MN 55144-1000

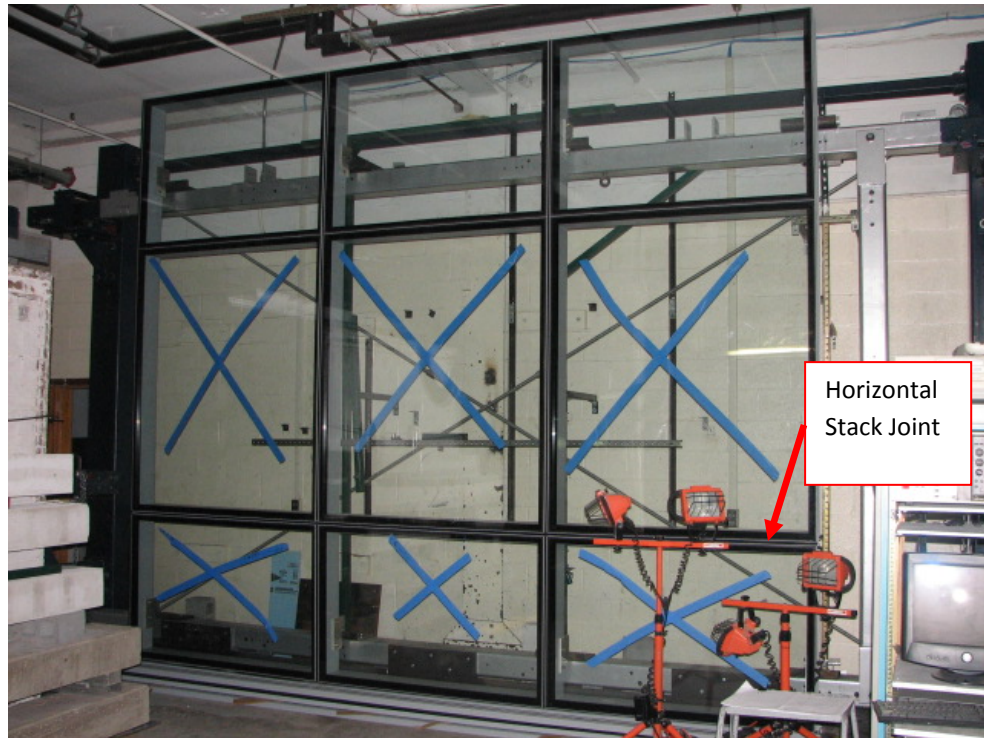
**Figure 5- Photo of the Actual Specimen on the Facility**

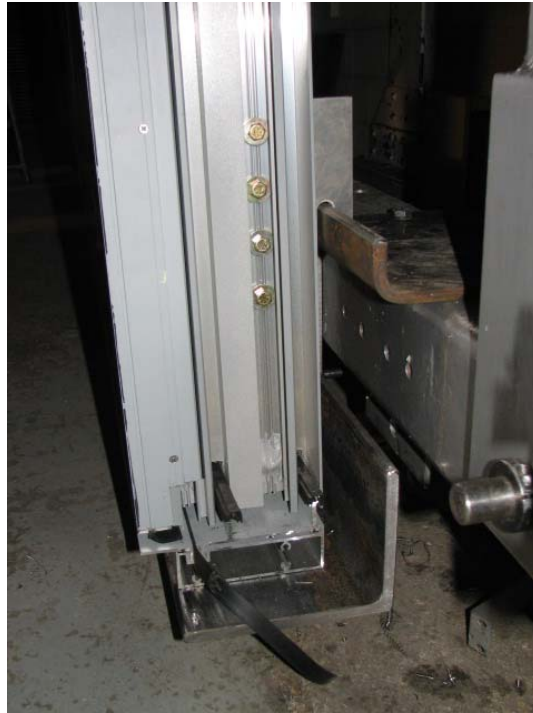
**Figure 7- Attachment of the Bottom of the Specimen to the Facility**

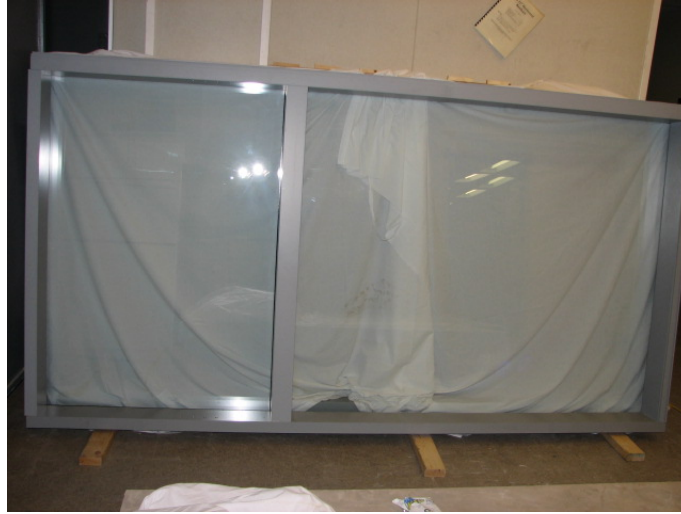
**Figure 8- Larger Unitized System Panel (Interior View)**

The EN-WALL 7250 Curtain Wall units were fabricated and glazed by EN-WALL in a shop environment. The completed units were then shipped to the Building Envelope Research Laboratory in the Architectural Engineering Department at Penn State University. The panels were assembled in the Building Envelope Research Laboratory to construct the specimen on the racking facility. The unitized system was composed of 6 panels, 3 of which are considered larger panels with two lites of glass (shown laying on its side in Figure 8) and the other 3 are considered smaller panels that are each composed of one glass lite (shown in Figure 9)

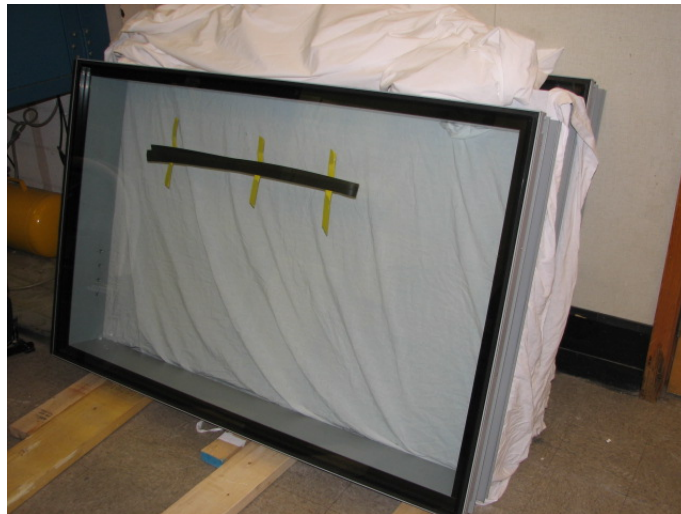
**Figure 9- Smaller Unitized System Panel (Exterior View)**

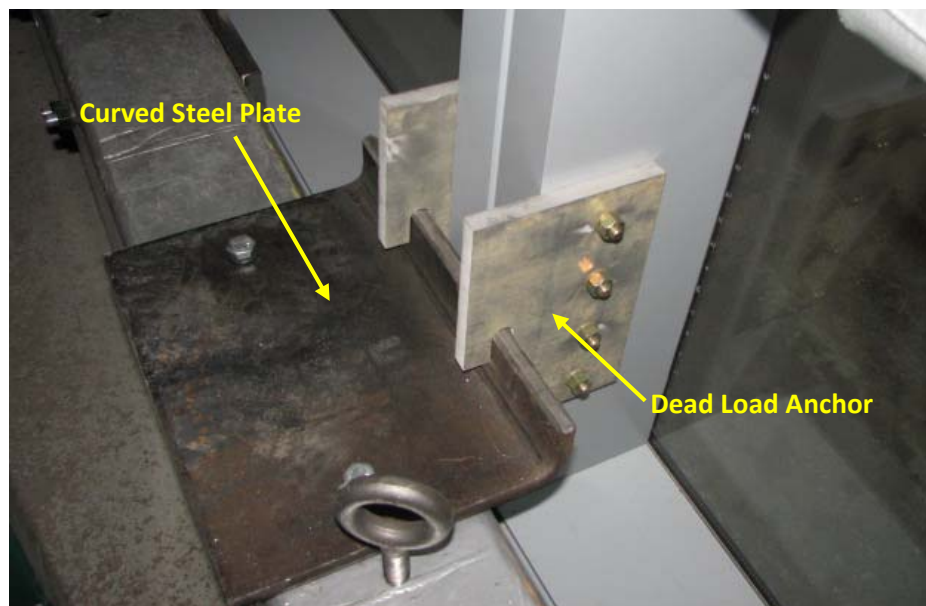
**Figure 14- Dead Load Anchor Attachment**

The system was mounted to the racking facility through twelve dead load anchors or knuckles. Six of these anchors were attached to the framing (mullions) connecting the top three panels and six were attached to the bottom three panels. The anchors were attached to the unitized system using four bolts so that the anchors were butted against the inside face of the vertical mullions. These anchors then “sat” on custom-formed angles (steel plates) that were curved at 90° on one end. The plates were then bolted to the sliding tubes of the facility. The anchor setup can be seen in Figure 14. The holes in the mullions that were used to attach the dead load anchors were predrilled before shipment. However, additional holes had to be drilled for proper assembly of the specimens. Once the dead load anchors were installed and the specimen mounted to the facility, it was noticed that the prescribed clearance between the upper and lower panels at the horizontal stack detail was too large by approximately 1/4 in. This gap can be seen in Figure 15. To rectify the difference, the bearing surfaces of the dead load anchors were filed down to allow the upper panels sit lower and hence close the mentioned gap to the prescribed distance. Each dead load anchor was uniquely filed down as some anchors needed less adjustment than others.

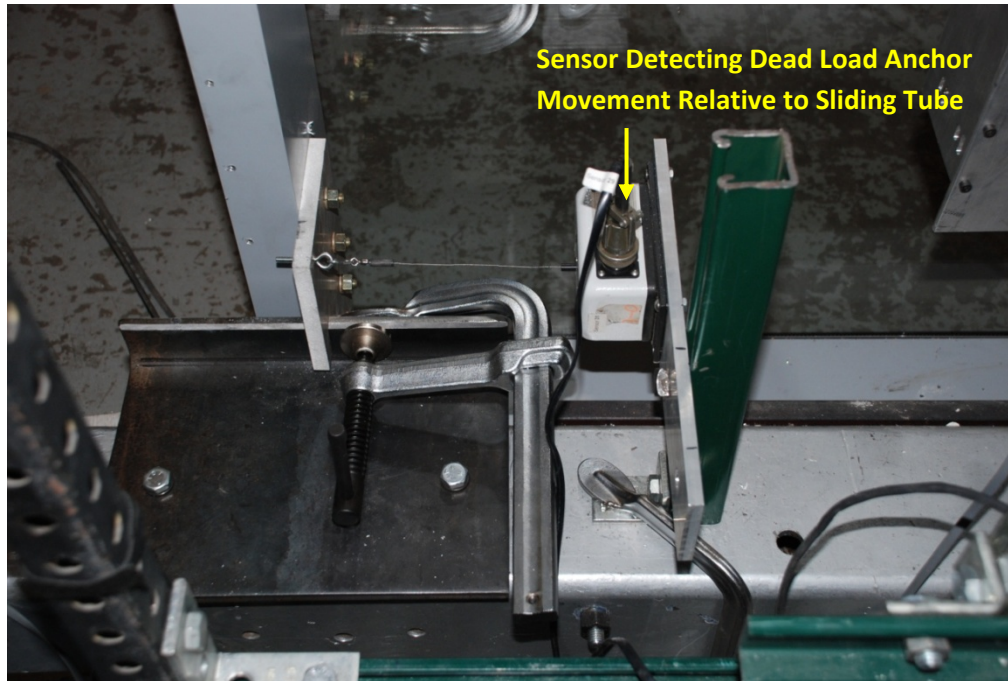
**Figure 17- Sensor on Dead Load Anchor**

determine if the dead load anchors were shifting relative to the facility. Table 1 summarizes the sensors that were used, and Figures 17 and 18 show photos of some of the sensors attached.

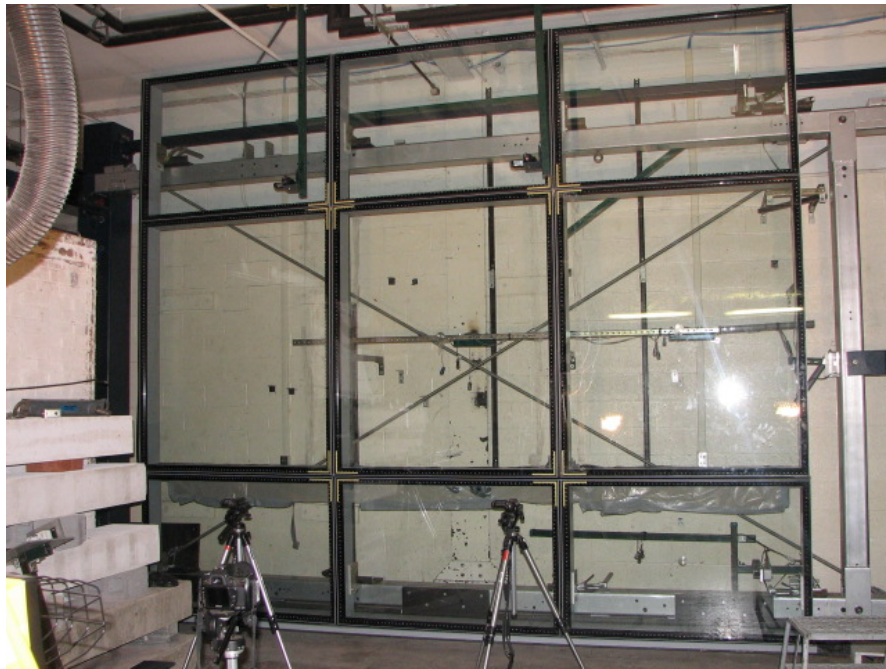
**Figure 19- Fully Built Unitized System Test Specimen**

the positive and negative directions. The average of these values was taken and compared to the rotation that the fulcrum arm experienced. A displacement adjustment was used to account for the differences between the fulcrum arm rotation and the displacement of the upper and lower sliding tubes. A fully built specimen is shown in Figure 19.

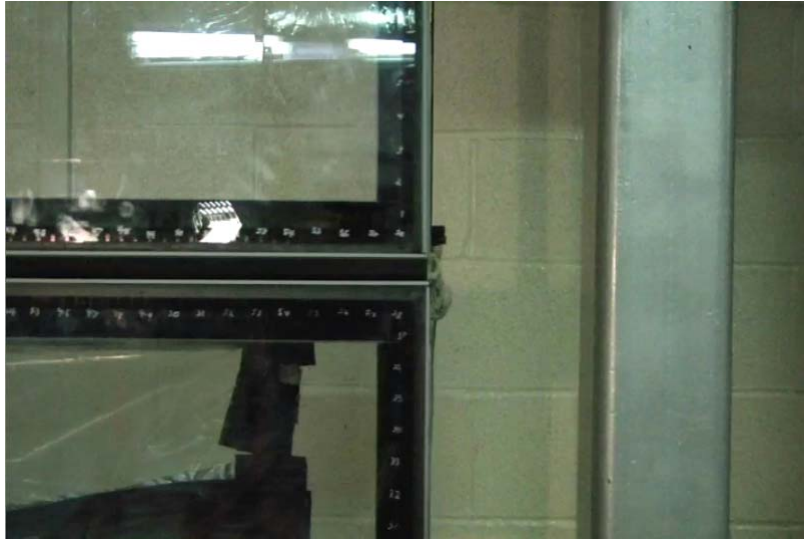
**Figure 20- Specimen 1. Test 1 before Racking Step**

Racking tests were performed on the previously described unitized system. Because of the nature of inter-panel connections (at stack joint) it was expected that the system would be able to handle large drifts before the onset of any damage to the specimen. As expected, the first racking test on the first specimen (Specimen 1, Test 1) indicated that the horizontal stack joint was free to slide relative to the lower panels. This in turn translated very little force to the glass panels themselves. The rubber gaskets that connect to the upper panels were able to hold the upper panels in place, but the horizontal stack joint's connection to the lower panels provided little resistance against free translation. This movement can be seen in Figures 20 and 21.

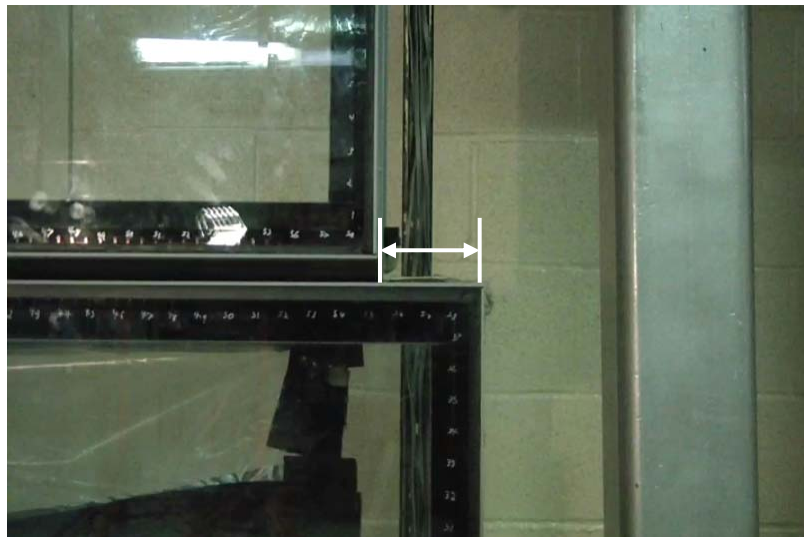
**Figure 21- Specimen 1, Test 1 during Racking Step**

The system also experienced permanent displacements similar to that shown in Figure 21. After the racking step of  $1\frac{3}{4}$  in., the upper panels displaced  $\frac{5}{8}$  in. to the left relative to the lower panels. This displacement continued to grow. After a racking step of 2 in., this displacement grew to  $1\frac{7}{16}$  in. Throughout the entire test, the three upper panels stayed connected to each other and the three lower panels stayed connected to each other. Glass panels did not rack and experienced very little load as a result of the sliding horizontal stack joint. However, upper

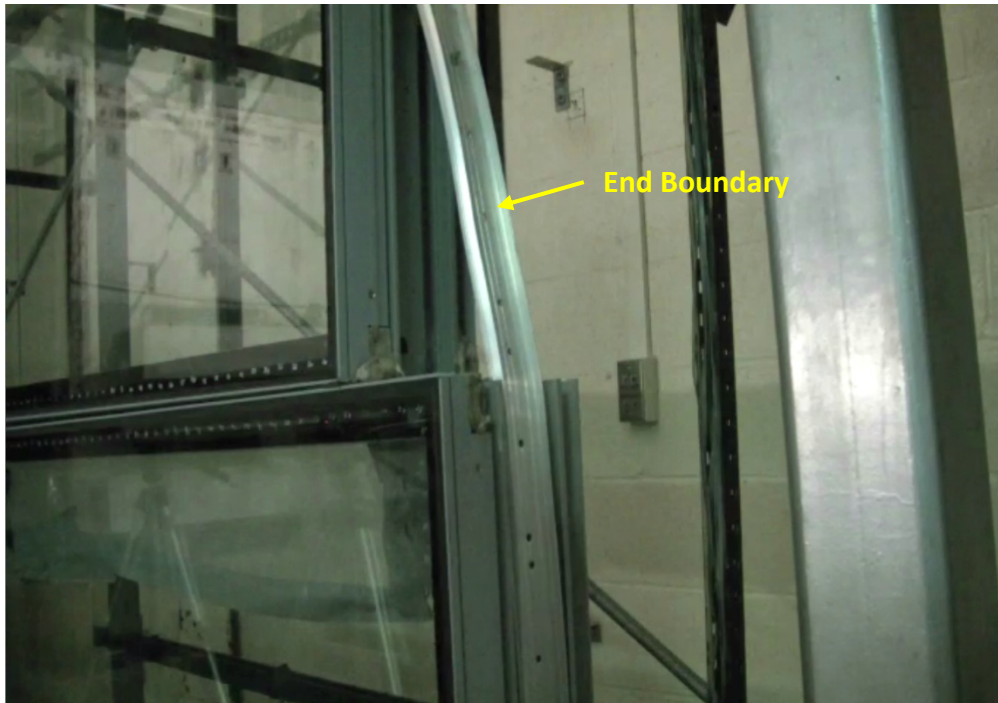
**Figure 28- End Boundary Acting as a Tension Member**

horizontal stack joint lost full engagement and began to pull out as shown in Figure 27. The screws that were placed farther away from the horizontal stack joint did not show signs of prying and stayed tightly fastened throughout the duration of the test. During larger displacements the pressure plate was observed to act solely as a tension member. Many screws were not subject to prying and therefore did not experience a large force in the direction of racking. These screws did, however, allow the pressure plate to carry the tensile loads created during racking movements. As the lower panels and upper panels move in opposite directions, the pressure plate was bent to meet this displacement. As a result, the pressure plate pulled the lower right panel towards the upper right panel (as shown in Figure 28). This does not represent a real world situation; however, the addition of this boundary condition induced some derailment. During the 5-3/4 in. racking step, the horizontal stack joint dislodged from the lower right panel. It is important to note that the wedge gasket could not be replaced before the second round of testing on this specimen (Specimen 1) and may have contributed to this behavior. The dislodged horizontal stack joint can be seen in Figure 29.

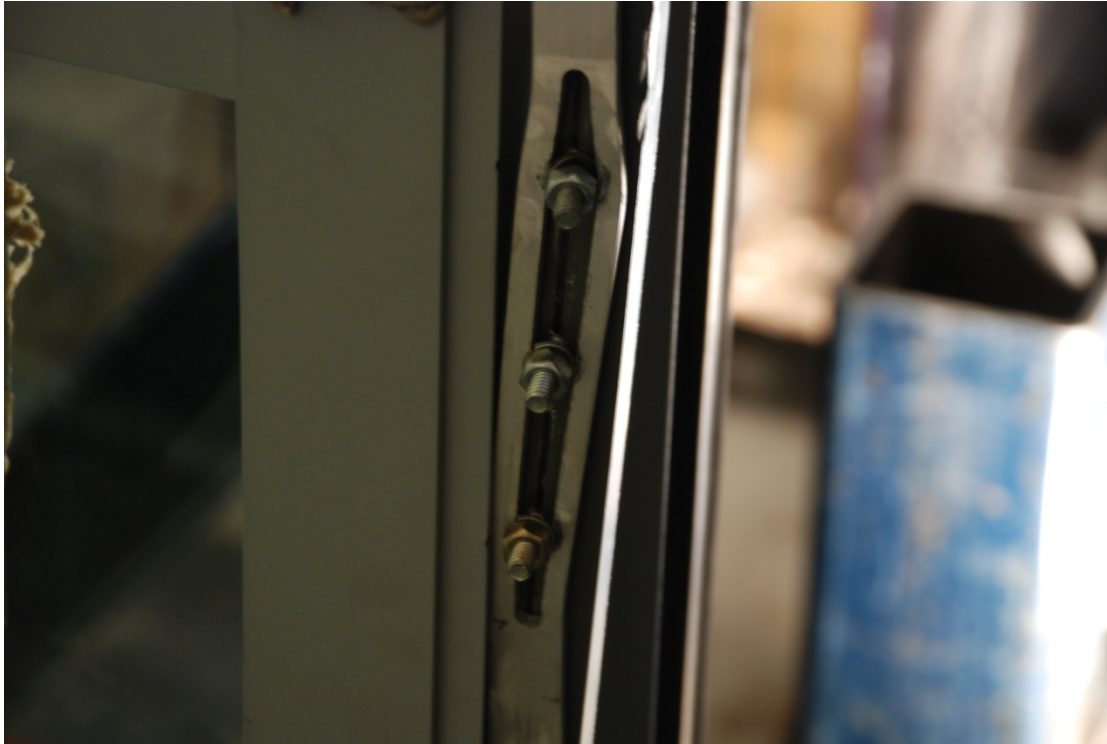
**Figure 33- Widening of Slotted-Holes**

The slotted holes allowed for movement along the length of the piece so that the end boundary could resist considerable tensile loads in the connection detail. Early on in the racking test, the slotted-hole detail was observed to perform as desired, and allowed the free movement of the connection piece along its length. Ultimately, the piece did not perform as desired in the direction of racking due to the small cross section of the slotted-hole piece. It was observed that after the 1-3/4 inch racking step that the slotted-holes widened due to the in-plane racking forces. This widening of the holes can be seen in Figure 33.

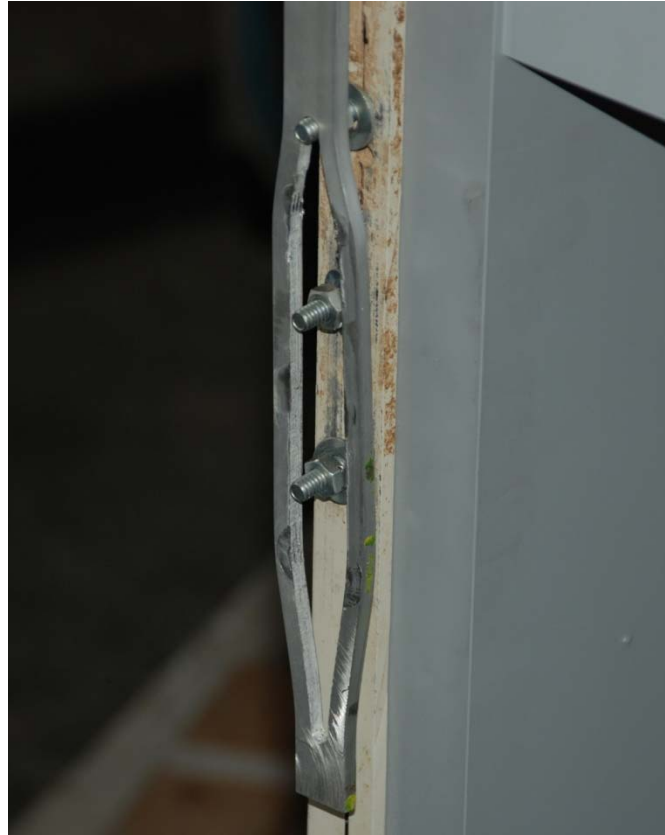
**Figure 34- Extent of Slotted-Hole Widening**

These holes continued to expand with racking, and at 2 ¼ in. drift the slotted holes effectively failed through widening and could not offer much restraint. Consequently beyond this point, the specimen behaved more like the first test of the second specimen with no boundary restraint. During the 2-1/4 in. racking step, the right boundary element failed and the slotted-hole connection piece was released from the system. The extent of the width of the slotted-holes can be seen in Figure 34. The test continued using only the left boundary element for two more racking steps and then the tests concluded when the right boundary element failed just as the left one did. Because of the lack of any effective boundary element, the system performed as an unrestrained system and of course no longer represented a realistic practical boundary condition. There was no failure in the unitized system during this test. It can be concluded that the boundary system used is not desirable for representing a corner condition found in typical

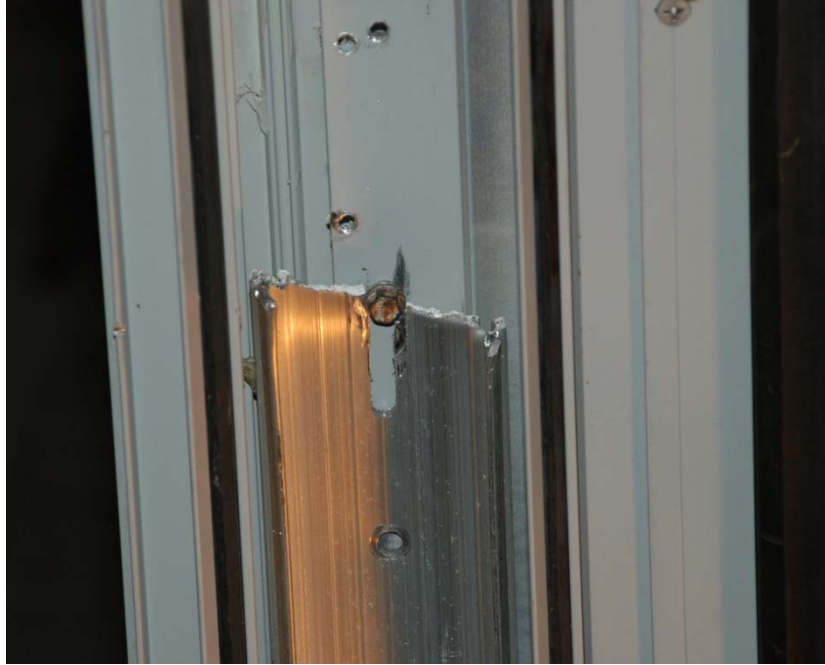
**Figure 36- Sheared Boundary Element**

During the subsequent two racking steps, the slotted-hole pressure plates sheared with the left boundary element shearing during the 4-1/2 in. racking step and the right boundary condition failing during the 4-3/4 in. racking step. By the time the boundary elements failed, the unitized system itself was thought to have reached a failure state (both vertical and horizontal joint dislodging). A sheared boundary element can be seen in Figure 36.

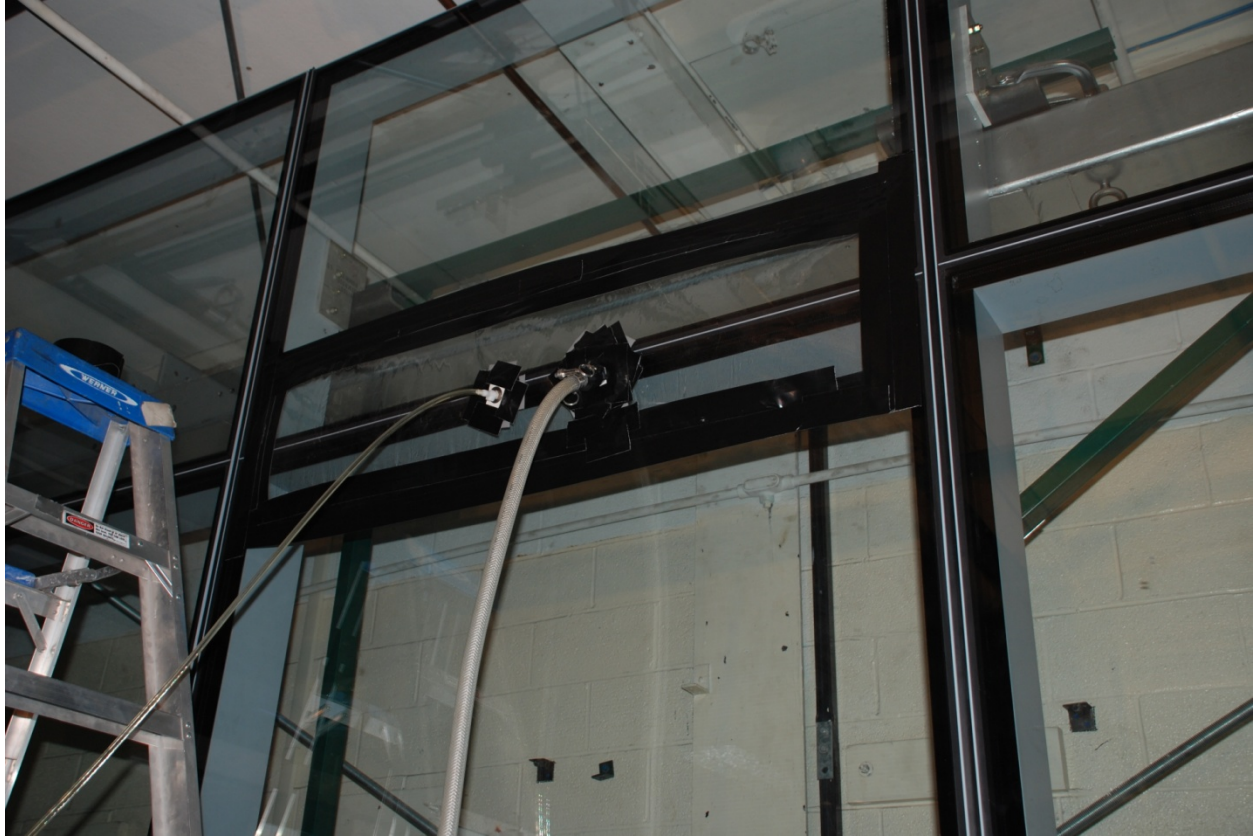
**Figure 38- Typical Shroud for Air Leakage Tests**

The joints are referred to as the left, right, top, and bottom joints (in the follow-up discussion) based on their orientation to the center panel from an exterior perspective. Plastic shrouds were made to serve as testing chambers. These shrouds were taped to the glass surrounding the joint of interest so that no air could escape. Then, the shroud was inflated to a desired pressure, as shown in Tables 5-11, and the air flow rate that it took to maintain that pressure was recorded. An example of a shroud used can be seen in Figure 38.
