**Report N°****TRADUCTION OF DICTUC REPORT N° 869240:  
"CRYSTAL CURTAIN WALLS MODULES ADHERED TO ALUMINIUM PROFILES  
BY MEANS OF 3M ADHESIVE TAPE  
CYCLIC SHEAR TEST AND MONOTONIC EMPTYING TEST, January 13, 2010"**

For:  
**3M CHILE S.A.**

Prepared by:  
**DICTUC S.A.**  
**Structural Engineering Laboratory**

### **CRYSTAL CURTAIN WALLS MODULES ADHERED TO ALUMINIUM PROFILES BY MEANS OF 3M ADHESIVE TAPE CYCLIC SHEAR TEST AND MONOTONIC EMPTYING TEST**

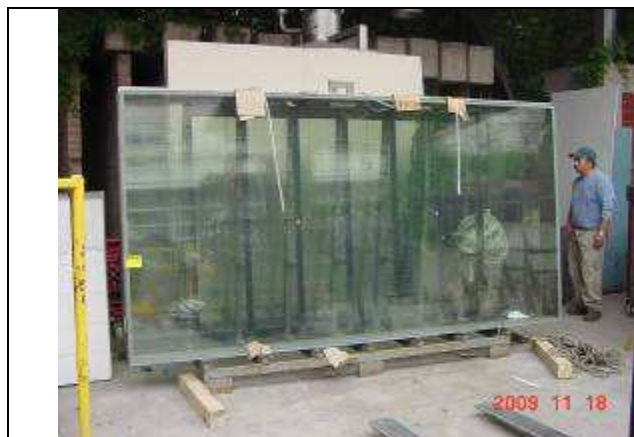
**Photograph 2.2: General view of the module with the aluminum perimetric frame.**

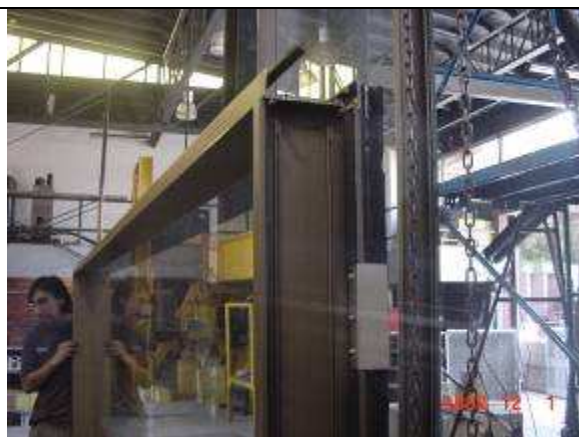
**Photograph 2.3: General partial view of the aluminum frame of one of the modules.**

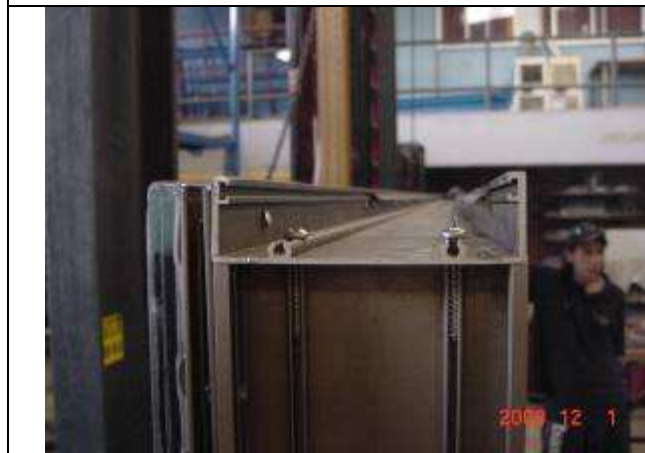
**Photograph 2.4: Geometry detail of the aluminum frame vertical profile that is located in one of the module ends.**

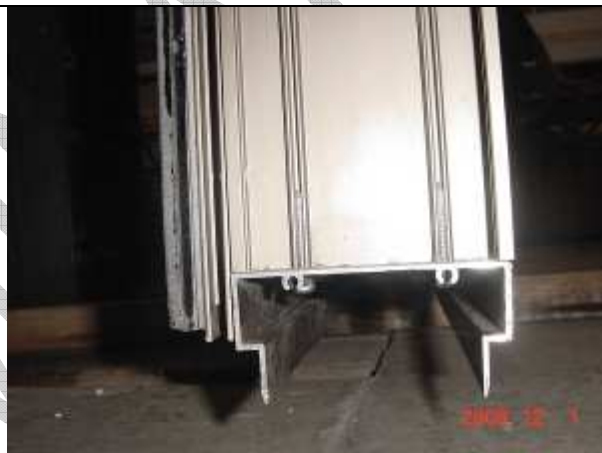
**Photographs 2.5: Geometry detail of the aluminum frame vertical profile that is located in the other module end.**

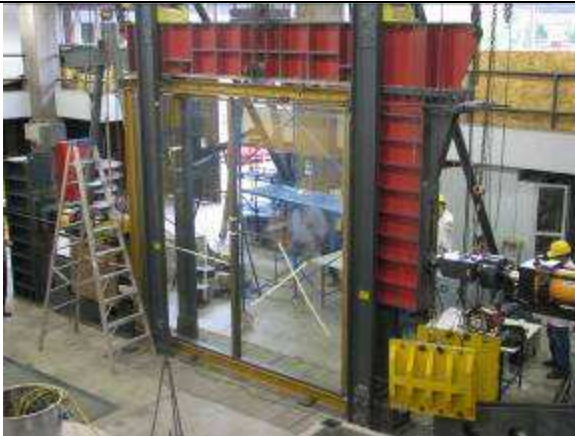
Photograph 3.1: General view of the wall curtain system cyclic shear test implementation.

In Pictures 3.1 and 3.2 a general view is presented of cyclic shear test implementation and a detail of the transducer that measures the total horizontal displacement. Picture 3.3 shows a detail of one of the load cells. Picture 3.4 shows a detail of some of the used graduated rulers. In Pictures 3.5, 3.6 and 3.7 are presented details of the located transducers to measure relative deformations between the aluminum frame and the crystals, and between the crystals.

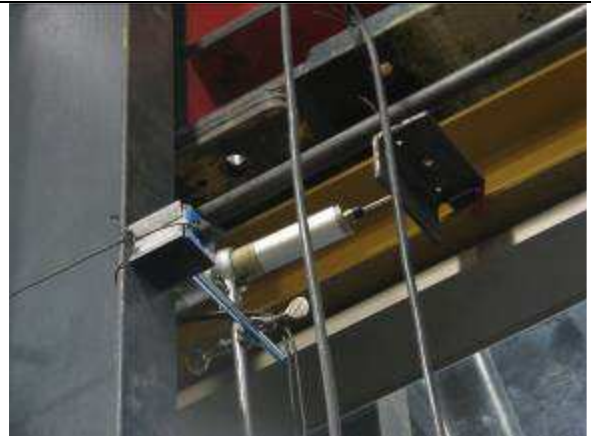
Photograph 3.2: Detail of the sample total horizontal displacement measuring transducer.

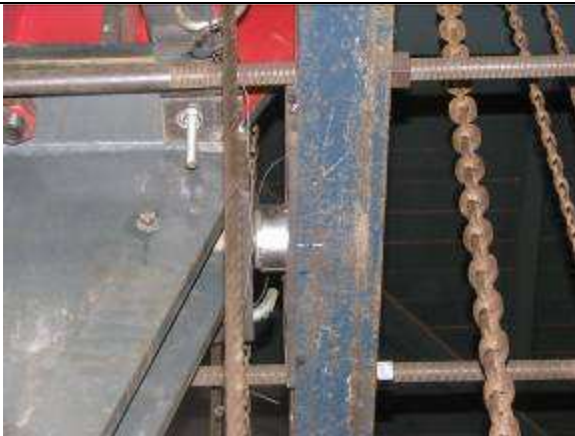
Photograph 3.3: Detail of one of the load cells implemented for the registration of the load applied to the system.

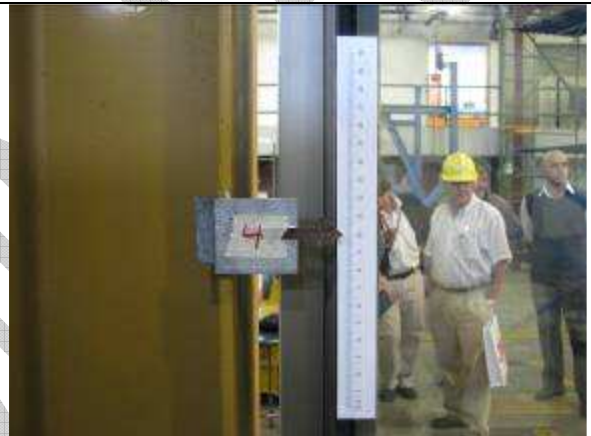
Photograph 3.4: Detail of one of the graduated rulers used to measure displacements in tests

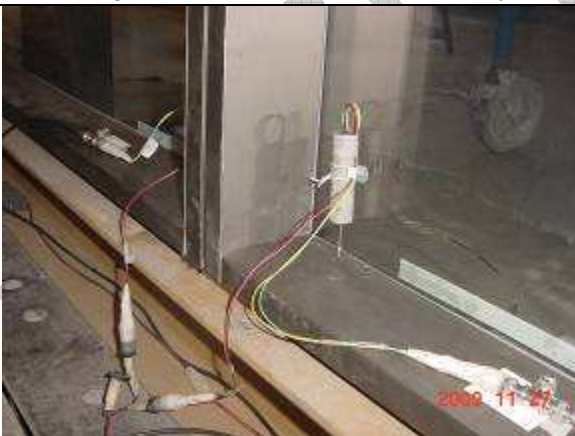
Photograph 3.5: Detail of the central located transducer for vertical displacement measurement of the aluminum frame bottom profile. West side.

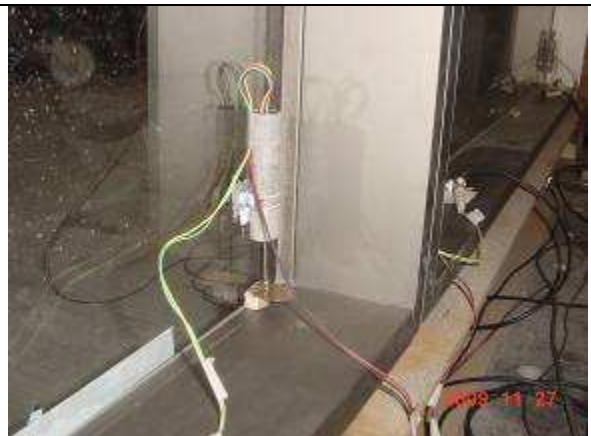
Photograph 3.6: Detail of the central located transducer for vertical displacement measurement of the aluminum frame bottom profile. East side.

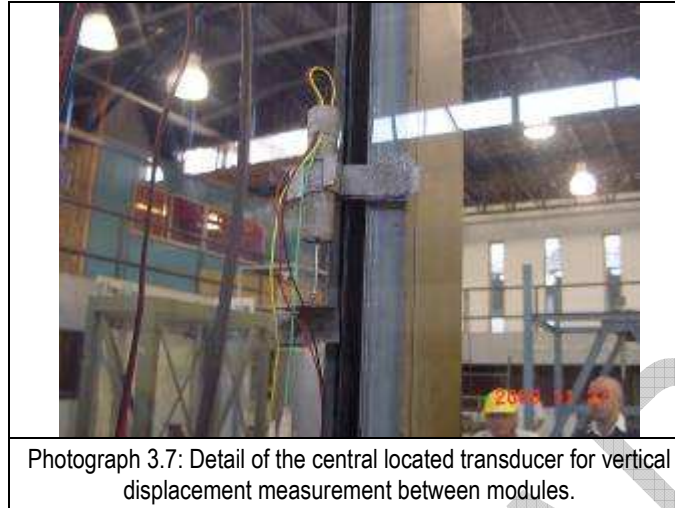
Photograph 3.7: Detail of the central located transducer for vertical displacement measurement between modules.

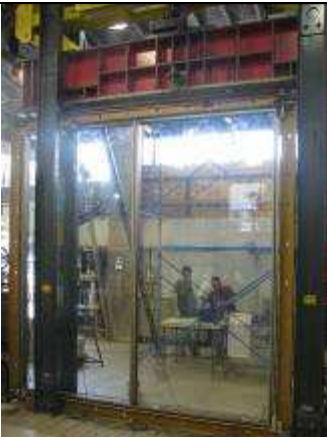
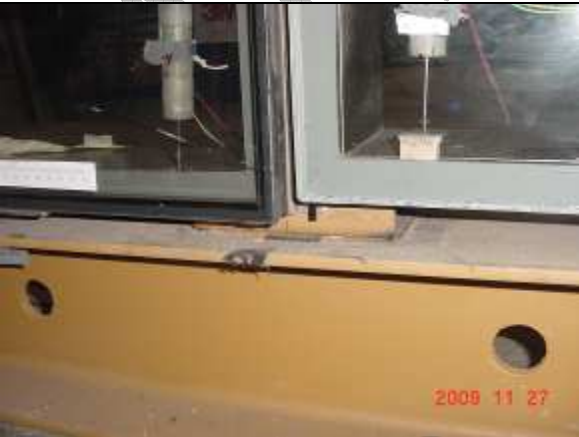
| <p><b>Photograph 4.1: General view of the final condition of one of the tested samples, where is possible to appreciate that it doesn't experience general system damages.</b></p> | <p><b>Photograph 4.2: Detail where it is appreciated that the connection between crystals and aluminum profile carried out with 3M tape remains without alterations during the whole shear test.</b></p> |

- General system damages because of test were not observed, neither in crystals nor in bolted connections (See Picture 4.1).
- Detachment of the 3M adhesive tape was not observed, neither the existence of permanent deformations or elongations of this. (See Picture 4.2).
- It was observed that modules presented rotations and displacements regarding the steel frame (mainly risings of the opposed to the direction of the movement inferior ends), besides existing relative displacements between the modules. (See Picture 4.3).
- It was observed that for the more deformation cycles (35mm cycle and further) the steel tabs didn't reach to be connected with the module frame aluminum profiles grooves, specifically in the side that rise because of movement. (See Picture 4.4).

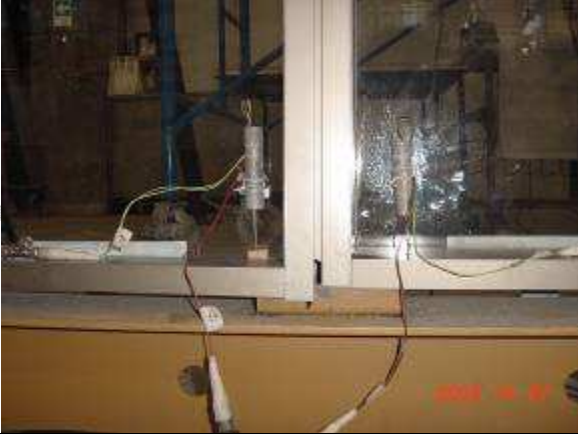
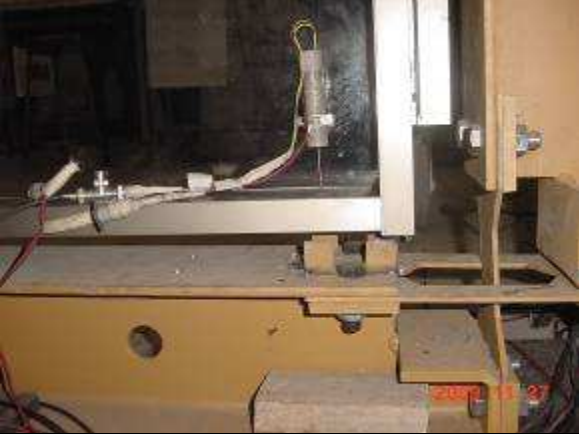
| <p><b>Photograph 4.3 Detail where the relative movement between the modules that conforms the system is appreciated.</b></p> | <p><b>Photograph 4.4: Details that it shows the disconnection between steel tabs and grooves of the aluminum profiles for deformation cycles equal or bigger than 35mm.</b></p> |

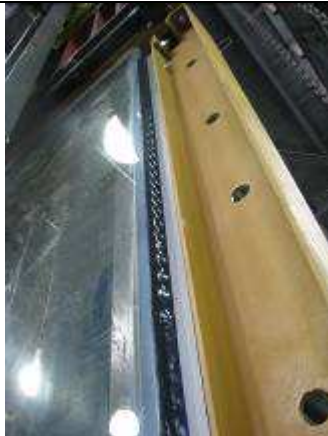
Photograph 4.5: Details that shows deformation of the silicon located in the vertical joints between modules and in their connections with the sides profiles.

- Damages were not observed in the aluminum frame.
- Deformation of silicon in modules joint was observed. This deformation increased as the amplitude of the displacements increased. (See Pictures 4.5 and 4.6).

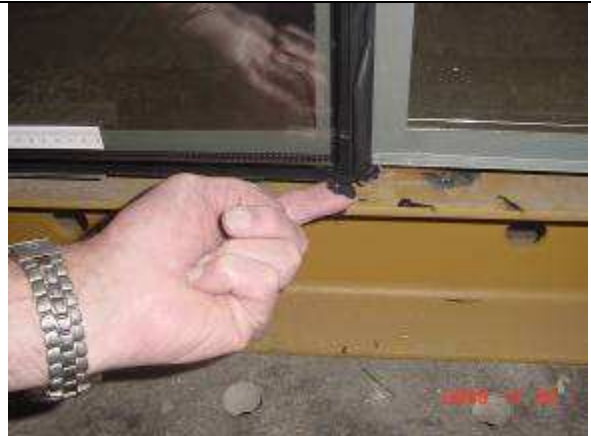
Photograph 4.6: Details of the silicon condition for the last displacements cycles in sample 1

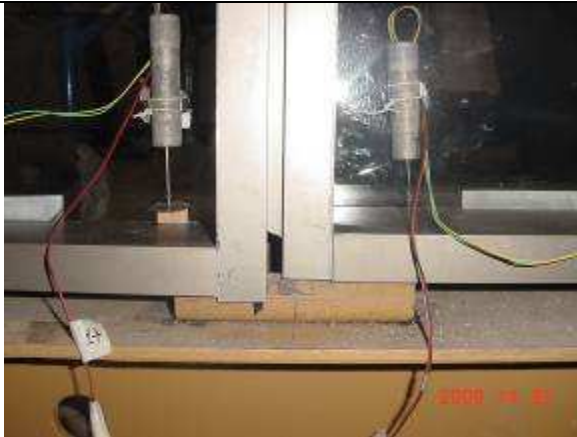
Photograph 4.7: Details where the small break is shown of one of the aluminum profiles in the bottom central sector of sample 2

- For the 40mm cycle, a small break of the aluminum profile took place in the central sector, and in the 50mm cycle a break of the horizontal inferior profile of the aluminum frame that makes up the module with the laminate glass. This break has its biggest magnitude in the bottom east area. Presumably these events have been cause by the lack of a fine adjustment between the steel tabs and the aluminum profile grooves, generating an important pressure. (See Pictures 4.7& 4.8).

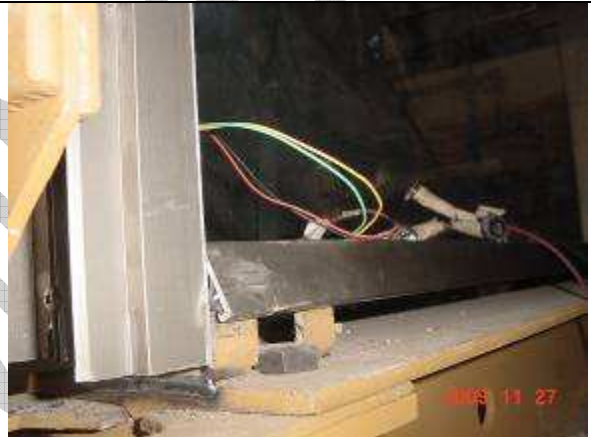
Fotografia 4.8: Details of the bottom east horizontal profile break of the of aluminum frame of the module with the laminated glass, in the 50mm cycle of the sample 2

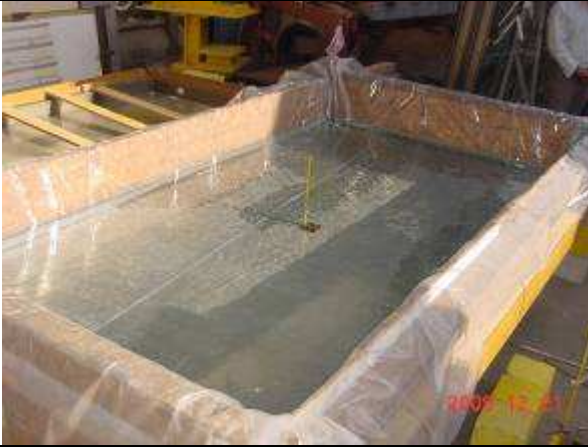
**Photograph 4.9: General view of the emptying test (filled pool) to thermo-panel system module.**

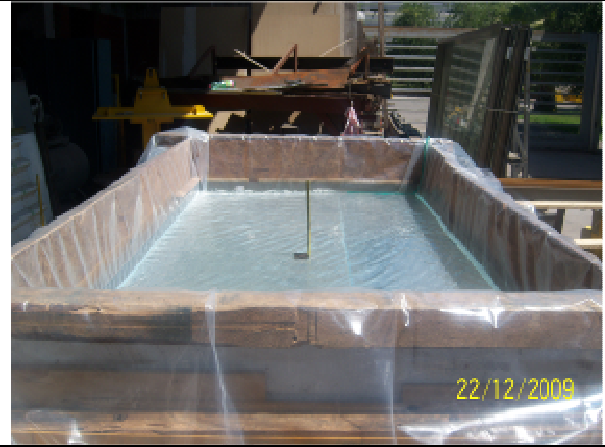
**Photograph 4.10: General view of the emptying test (filled pool) to laminated glass system module.**

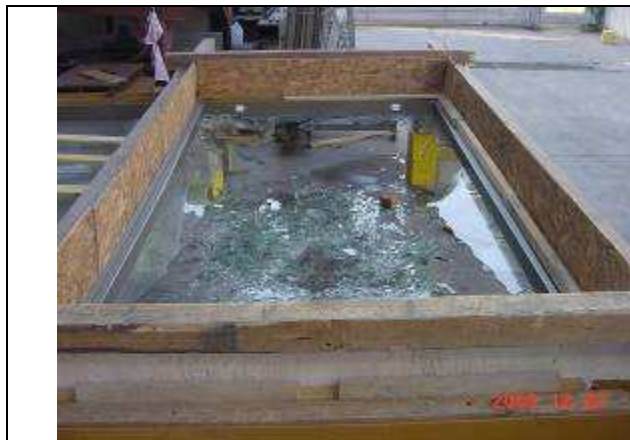
**Photograph 4.11: General view of the final condition of thermo-panel module subjected to emptying test.**

- During test, several noises were heard, attributable to previous to failure system accommodation.
- Aluminum vertical profile significant deformation was observed, mainly the one that is located in the central area (connection area between modules).
- The failure mechanism consisted in fragile crystal breaking (Because assembly reasons, the system had inner glass only). (See Picture 4.11)

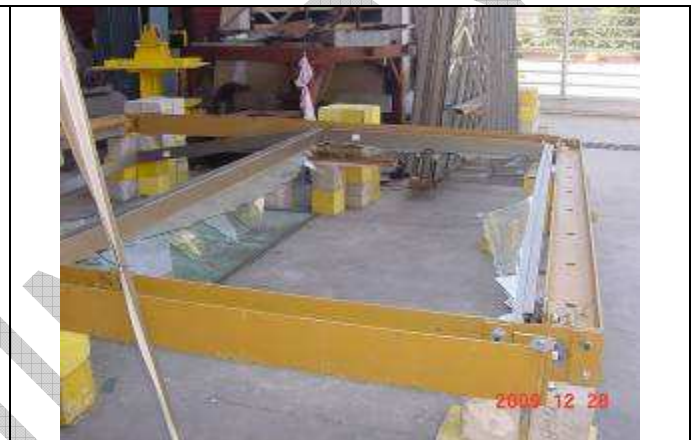
**Photograph 4.12: General view of the final condition of thermo-panel module subjected to emptying test.**

- Detachment of the aluminum frame regarding connection in the ends of the long side of the module was not observed (connection with external vertical profile and with the other module). (See Picture 4.12)
- Detachment of aluminum frame system - 3M tape - thermo-panel was not observed. The glass borders remained adhered to the aluminum frame by 3M tape. In some places, elongation of 3M tape was observed. (See Picture 4.13)
- Breaking of glass was in such a way that the whole central area was in pieces, but the border was adhered to the aluminum frame by means of 3M tape. Borders breaking was irregular, except in the four corners of glass, where the cracks radially, practically in 45° regarding the corner. (See Picture 4.14).

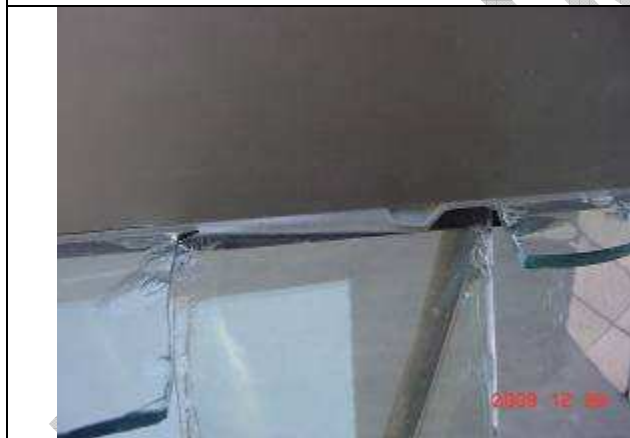
**Photograph 4.13: Detail of one of the borders, where it is possible to observe a segment of elongation of the 3M tape, concluded the thermo-panel module emptying test.**

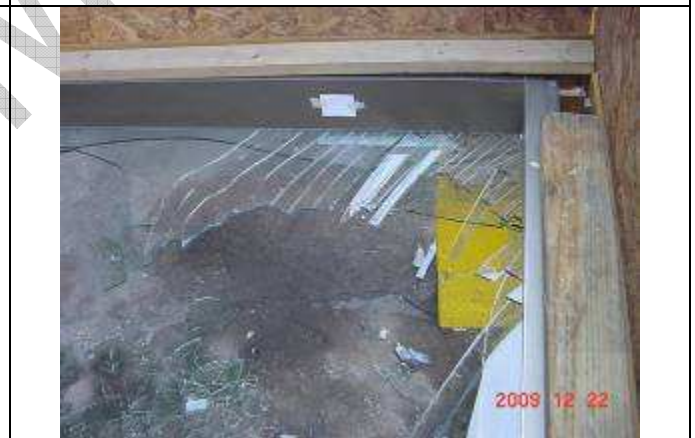
**Photograph 4.14: Details of the breaking mechanism in the thermo-panel system corners**

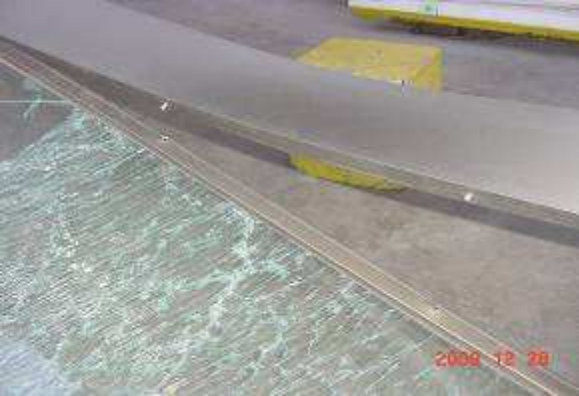
| <p><b>Photograph 4.15: General view of final condition of the module with laminated glass subjected to emptying test.</b></p> | <p><b>Photograph 4.16: Details of failure mechanism product of framework profile detachment because rivets failure.</b></p> |

- The failure mechanism consisted on detachment of the framework profile regarding the aluminum frame, due to the failure of the rivets used for its union. The failure mechanism was fragile. (See Picture 4.15 and 4.16).

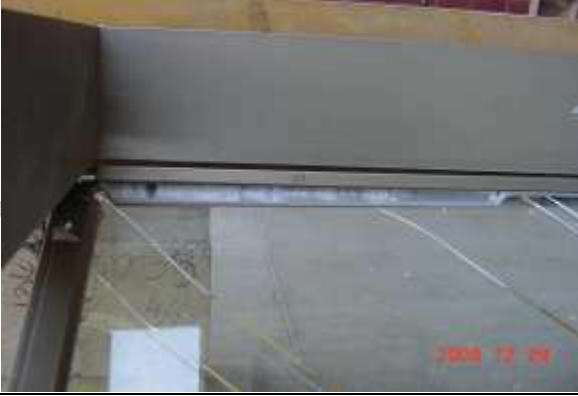
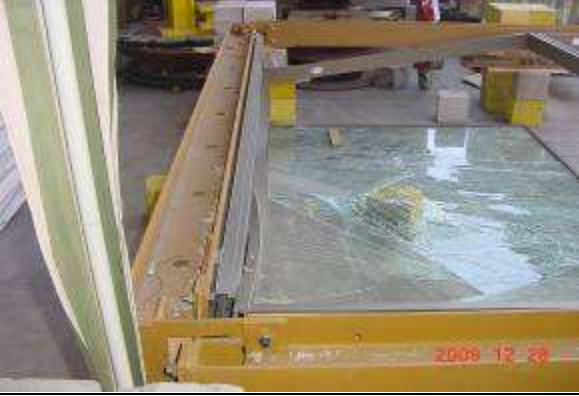
| <p><b>Photograph 4.17: Detail of one of the borders, where it is possible to observe a segment of elongation of the 3M tape, concluded the laminated glass module emptying test.</b></p> | <p><b>Photograph 4.18: General view of the aluminum frame upper east corner detachment, and crystal condition, once concluded the laminated glass module emptying test.</b></p> |

- No kind of detachment of the framework profile - 3M tape - laminated crystal system was observed. In most areas, crystal is completely adhered to the profile. There are other areas where adhesive tape elongation was observed, without presenting separation. (See Picture 4.17)
