Test Report Nº 2009-125/2

Type Test
of a 145 kV Termination
Type TS 145-II

Client: 3 M Deutschland GmbH
Carl-Schurz-Str.1

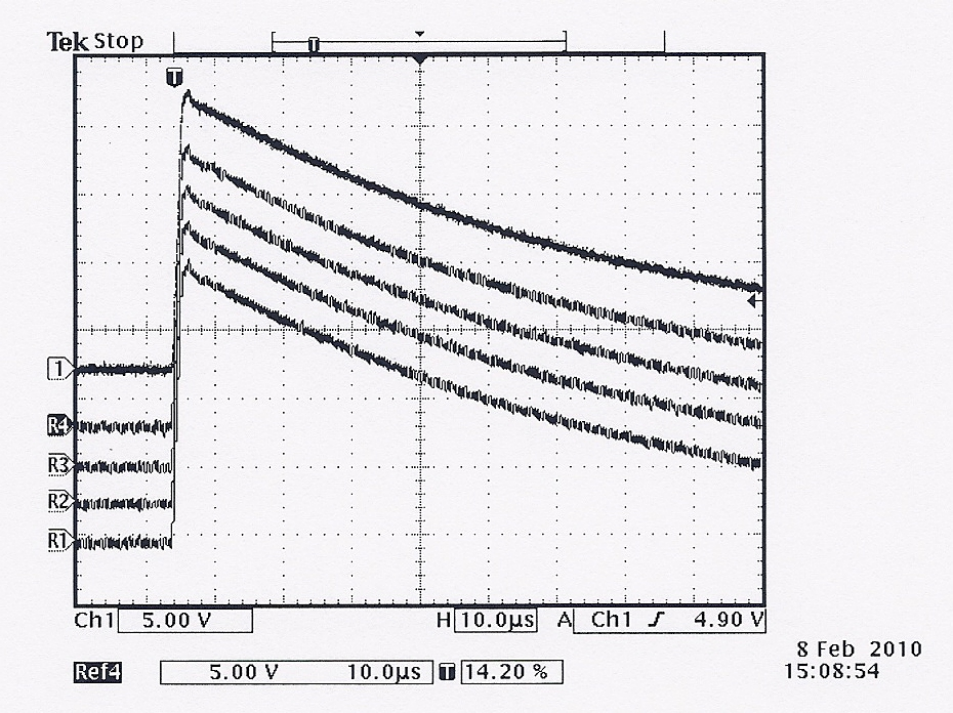
Figure 5.6.1: 100%-stress 1 - 5, positive polarity
Hor.: 10µs/Div; Vert.: 5V/Div; probe 10:1; ü = 3215

Neither flashover nor breakdown occurred at the test objects during all lightning impulse voltage tests.
