10 June 2020

PRODUCT ADVISORY – PLEASE READ

3M™ DBI-SALA® Self-Rescue Training Descent Systems P/N 3320037

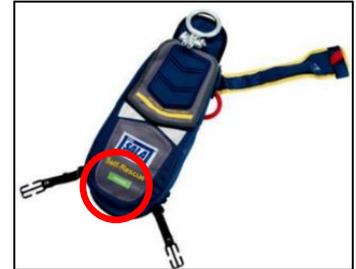
This product advisory applies only to the training model RSQ (#3320037). No other models are affected. A training RSQ has the word “Training” in green on the outside of the backpack (see photograph).
