# Inspection / Evaluation of 3M VHB Structural Glazing Tape for Structural Integrity after Years of Service

CLIENT:	<b>3M INDUSTRIAL ADHESIVES &amp; TAPES DIVISION</b>
CDC PROJECT #:	F00892
TESTING PERFORMED BY:	KEN BOWNDS & BRYAN HEAKE (CDC)
TESTING ASSISTED BY:	STEVE AUSTIN, KEN GOH, & PEDRO TERZI (3M)
REPORT PREPARED BY:	BRYAN HEAKE
SUBMITTED ON:	JANUARY 11, 2011

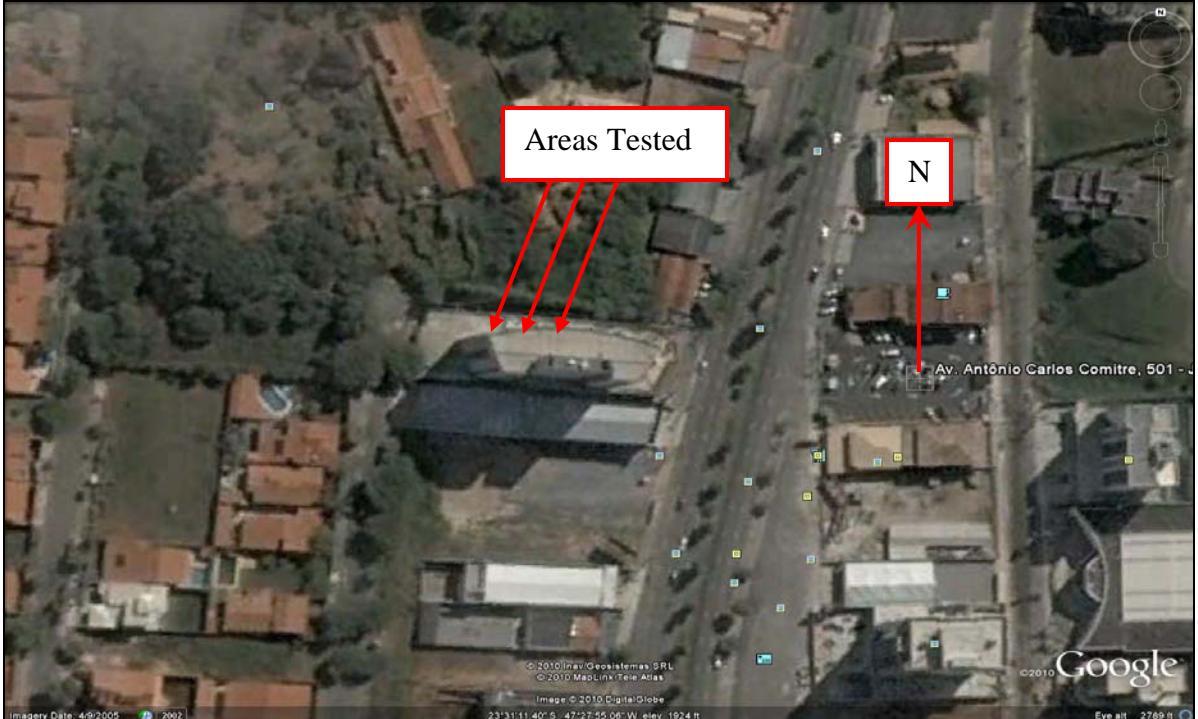
Photo #009: Aerial View of Test Location #2-Dallas Tower

Locations 3 through 7 were located on Level 4, facing North. The glass make-up is: 4mm Reflective/PVB/4mm Clear. The measured tape width was 1.17 inches (29.72 mm). Design Load = 1.17" X 11.75" X 12 psi = 165 lbs. (75 kg) Overload = 1.17" X 11.75" X 18 psi = 247.5 lbs. (112 kg)

Each location passed, with no evident adhesion or cohesion failure.

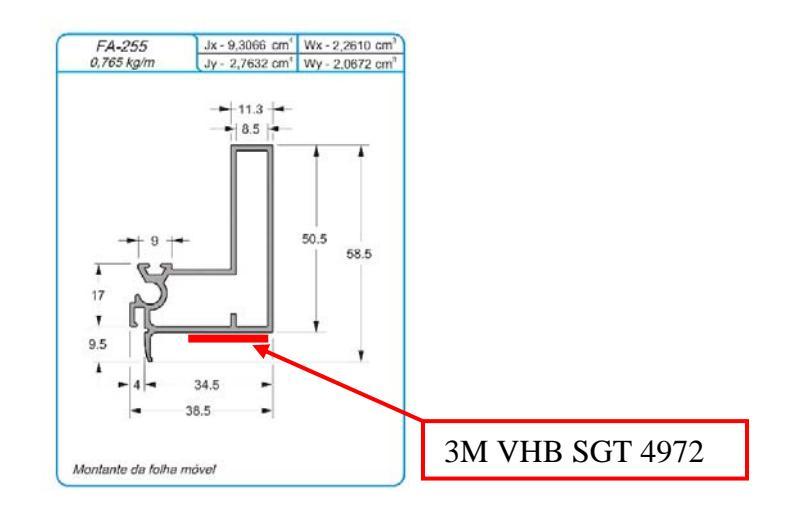
The window system was primarily operable window frames installed within a structural aluminum grid. Below is the extrusion which the glass was attached to with 3M VHB SGT 4972:

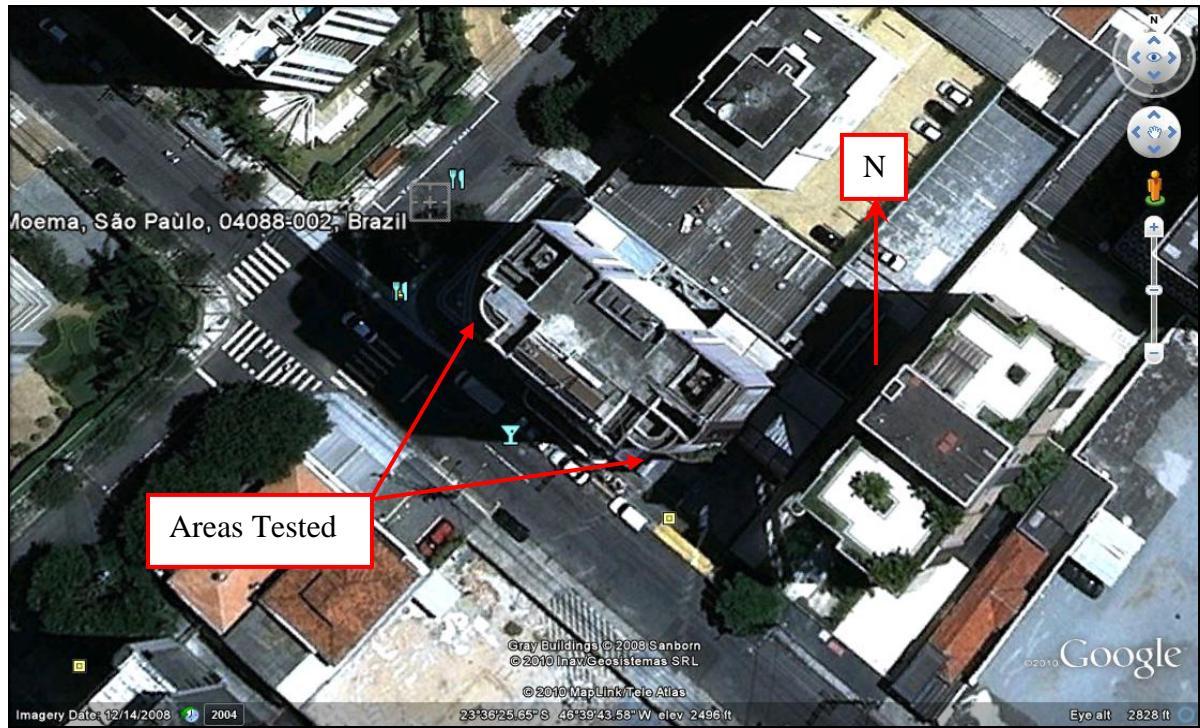
Photo #011: Aerial View of Test Location #3-Glass Tower

Each location passed, with no evident adhesion or cohesion failure.

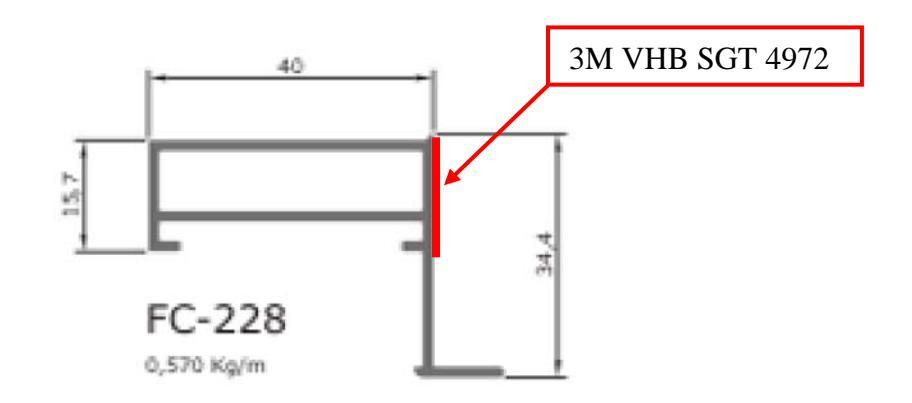
The window system was fixed window frames installed within a structural aluminum grid. Below is the extrusion which the glass was attached to with 3M VHB SGT 4972:
