Helping Protect Grid Integrity

3M Aluminum Conductor Technology Satisfies Power Utility Requirements.

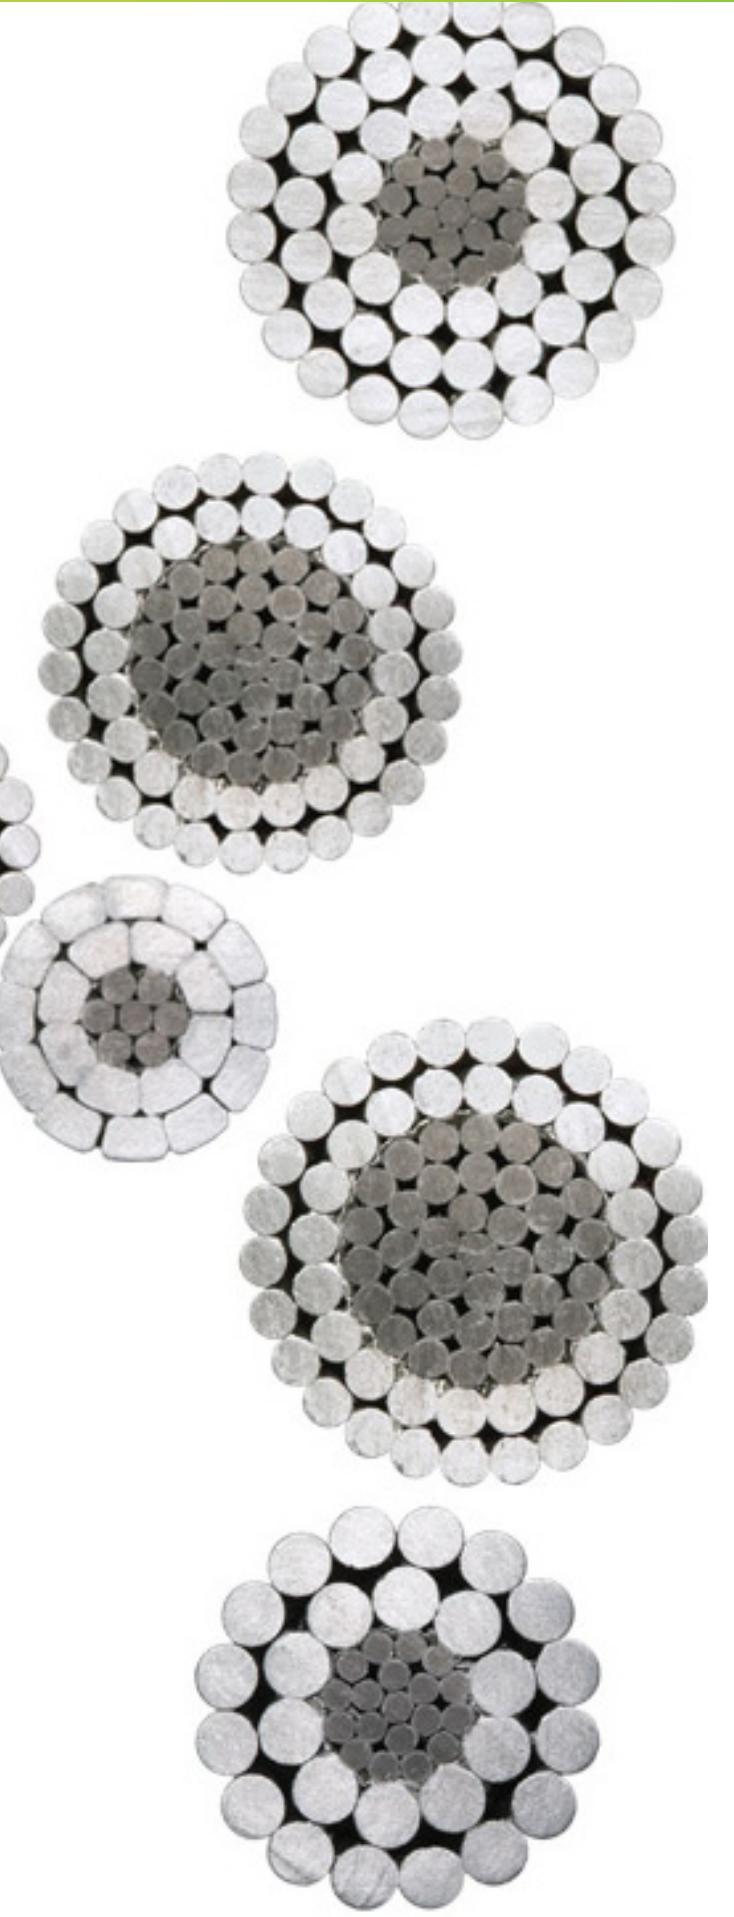
3M ACCR conductor is an advanced, all-aluminum, high-temperature, low-sag and high-durability power transmission conductor. It consists of aluminum oxide fibers embedded in high-purity aluminum, and offers high-temperature, low-weight and low-sag properties, along with high current capacity. Photo by Mitch McPherson

Based on enhanced 3M ACCR conductor performance, the construction crew was able to use 3 of 6 phase conductor positions from each tower, add shield wire protection, install fiber-optic cable for data transfer on the top two positions, and leave one position unused.

The new configuration has three phases of 3M[™] ACCR 26/19 conductor cable, one 0.508-in. OPGW fiber optic cable, and one 7#8 Alumoweld® Aluminum-Clad Steel Overhead Ground Wire.
