INSPECTION NOTICE

PROTECTA REBEL SRL

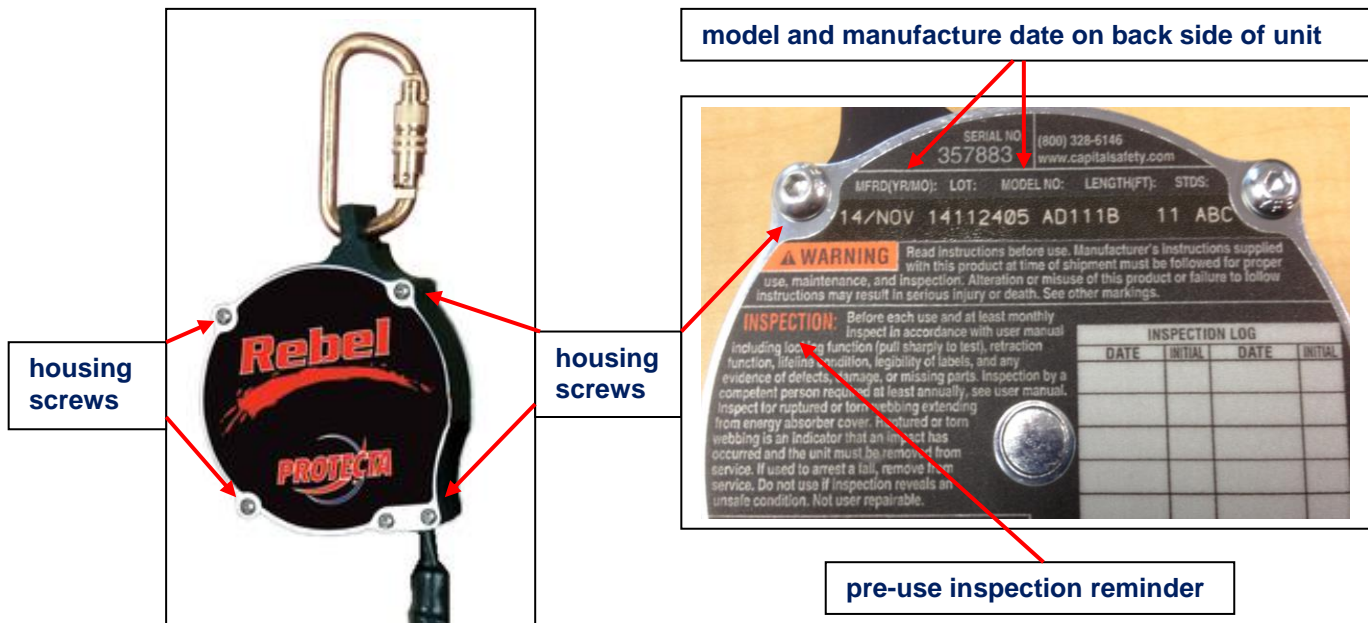
Capital Safety has learned of broken screw heads found in a limited number of Protecta brand Rebel Self-Retracting Lifelines (SRLs). The units affected by this notice are the black, extruded aluminum housing versions of the Rebel, manufactured between 1 April 2014 and 30 November 2014. (See photograph below.) The affected models are:

Although these units passed final assembly inspection by Capital Safety, reports indicate that the heads of some housing screws have been found broken off by end-users. These units have a total of ten externally visible screws that attach the two exterior housing plates to the main housing (five screws on each side, front and back).

Only the Protecta Rebel SRL models identified above are affected by this notice, and only those units manufactured between 1 April 2014 and 30 November 2014. Although we are confident this issue is limited to a select manufacturing lot of screws supplied by our vendor, we have taken the precaution of changing the type of screws used in these units to eliminate any potential of the condition reported.

- a) remind your workers to conduct pre-use inspections of their Rebel SRLs (as well as their other fall protection equipment);
 - the Rebel pre-use inspection checklist is
 - i. summarized on the product label under "Inspection" (see photograph on previous page), "check for any evidence of missing parts" and
 - ii. set out in full in the Rebel user manual, including the specific requirement to check that "all screws and rivets are present."
 - missing or broken housing screw heads will be readily visible;
- b) if any housing screw heads are missing or broken, take the unit out of service;
- c) if no housing screw heads are missing or broken, the units are safe to remain in service.

What to do if any Rebel SRL manufactured between 1 April 2014 and 30 November 2014 is found with a broken or missing housing screw head: The SRL should be removed from service and returned via distribution to Capital Safety, or users can call our Customer Service department directly at 1-800-328-6146 to arrange to return their unit.
