Production and placement of 3-unit posterior bridge and molar crown made of 3M™ Lava™ Esthetic Fluorescent Full-Contour Zirconia

Clinical dentistry and photography by: Dr. Gunnar Reich, Munich, Germany
Lab work by: MDT Nicole Freund, Tutzing, Germany

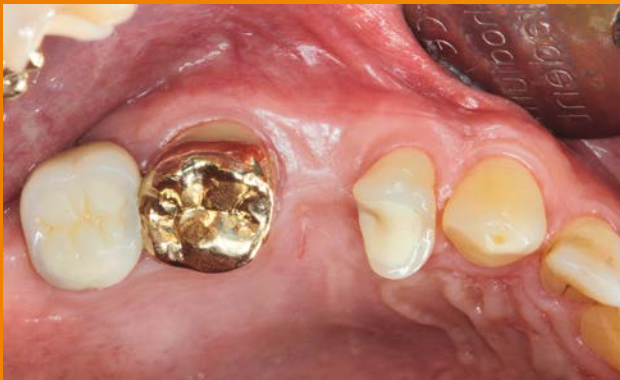
Initial situation: Missing second premolar #25 and chipped porcelain fused-to-zirconia crown on tooth #27.

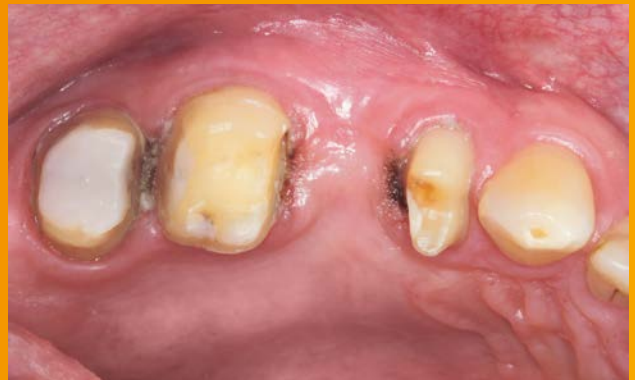
Preparations.

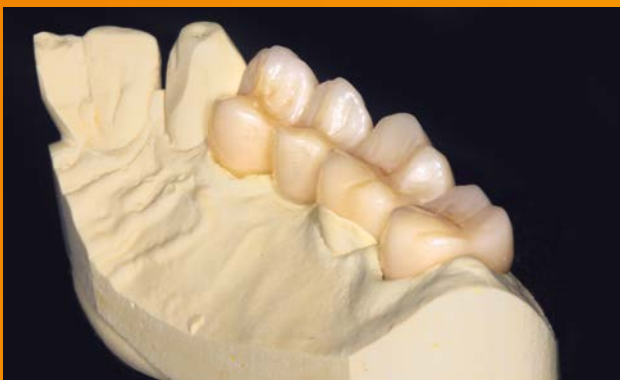
Glazed 3M™ Lava™ Esthetic Fluorescent Full-Contour Zirconia bridge and crown on model.

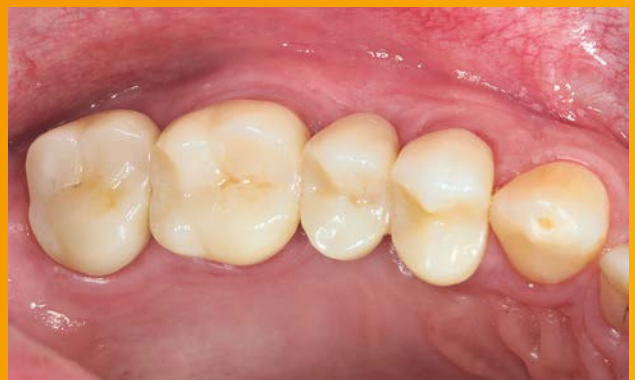
Final situation: 3M™ Lava™ Esthetic Fluorescent Full-Contour Zirconia bridge and crown, shade A3, both cemented with 3M™ RelyX™ Unicem 2 Automix Self-Adhesive Resin Cement.
