Test Report No. F690101/LF-CTSAYHA13-05151

SGS File No. : AYHA13-05151
Product Name : Cabinet lock
Item No./Part No. : N/A
Received Date : 2013. 08. 08
Test Period : 2013. 08. 09 to 2013. 08. 20
Test Results : For further details, please refer to following page(s)
Test Performed : SGS Korea tested the sample(s) selected by applicant with following results.

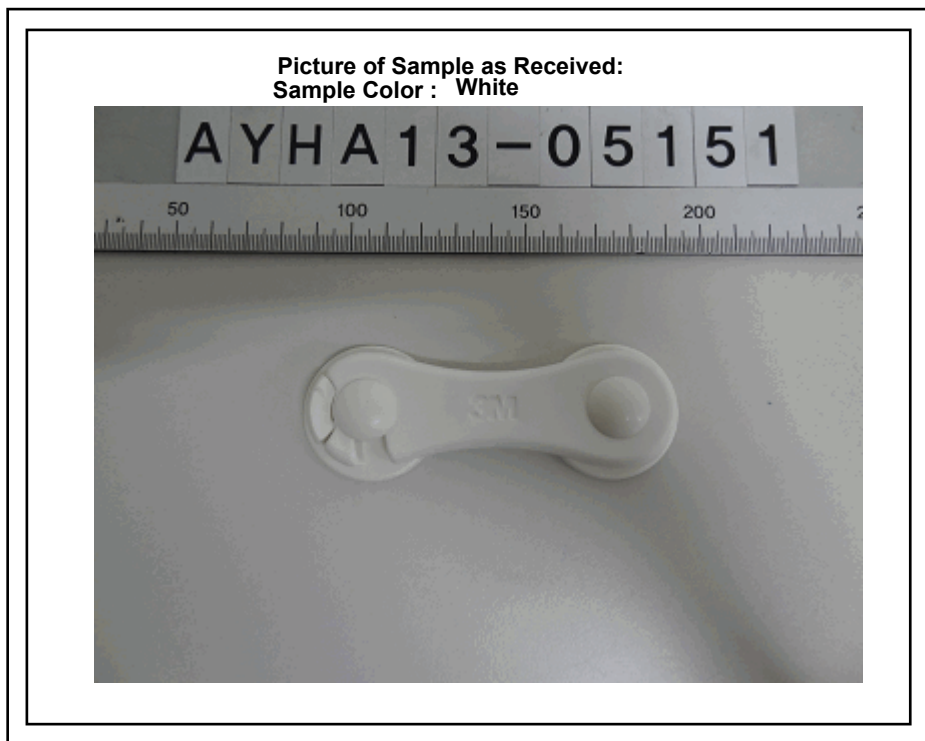
Sample No. : AYHA13-05151.001
Sample Description : White plastic
Item No./Part No. : N/A
Materials : ABS / acryl foam tape

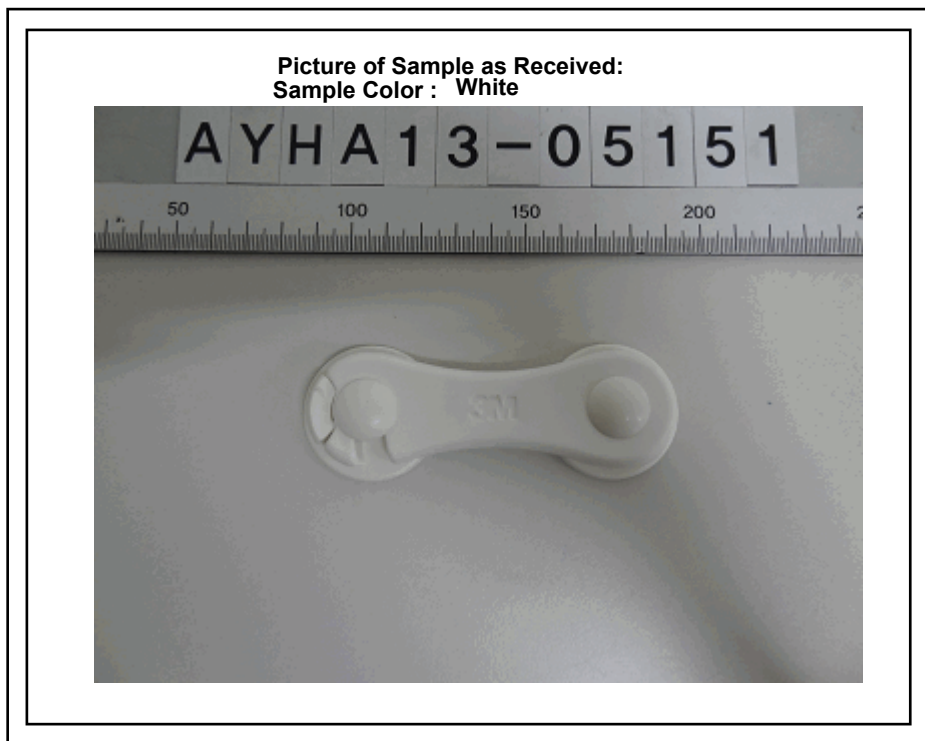
Sample No. : AYHA13-05151.002
Sample Description : White foam
Item No./Part No. : N/A
Materials : ABS / acryl foam tape
