Esthetic Restoration of Maxillary Central Incisors.

Prof. Cathia Bergeron, DMD, MS

Case Report

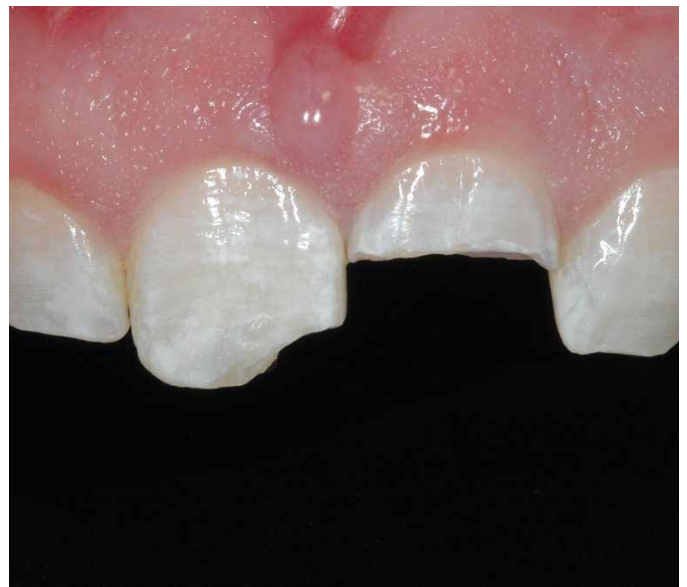
The patient, a 22-year-old male, visited the clinic after having broken teeth Nos. 1.1 and 2.1 in a fall the previous night (Fig. 1). The patient's college graduation was in 3 days, and he was seeking a way to repair the teeth quickly and esthetically. Radiographs were taken, and because of the severity of the break on tooth No. 2.1, it was also tested for vitality with an electric pulp test, a cold test, and a percussion test prior to determination of treatment. All test results showed the tooth to be vital, and the patient agreed to proceed with a resin buildup. The patient was informed at this time that tooth No. 2.1 would have to be monitored closely with regular 6-month checkups to ensure its ongoing vitality, and he understood that a root canal might eventually become necessary.

Figure 1: The patient had broken both teeth Nos. 1.1 and 2.1 from a fall.

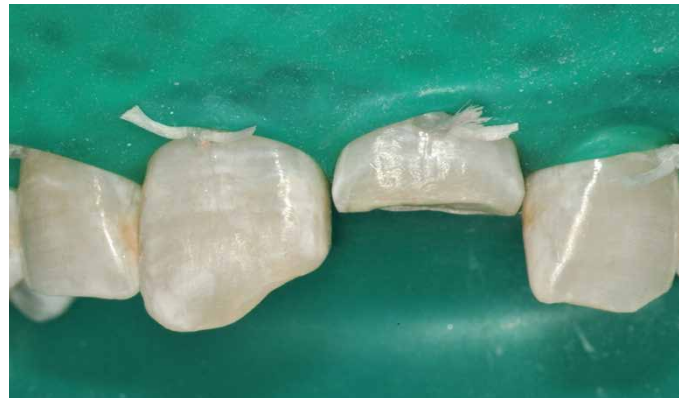
Figure 2: The teeth were prepared with infinite bevels.

Next, a rubber dam was placed and ligated with floss. Then, the preparations were done using a flame diamond (8862-014 [Brasseler USA]) to create a bevel around the teeth. A flexible disc (3M Sof-Lex™ Extra-Thin Contouring & Polishing Disc) was then used to blend the bevel on the tooth surface and to round the sharp angles interproximally (Fig. 2).

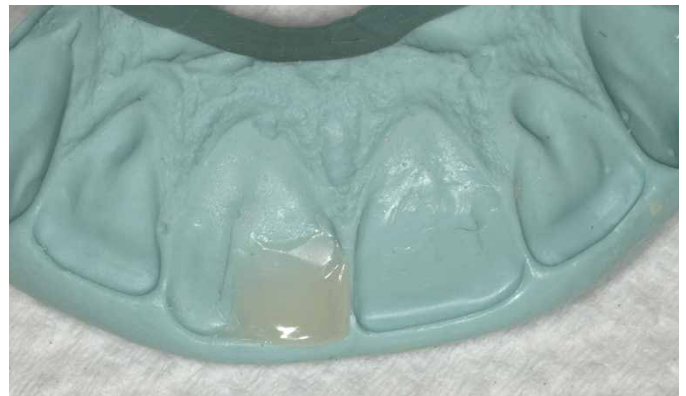
Figure 3: A small amount of composite in shade A1E was placed in the lingual matrix.

A small amount of Filtek™ Z350 XT Universal Restorative (3M) in shade A1E was placed in the lingual matrix (Fig. 3), and the matrix was then held to the lingual of the teeth. The resin was attached to tooth No. 1.1 with a football burnisher and cured in place (Fig. 4). This process created a lingual shell upon which to build the remainder of the restoration, with the proper width and height pre-determined by the diagnostic wax-up (Fig. 5).

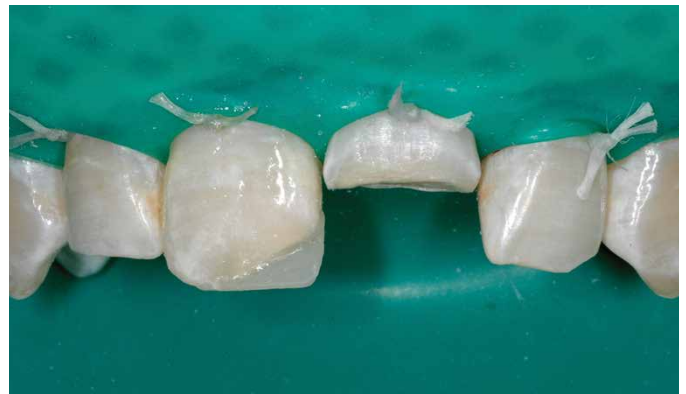
Figure 5: The index was removed, leaving a lingual shell on which the remainder of the restoration was built.

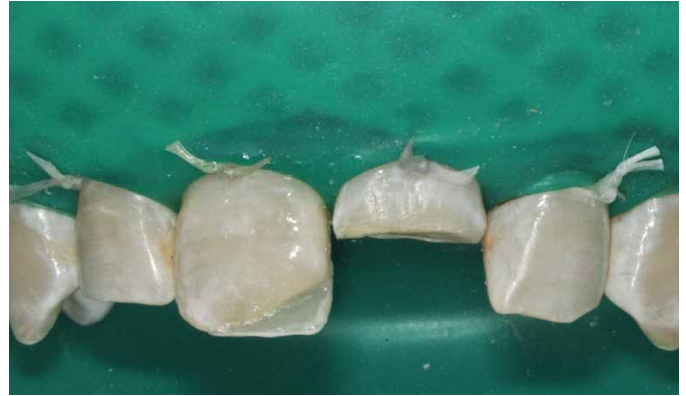
Figure 6: A halo was created with white tint at the incisal edge.

A fine line of white tint was then applied at the incisal edge to create a "halo" on the tooth (Fig. 6), and the dentine buildup was then performed with the more opaque and darker shade of Filtek™ Z350 XT A2B shade (Fig. 7). The dentine component was cured, and incisal translucent material was placed in the incisal third. These layers were followed with additional white tint to recreate the white spot effect on the patient's other teeth. The final enamel layer was placed with A1E material, and was then shaped with an interproximal carver, a gold Almore instrument, and brushes to make the surface smooth and to bring the restoration to the proper contour (Fig. 8).

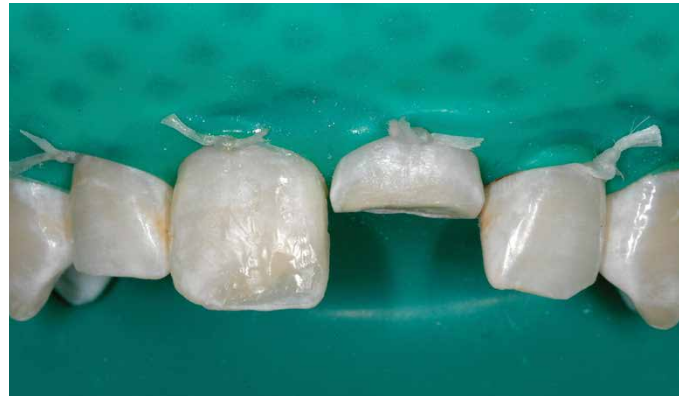
Figure 7: Shade A2B was utilised for the dentine buildup.

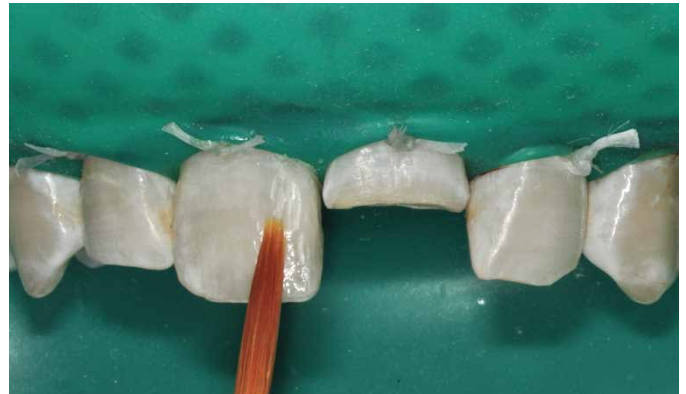
Figure 8: The final enamel layer was shaped with an IPC, gold Almore instrument, and brushes.

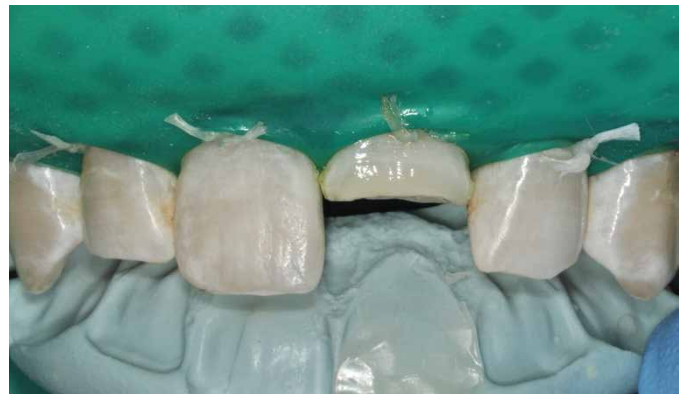
Figure 9: Composite was placed first in the lingual matrix, then brought to the teeth and attached with a football burnisher and a brush to create the lingual shelf.

Following completion of tooth No. 1.1, tooth No. 2.1 was treated similarly. Celluloid strips were placed to protect the adjacent teeth during etching and bonding, then removed following curing of the bonding agent. Composite resin was again placed first in the lingual matrix (Fig. 9), then brought to the teeth and attached with a football burnisher and a brush to create the lingual shelf. A metal matrix (Original Tofflemire® matrix band #1, .0015in. [Waterpik]) was placed and the distal contact and surface were built with A1E material (Fig. 10). The same process was then used to create the mesial contact, surface and embrasure (Fig. 11). With the lingual, mesial and distal components in place (Fig. 12), the dentine buildup was performed with Filtek™ Z350 XT A2B material. The dentinal lobes were shaped and cured, and an incisal halo was again created using white tint. Clear translucent material was used in the incisal third between the dentinal lobes, and white tint was then applied and cured. The final layer of A1E was placed and shaped as described for No. 8 (Fig. 13).

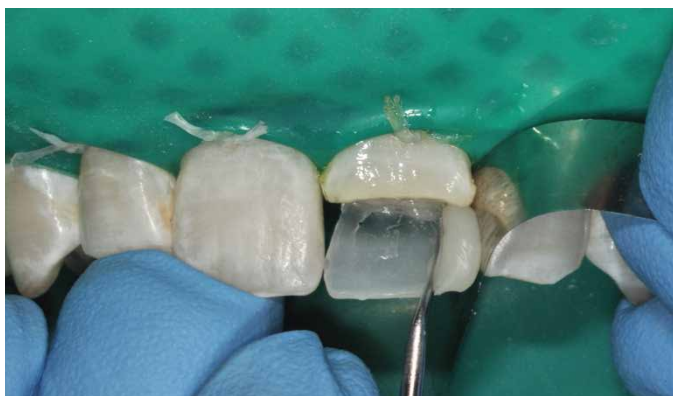
Figure 10: The distal contact and surface were formed.

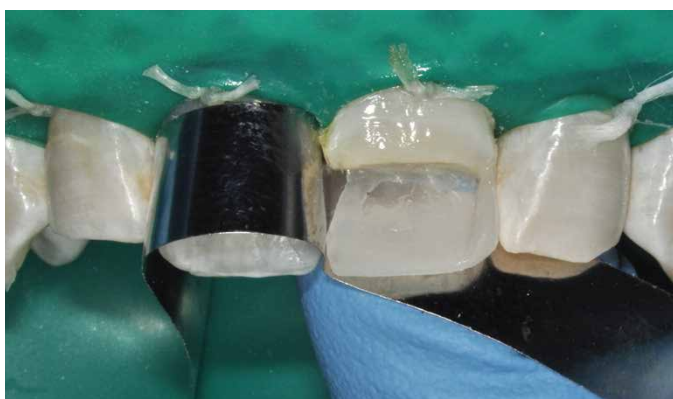
Figure 11: The mesial contact, surface and embrasure were created.

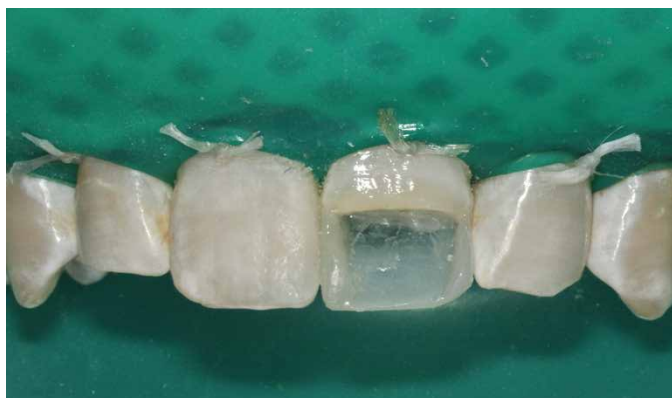
Figure 12: The final proximal surfaces.

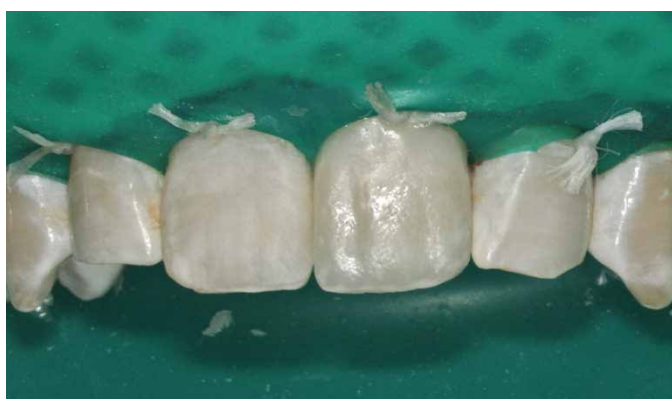
Figure 13: Final contour of the restorations before finishing.

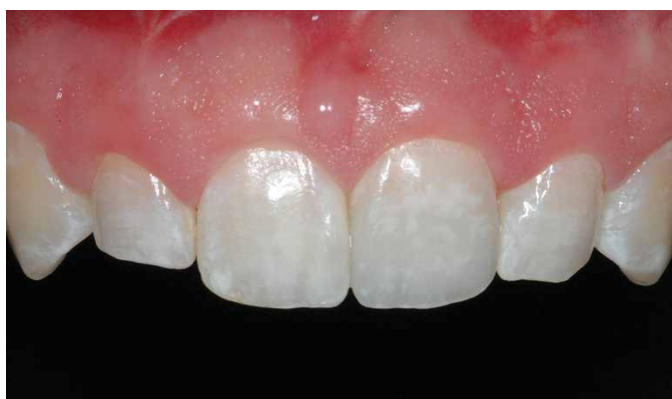
Figure 14: The completed restorations.

The completed restorations showed a very natural emergence profile and the overall match to the patient's teeth was excellent (Figs 14 and 15). The patient was very pleased with the final result and felt confident heading in to his graduation. Despite the success of this treatment, the patient understands that the area must be monitored carefully in the future due to the trauma the teeth suffered. However, if tooth No. 2.1 remains vital, it is hoped that these restorations will serve for a number of years.

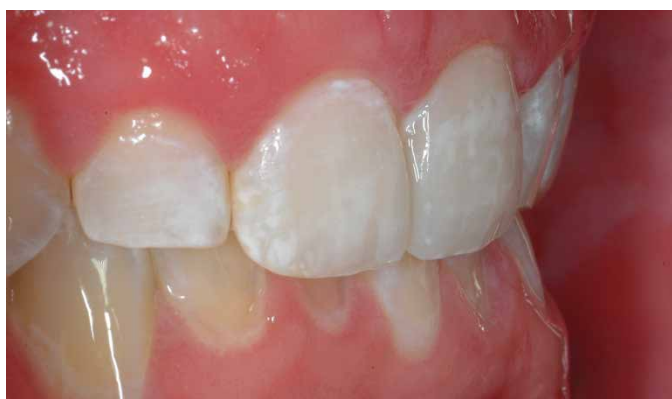
Figure 15: A very natural emergence profile was achieved.
