Negative pressure wound therapy you can trust

Discover the value of 3M[™] V.A.C. Therapy, now with 3M[™] V.A.C. Dermatac[™] Drape

3M™ V.A.C.® Therapy: Technology you can trust

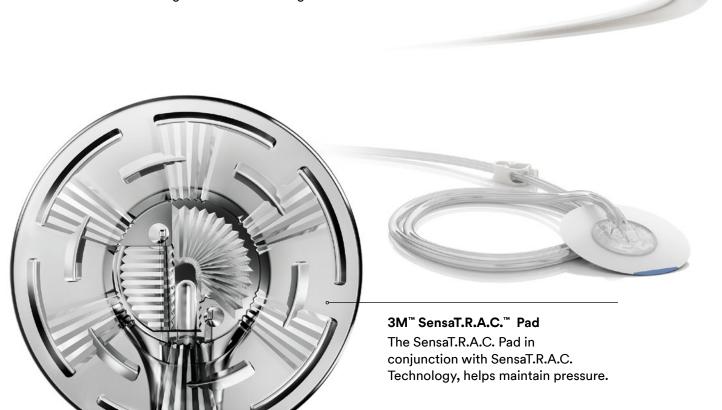
3M™ SensaT.R.A.C.™ Tubing

SensaT.R.A.C. Tubing efficiently draws exudate away from the wound and independently monitors target pressure through multi-lumen tubing.

Exudate removal

Monitor

3M™ SensaT.R.A.C.™ Technology in action

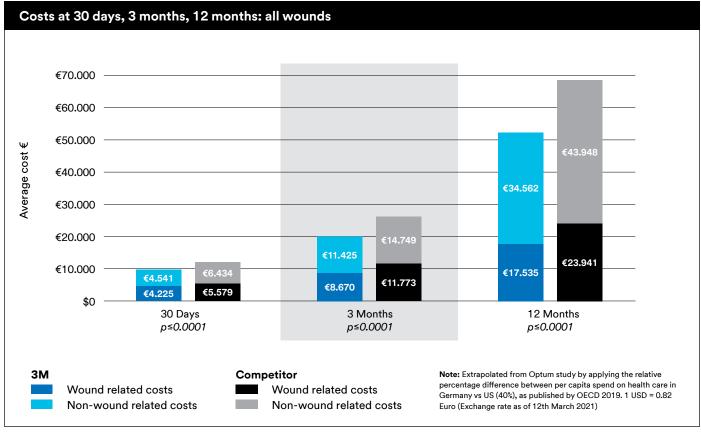
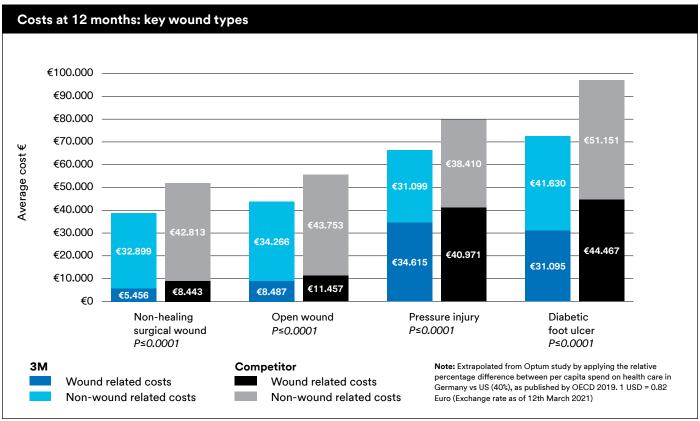
Retrospective analysis of U.S. insurance claims database compared total and wound-related costs for 15,180 patients who received 3M™ V.A.C.® Therapy versus competitor NPWT in the outpatient setting between January 2016 and September 2018. Costs were compared across care settings and wound types at 30 days, 3 months, and 12 months after initial claim.⁶

- 3M[™] V.A.C.® Therapy patients had lower total and wound related costs across all time periods and across all wound types at 12 months.
- V.A.C.® Therapy patients experienced shorter average length of therapy and were less likely to be switched to another supplier.
