ACTIV.A.C.™ Therapy System Alarm Troubleshooting

Quick reference for the delivery of prescribed therapy.

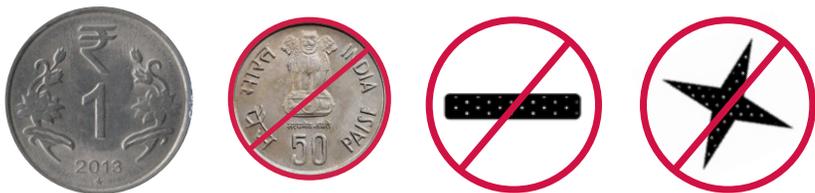
One Rupee coin-sized is the Right Size

IMPORTANT! To help optimize performance of the SENSAT.R.A.C.™ Pad, you must cut One Rupee coin-sized (2.5cm) hole in the dressing. A smaller hole, an “x” or a slit may cause blockage, pressure fluctuations and other functionality issues. This can prevent delivery of prescribed therapy and cost patients valuable healing time.

Sensing Lumens

Blockage Alarm	Unit has determined that blockage is present	<ul style="list-style-type: none"> Check tubing for closed clamps, kinks, crimps or blockages Inspect to ensure One Rupee coin-sized (2.5cm) hole has been cut in the drape Ensure dressing and drape have not shifted and blocked SENSAT.R.A.C.™ Pad outer lumens 	<ul style="list-style-type: none"> Ensure One Rupee coin-sized (2.5cm) hole has been cut in the drape A smaller hole, an "x" or a slit may cause blockage, pressure fluctuations and other functionality issues Ensure SENSAT.R.A.C.™ pad is located in a flat area of the body, avoiding a skin fold Avoid the additional use and application of adhesive tape on or over SENSAT.R.A.C.™ Pad

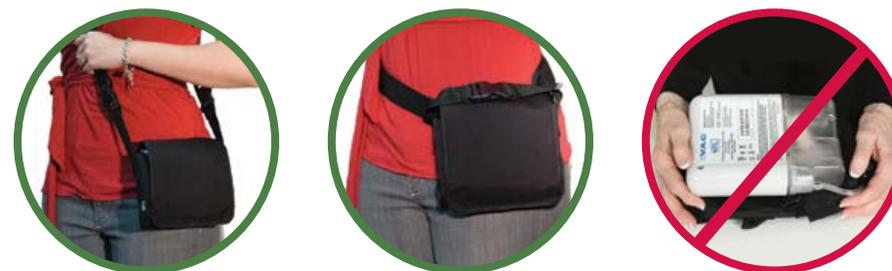
Optimal Orientation

To help minimize canister alarms when not being worn, maintain the unit in an upright position. Avoid placing therapy unit upside down (with touchscreen facing down).

System Alarm	Alarm Condition	Action/Resolution	User Tips	
Canister Full Alarm	Unit has detected the canister is full and should be replaced. If minimal amounts of fluid in canister, please call your local representative	<ul style="list-style-type: none"> Change ACTIV.A.C.™ canister 	<ul style="list-style-type: none"> Avoid placing the ACTIV.A.C.™ Therapy Unit into carrying bag with canister pointing upwards. Unit should be worn or hung so that touchscreen is visible in window Avoid placing therapy unit upside down (with touchscreen facing down) for prolonged periods of time
