**Immediate Action Required**

Select 3M DBI-SALA® Sealed-Blok™ Self-Retracting Lifeline, Retrieval

Select 3M DBI-SALA® Sealed-Blok™ Brake Assemblies

3M is issuing this “Stop Use and Remediate” notice for select 175 ft 3M DBI-SALA® Sealed-Blok™ Self-Retracting Lifelines with retrieval function.

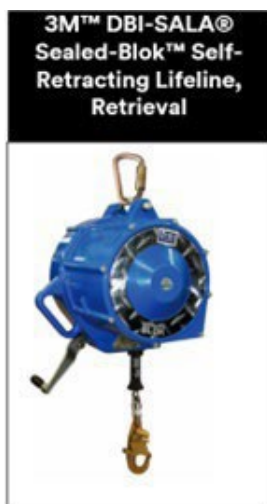
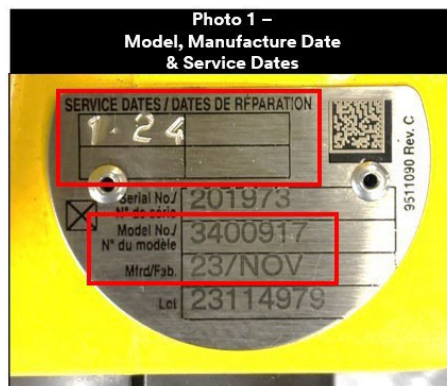
**Step 1 a.** Locate the model number on the metal identification label (see Photo 1). If your device model number is listed in the table below, proceed to **step 2a**. If the model number is not listed below, it is not part of the notice and can be returned to service.

**Step 2a.** Locate the manufacturing and service date records on the metal identification label. If the device was manufactured OR serviced from January 2022 to October 2024, go to **step 3a**. If the device was not manufactured or serviced during the affected timeframe, it is not part of the notice and can be returned to service. (See Appendix A for remediation mark on label).

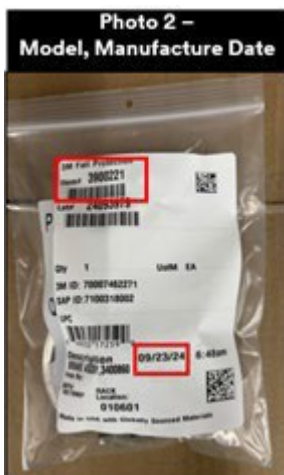
**Step 1 b.** Regarding brake assemblies, locate the model number on the label (see Photo 2). If your brake assembly model number is listed in the table below, proceed to **step 2b**. If the model number is not included, it is not part of the notice and can be returned to service

**Step 2b.** Locate the manufacturing date record on the brake assembly label. If the brake assembly was manufactured from January 2022 to October 2024, go to **step 3b**. If the brake assembly was not manufactured during the affected timeframe, it is not part of the notice and can be returned to inventory for use in services/repairs.

- Sort option: Use Service Bulletin 65 with provided go/no-go gauge part number 9600125 to sort brake assemblies. Any passing the go/no-go check should get green checkmark on the bag and be returned to inventory. Any not passing the go/no-go check should be marked with a red **X** to be returned to 3M for credit
- Return all option: If you will not sort brake assemblies and prefer to return them to 3M, please contact 3M Customer Service to setup a Return Material Authorization (RMA) and receive product credit or replacement. Not all replacement or remediation options are immediately available at the time of this communication.

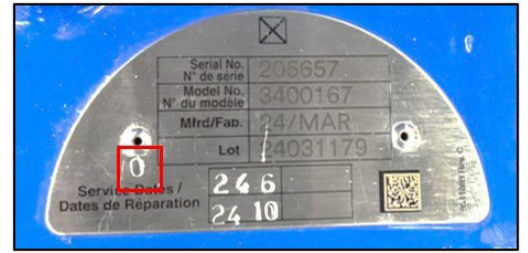
3M DBI-SALA® Sealed-Blok™ Self-Retracting Lifelines that have gone through remediation will have a “0” marked on the metal identification label near Lot or Manufactured Date (see image).

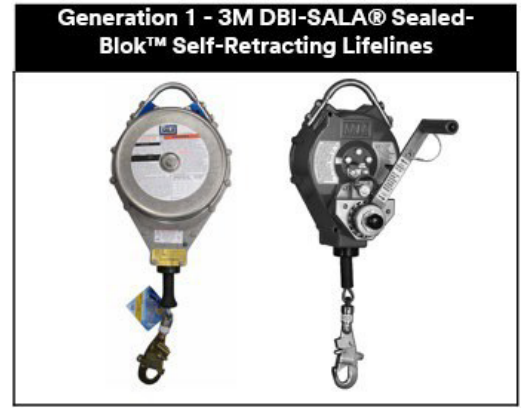
Generation 1 Sealed-Blok™ Self-Retracting Lifelines, produced prior to 2015, have a different housing (teardrop shape). They are **not** part of the notice and can continue to be used and repaired as directed.
