# THE DENTAL ADVISOR

## 3M ESPE Z100™ Restorative 15-year Clinical Performance + + + + +

### Description

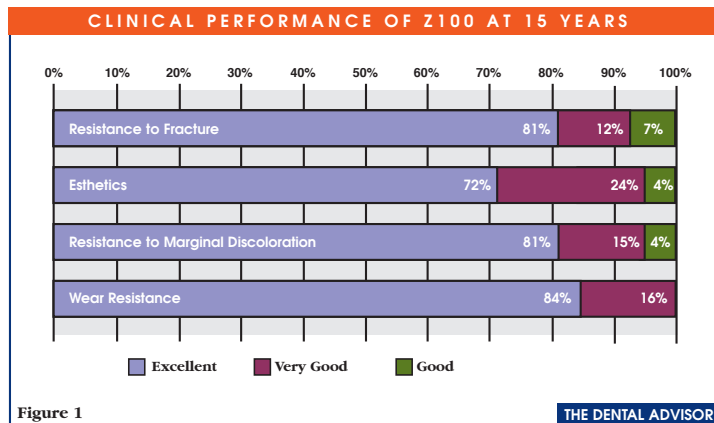
Figure 1 summarizes the ratings that the 129 restorations received in the categories evaluated: resistance to fracture, esthetics, resistance to marginal discoloration, and wear resistance.

One hundred five of 129 restorations exhibited no fracture or chipping (81%). The remaining 19% showed some minor chipping. None of these restorations required replacement.

Very little shade change took place over the 15-year period. Seventy-two percent of the recalled restorations exhibited excellent shade match. About 28% showed slight discoloration, some of which could be due to water sorption. Marginal discoloration is likely related to the bond of the composite to the tooth. In most cases, the composite was bonded with a 4<sup>th</sup>-generation bonding agent. Some of the discoloration at the margins was due to chipping and it was most visible in patients who smoked. Eighty-one percent of the restorations had no discoloration at the margin.

most cases, wear was almost undetectable, either with an explorer or an intraoral camera. The low wear rate of **Z100** is consistent with the normal amount of wear observed on tooth enamel and amalgam restorations. None of the restorations were replaced because of excessive wear. In fact, in 84% of the restorations, the wear was undetectable visually.
